**HUGHES  
SERVICE INFORMATION  
NOTICE**

NOTICE NO. HN-80

**SUBJECT:** BENDIX SERVICE BULLETIN NO. 109, DATED 10/22/74  
INSPECTION, FLEXIBLE COUPLING LOCKNUTS

# Service Bulletin No. 109

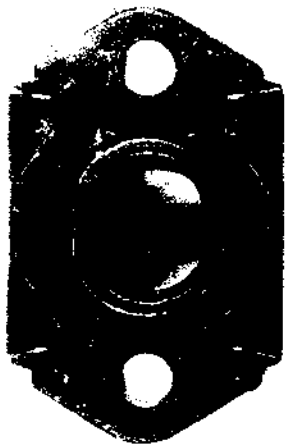
**B**

Investigation revealed a condition wherein the locking nut was noted to crack in the clinched area, which can result in the loss of the locking feature of the unit.

Research of records indicate receipt of one lot of floating nuts as depicted in "B", Figure 1. It is recommended the nuts illustrated in "B", be replaced to preclude cracking. Floating nuts as illustrated in "A", Figure 1, are acceptable and do not require replacing.

Parts conforming to "B", Figure 1, inspect for any cracks or indication of cracks in the clinched area of nut.

B) Replace at once any floating nuts which are cracked or have indication of crack.

C) Floating nuts which do not indicate cracks, replace as soon as practical but no later than twenty (20) days after receipt of parts.

Remove rivets by drilling out rivet head. Use a No. 34 drill (.111 inch diameter). Use care when rivet head breaks loose not to drill into or damage area around rivet hole in coupling flange. Replace coupling if drill contacts diaphragm.

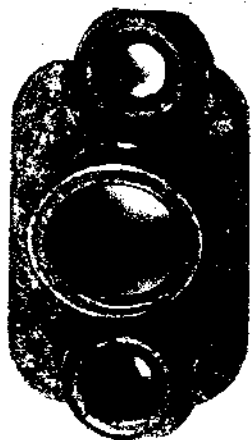
**A**

Inspect subject shafts and couplings to determine type floating nuts installed. Parts conforming to floating nuts illustrated in "A", Figure 1, do not require replacing.

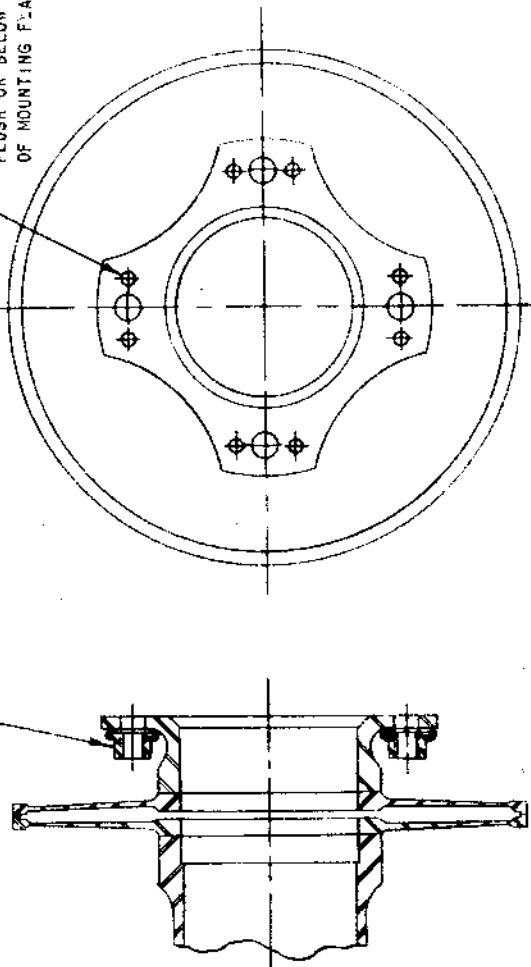
FIGURE 2

MS 20605MP3K3  
RIVET HEAD MUST BE  
FLUSH OR BELOW FACE  
OF MOUNTING FLANGE

When practical and with availability of riveting tool, reinstall Nut, NAS1068A4, with rivets using proper riveting tool. Rivet heads must be flush or below flange surface. Reference Figure 2.
