SERVICE BULLETIN

CORROSION INSPECTION/TREATMENT – ONE-WAY LOCK SUPPORT ASSEMBLY, P/N 369A7314 AND 369N2648

All 500C Model 369H Series Helicopters

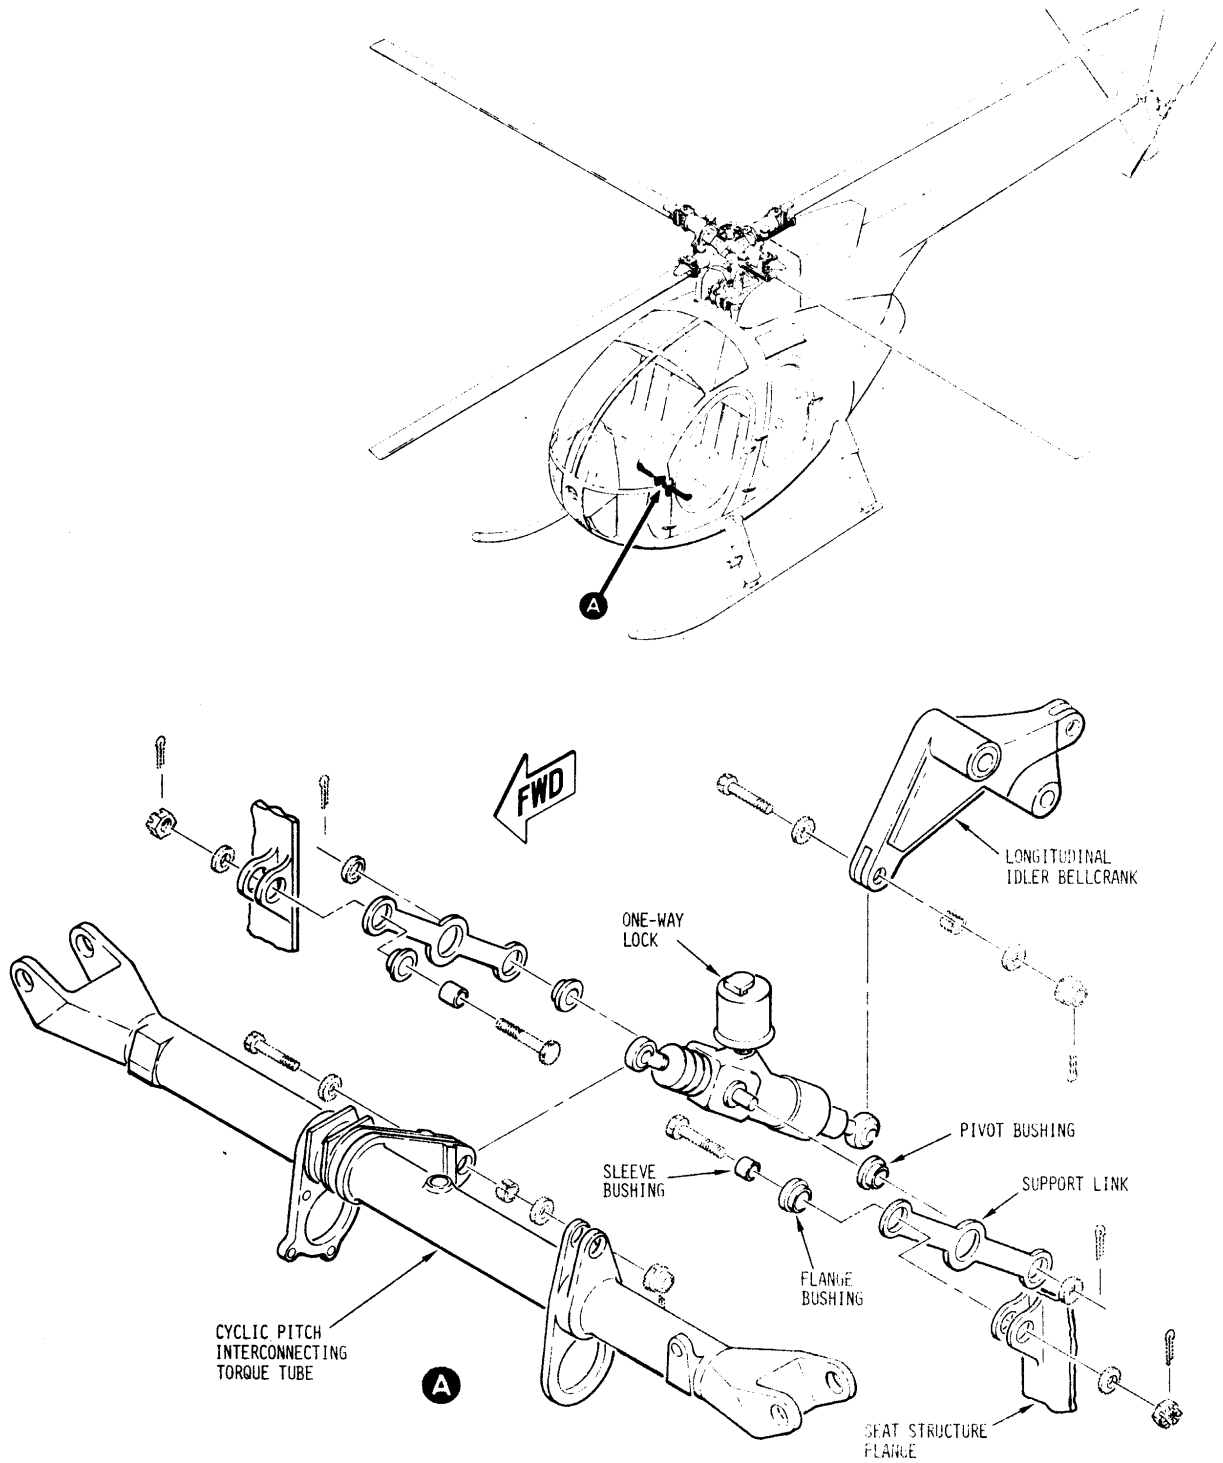
Figure 1. One-Way Lock Control System

It is to be noted that galvanic corrosion has occurred at the aft (lower) ends of the magnesium alloy support links where the brass pivot bushing (P/N NAS77A8-21P) and steel washer contact the link. However, the possibility for corrosion also exists at the forward (upper) end of each link where it contacts the brass flange bushing (P/N NAS77A6-23P) and a steel washer. Each of the support links is to be inspected, treated if necessary, and sealed with a corrosion inhibiting sealing and coating compound. Procedures are also included for the interchangeable aluminum support assembly, PN 369N2648.

f. Reassemble support link assemblies and the one-way lock assembly into the cyclic control system, as follows:

1. Assemble aft end (farthest from center hole) as follows:

- (a) Insert the brass pivot bushing.
- (b) Place the assembled bushing and support link on a uni-loc trunnion, with the bushing flange next to the uni-loc.
- (c) Place steel washer on protruding trunnion and secure with cotter pin.
- (d) Ensure that all contacting surfaces between the magnesium alloy or aluminum support link and all dissimilar metals are coated with sealant.

2. Assemble forward end (closest to center hole) as follows:

- (a) Place the steel sleeve bushing on the bolt.
- (b) Place the brass flange bushing on the assembled bolt and sleeve. Ensure that the bushing flange is next to the bolt head.
- (c) Align the hole in the forward end of the support link with the hole in the seat structure flange.
- (d) Insert the assembled bolt and bushings through the support link and through the seat structure flange.
- (e) On the threaded end of the protruding bolt, place steel washer and nut. Secure with cotter pin.
- (f) Ensure that all contacting surfaces between the magnesium alloy or aluminum support link and all dissimilar metals are coated with sealant.
