HN-198.1\*  
DN-131.1\*  
EN-020.1\*  
FN-008.1\*

# SERVICE BULLETIN

DATE: 30 OCTOBER 1987  
PAGE 1 OF 7

## CORROSION REMOVAL AND MAGNETIC RUBBER INSPECTION OF MAIN ROTOR DRIVE SHAFT I.D.

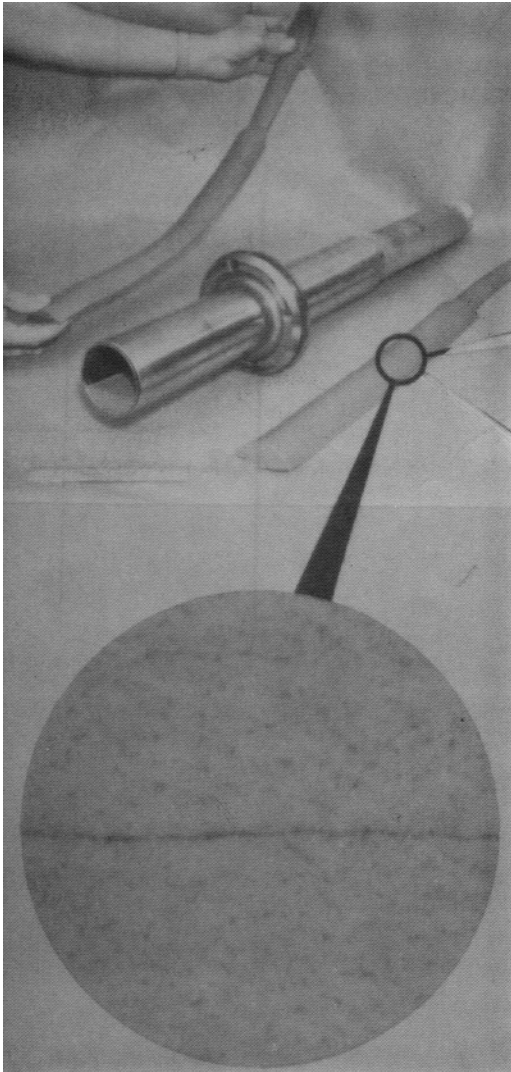
**Figure 1. Inspection of Main Rotor Drive Shaft Inside Diameter.**

INDICATIONS OF CRACKING  
WHEN VIEWED WITH A  
10X MAGNIFYING GLASS  
(UNACCEPTABLE DRIVE SHAFT)

SMALL CRACKS EASILY SEEN UNDER 10X MAGNIFICATION

- Questionable replicant indications shall be carefully packaged and sent to MDHI for evaluation. If considerable corrosion is noted, the drive shaft can be sent to MDHI Warranty and Repair Department for inspection and interpretation.
- If any cracks are noted, scrap and replace shaft (see Figure 1.)
- See Figure 2 for location of acceptable machining indications.

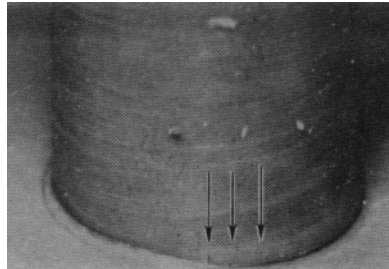
A. EDGE CRACKS IN THE .002"  
TO .015" SIZE RANGE

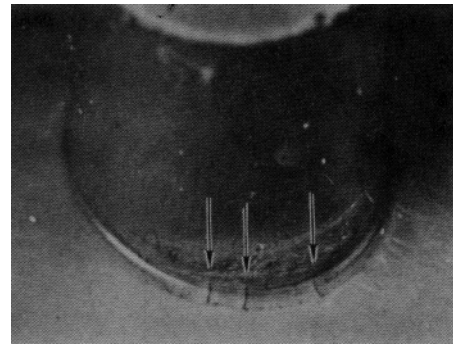
B. .020" TO .030" EDGE CRACKS

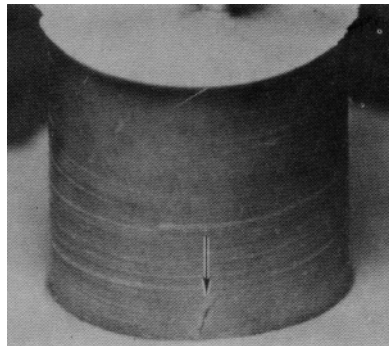
C. INTERNAL CRACK IN HOLE IS .050"  
IN LENGTH
