SB369H-256
SB369E-112
SB500N-052

SERVICE BULLETIN

DATE: 30 JUNE 2015

EXCHANGE OF ENGINE BAY DOOR LATCH ASSEMBLIES WITH MISSING LOCKWIRE HOLE

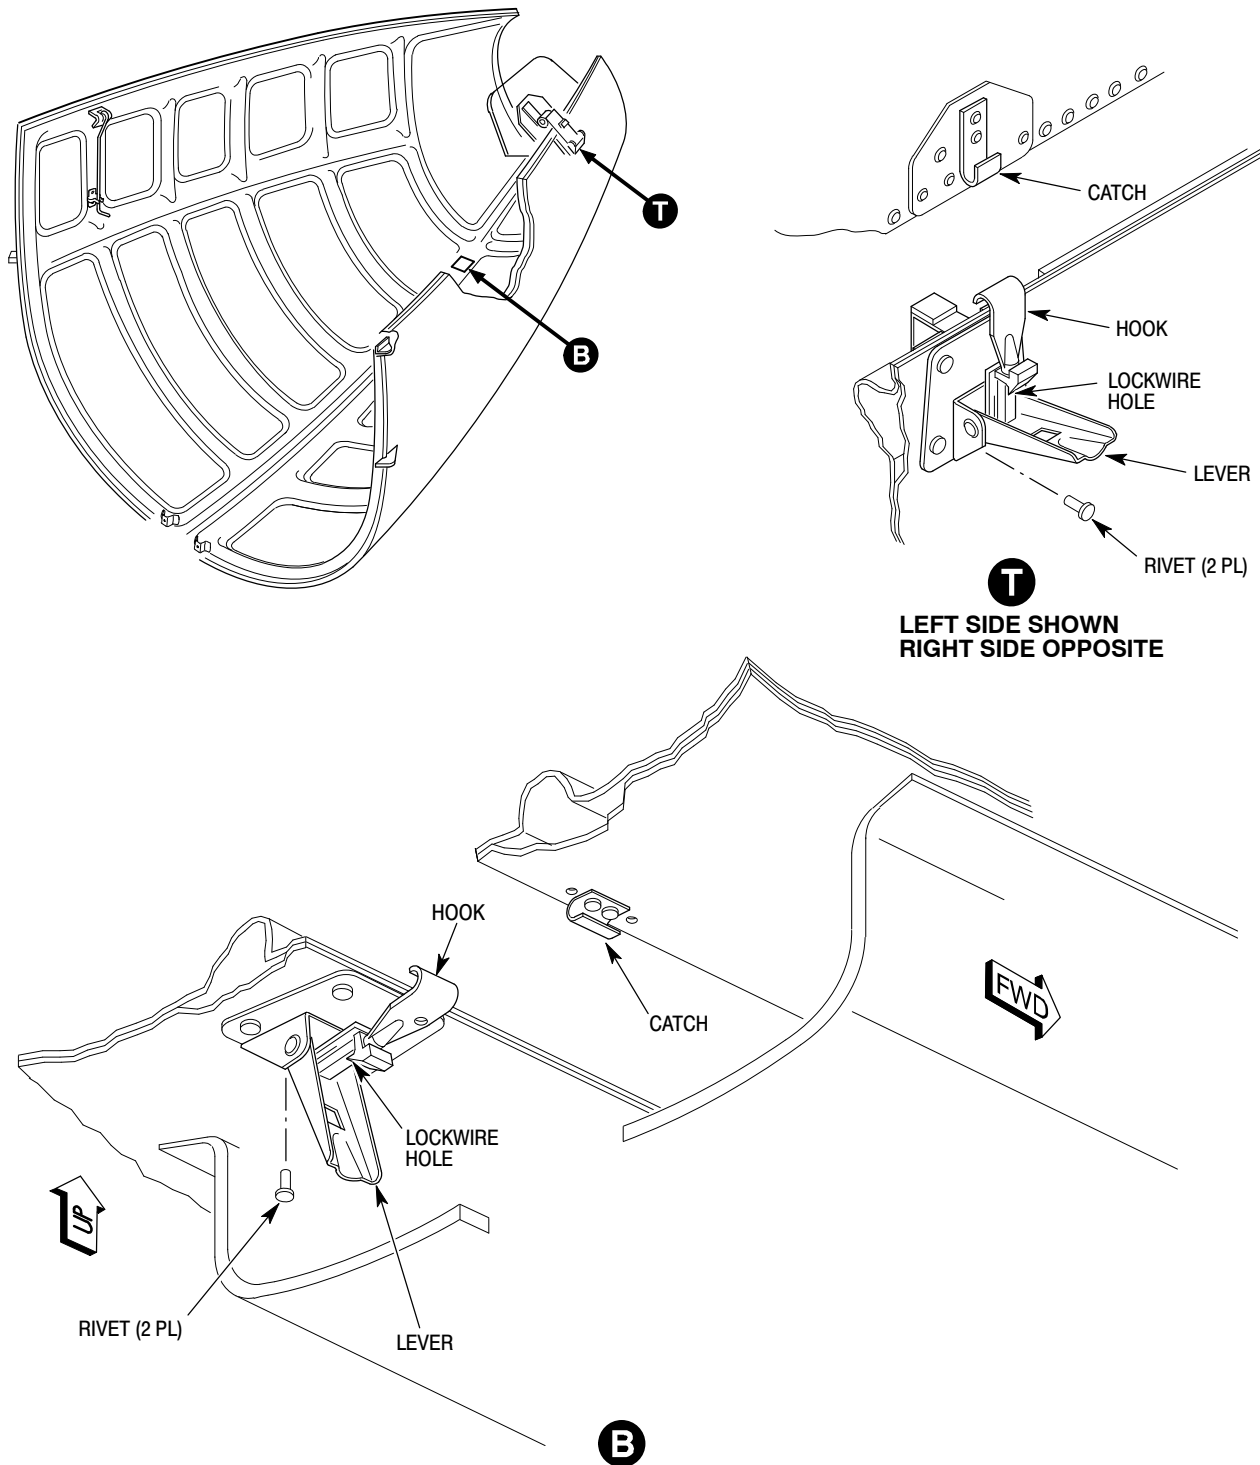
Figure 1. Location of Latch Assemblies

The V951L04-1X38P latch assembly, which is used in three places to lock the engine bay doors does not have the necessary lockwire hole in the draw hook. The lockwire provision is used to safety the draw hook once rigged.

(Ref. Figure 1)

- (1). Do an inspection of helicopter maintenance records for the installation of V951L04-1X38P latch assemblies.
- (2). Do an inspection of helicopters for installed V951L04-1X38P latch assemblies.
 - (a). The V951L04-1X38P latch assemblies will not have the lockwire hole.
 - (b). Tell MDHI Field Service of an incorrect latch to get the correct latch sent to you immediately.
- (3). Remove installed V951L04-1X38P latch assemblies (ref. CSP-HMI-2, Subject 52-40-00).
- (4). Send removed V951L04-1X38P latch assemblies to MDHI with an SOR.
- (5). Install correct latch assembly on the engine access door (ref. CSP-HMI-2, Subject 52-40-00).
