SERVICE BULLETIN

DATE: 15 APRIL 1981

FIELD INSPECTION AND REPAIR OF TAIL ROTOR TRANSMISSION MAIN HOUSING ASSEMBLY, PN 369A5401

All 500C Model 369H Series Helicopters

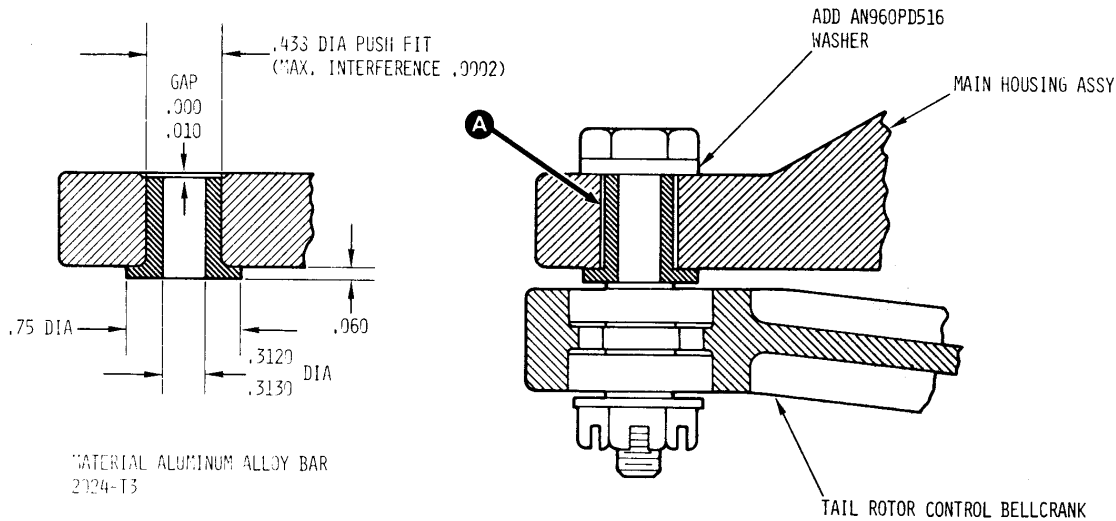
Figure 2. Repair Bushing Fabrication and Installation Details

This service notice provides procedures for inspecting and correcting an elongation of the bolt hole in the support arm portion of the main housing assembly of the tail rotor transmission caused by looseness of the bellcrank fulcrum bolt and nut. Elongation of the subject hole could affect control response sensitivity. If the condition were allowed to persist, it could lead to eventual separation of the bellcrank and support lug of the tail rotor gearbox main housing.

- k. Install transmission assembly on milling machine, and mill 0.060 inch from boss of main housing assembly. (See Figure 2.)
- l. Transfer transmission assembly to drill press or retool mill with 7/16 inch reamer or drill bit to correct elongated hole in support arm portion of main housing assembly.

- q. Fabricate aluminum bushing to comply with specifications provided in Figure 2.
- r. Wash bushing with MEK, and dry thoroughly.
- s. Immediately treat all surfaces of bushing with Turcoat Liquid Accelogold (this is a premixed, ready-to-use product conforming to military specification MIL-C-81706).

TORQUE NUT 100-140 IN.-LBS. ADVANCE NUT TO MEET HOLE AFTER REQUIRED TORQUE IS REACHED. WASHERS AS REQUIRED TO STAY WITHIN TORQUE LIMITS.
