SERVICE BULLETIN

DATE: 26 SEPTEMBER 1994
PAGE 1 OF 6

FIREWALL FUEL FITTING MODIFICATION

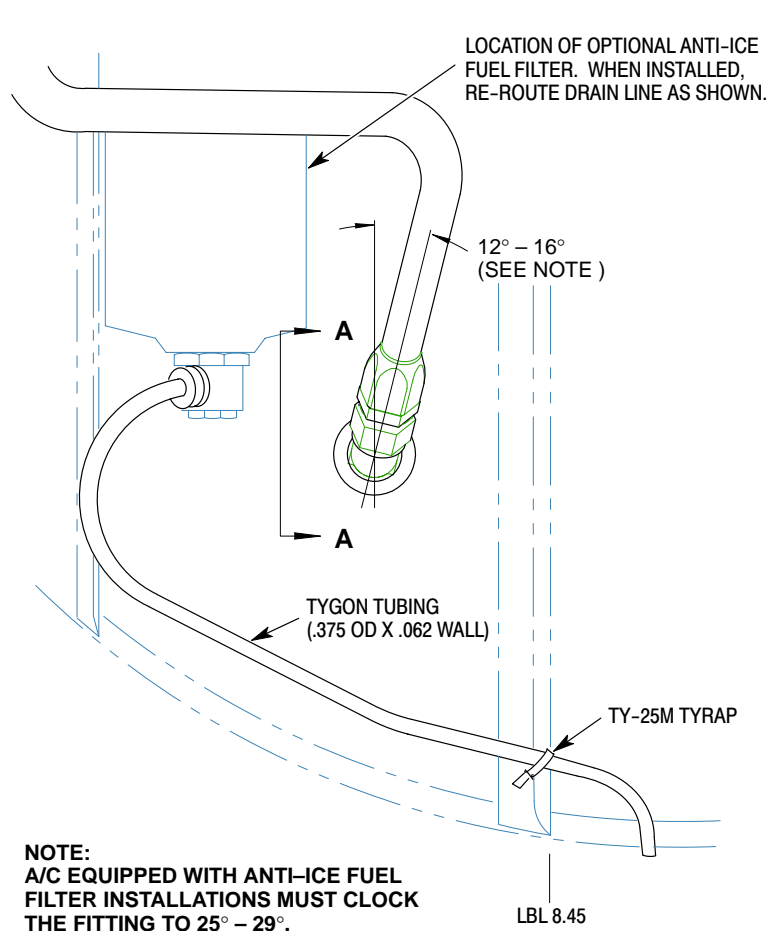
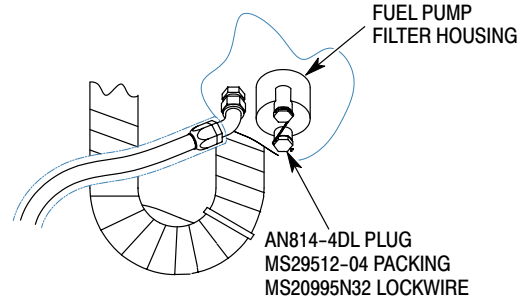
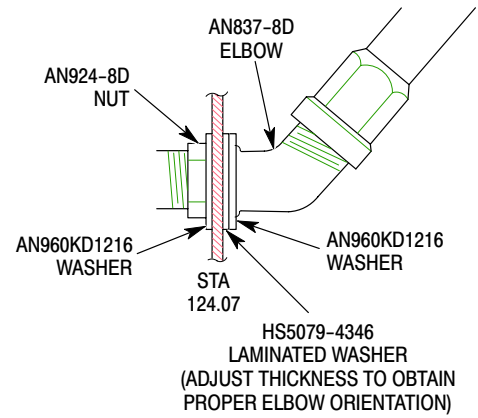
Figure 1. Firewall Fuel Fitting Modification (Installation).

MDHI has received reports from the field of the station 124 firewall fuel fitting interfering with the landing gear brace. As a result, there is a possibility of the fuel fitting becoming damaged, thus creating a potential for fuel leakage. Therefore, MDHI is requiring all operators to modify their aircraft according to procedures contained in this Notice.

- (3). Install AN924-8D (nut), (2) AN960KD1216 (washers), HS5079-4346 (laminated washer) and AN837-8D (elbow) as shown in Figure 1.
- (4). Ensure that AN837-8D is clocked 12° to 16° (25° to 29° for fuel systems equipped with anti-ice fuel filter installations) inboard as shown in Figure 1.

- (5). Reassemble fuel cell lacing per the HMI Vol. I, Section 28-00-00.
- (6). Re-install hoses to the AN837-8D fitting (see Figure 1). Torque hoses per the HMI-CSP-2, Vol. I, Section 28-00-00.

- (7). Install AN814-4DL plug, MS29512-04 packing and MS20995N32 lockwire to engine fuel pump housing 369A8100-507 configurations only at location shown in Figure 1.
- (8). Re-fuel aircraft per servicing instructions contained in the Handbook of Maintenance Instructions (HMI).

NOTE:
A/C EQUIPPED WITH ANTI-ICE FUEL FILTER INSTALLATIONS MUST CLOCK THE FITTING TO 25° - 29°.
