HN-236  
DN-184  
EN-77  
FN-63  
NN-005

# SERVICE BULLETIN

DATE: 10 MARCH 1994

## FOUR-WAY TRIM SWITCH REPLACEMENT PROGRAM

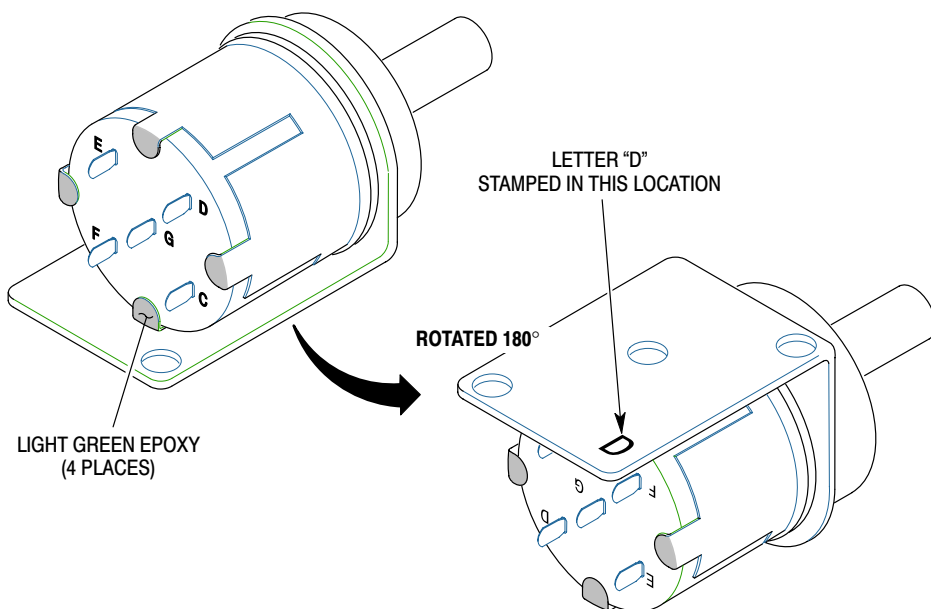
**Figure 1. Four-way Trim Switch.**

Procedures in this notice require operators to replace affected four-way trim switches with switches that have been upgraded by Guardian to a Rev. "D" configuration. Upgraded A218-100646-03 switches can be readily identified by the green colored epoxy added to the four tabs at the bottom of the switch and Rev. "D" stamped on the bottom of the mounting bracket of the switch (see Figure 1).

- (1). Remove affected A218-100646-03 switches per instructions contained in the Handbook of Maintenance Instructions (CSP-HMI-2).
- (2). Install an A218-100646-03, marked with Rev. "D" on its mounting bracket, per instructions contained in the Handbook of Maintenance Instructions (CSP-HMI-2). **NOTE:** A218-100646-03 switches marked with Rev. "D" will also have green epoxy over the four tabs at the base of the switch (see Figure 1).
