SERVICE BULLETIN

DATE: 19 NOVEMBER 1969

INSPECTION AND POSSIBLE RETIREMENT – MAIN ROTOR BLADES, P/N 369A1100–501

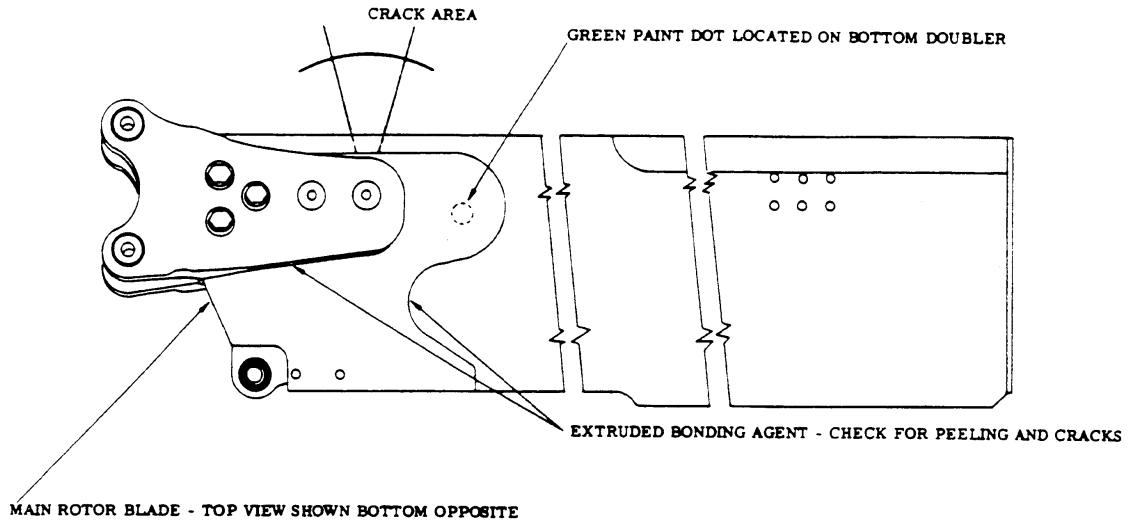
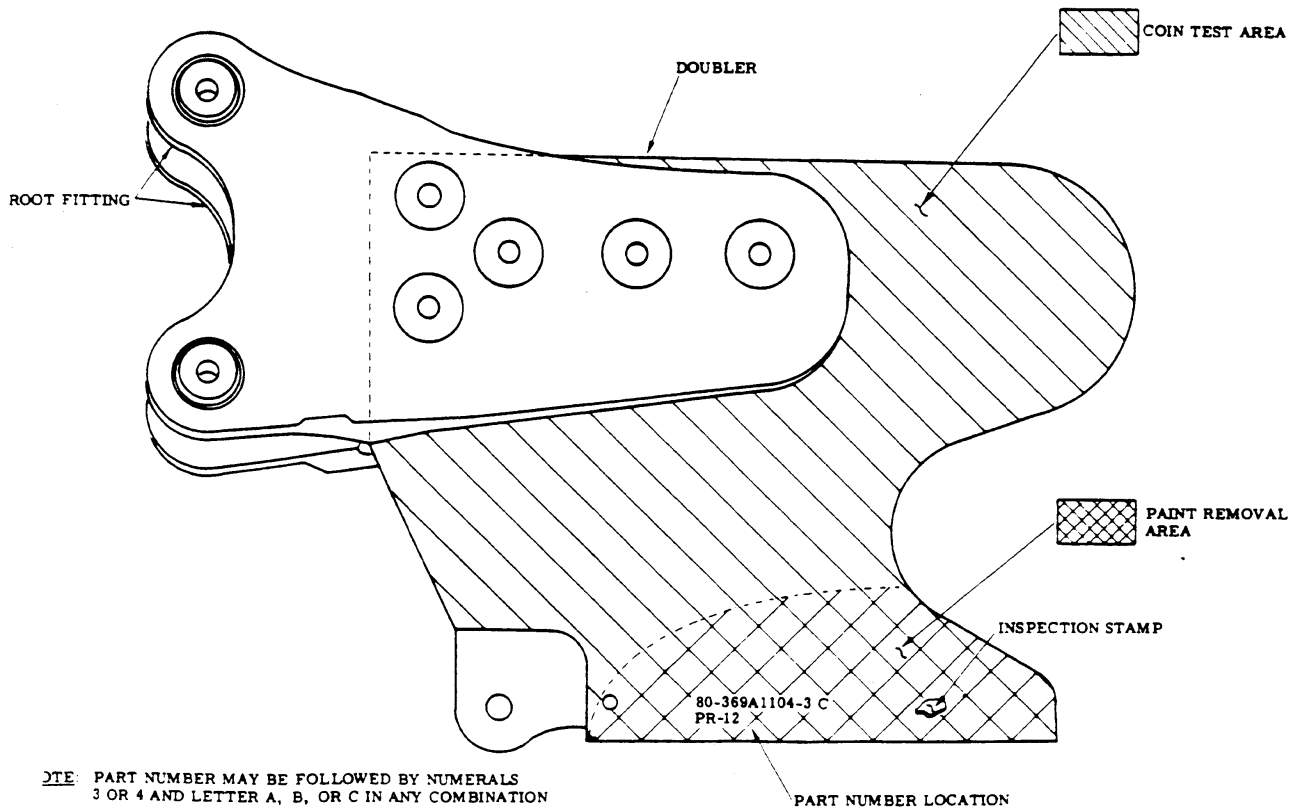
Figure 1. Main Rotor and Doubler Inspection

It has recently been determined that a number of P/N 369A1104 main rotor blade root fitting doublers have been improperly processed. This can result in unsatisfactory bonding of the doubler to the blade, which can cause a reduction in service life.

(2) Visually inspect doubler for peeling along doubler edge; inspect doubler for cracks adjacent to root fitting and blade for cracks emanating from under doubler. Pay particular attention to leading edge of blade adjacent to outboard root fitting bolt.

NOTE: If damage is noted, retire blade from service prior to next flight.

e. Apply 1/4-inch diameter green paint dot to under side of blade on doubler. (Refer to Figure 1).
