SERVICE BULLETIN

IDENTIFICATION AND POSSIBLE REWORK OF SEAT BELT AND SHOULDER HARNESS ASSEMBLIES

All Model 369H Series Helicopters

SERVICE BULLETIN NO. CP-1002

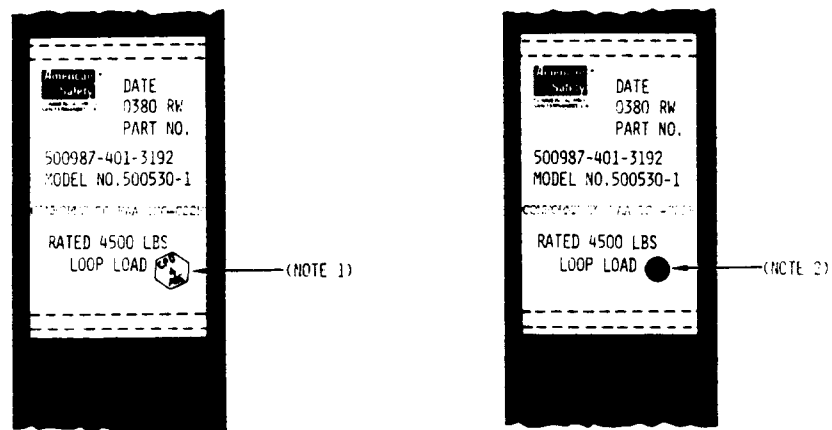
Figure 1. Identification of Reworked Seat Belt Assemblies

If seat belt assemblies are manufactured by American Safety Equipment Corporation, and seat belt tag (See Figure 1) has green hex-shaped stamp, perform step d only.

1. GREEN HEX-SHAPED STAMP DENOTES LAP BELT ASSEMBLY REWORKED BY AMERICAN SAFETY EQUIPMENT CORPORATION (NO FIELD REWORK REQUIRED).
2. GREEN DOT DENOTES LAP BELT ASSEMBLY REWORK ACCOMPLISHED PER THIS NOTICE.

- b. As required, rework American Safety lap belt assemblies per attached Service Bulletin No. CP-1002.
- c. Apply 3/8 - inch green dot on tag at location shown in Figure 1.
- d. Record compliance with this Service Information Notice in Compliance Record of helicopter Log Book.

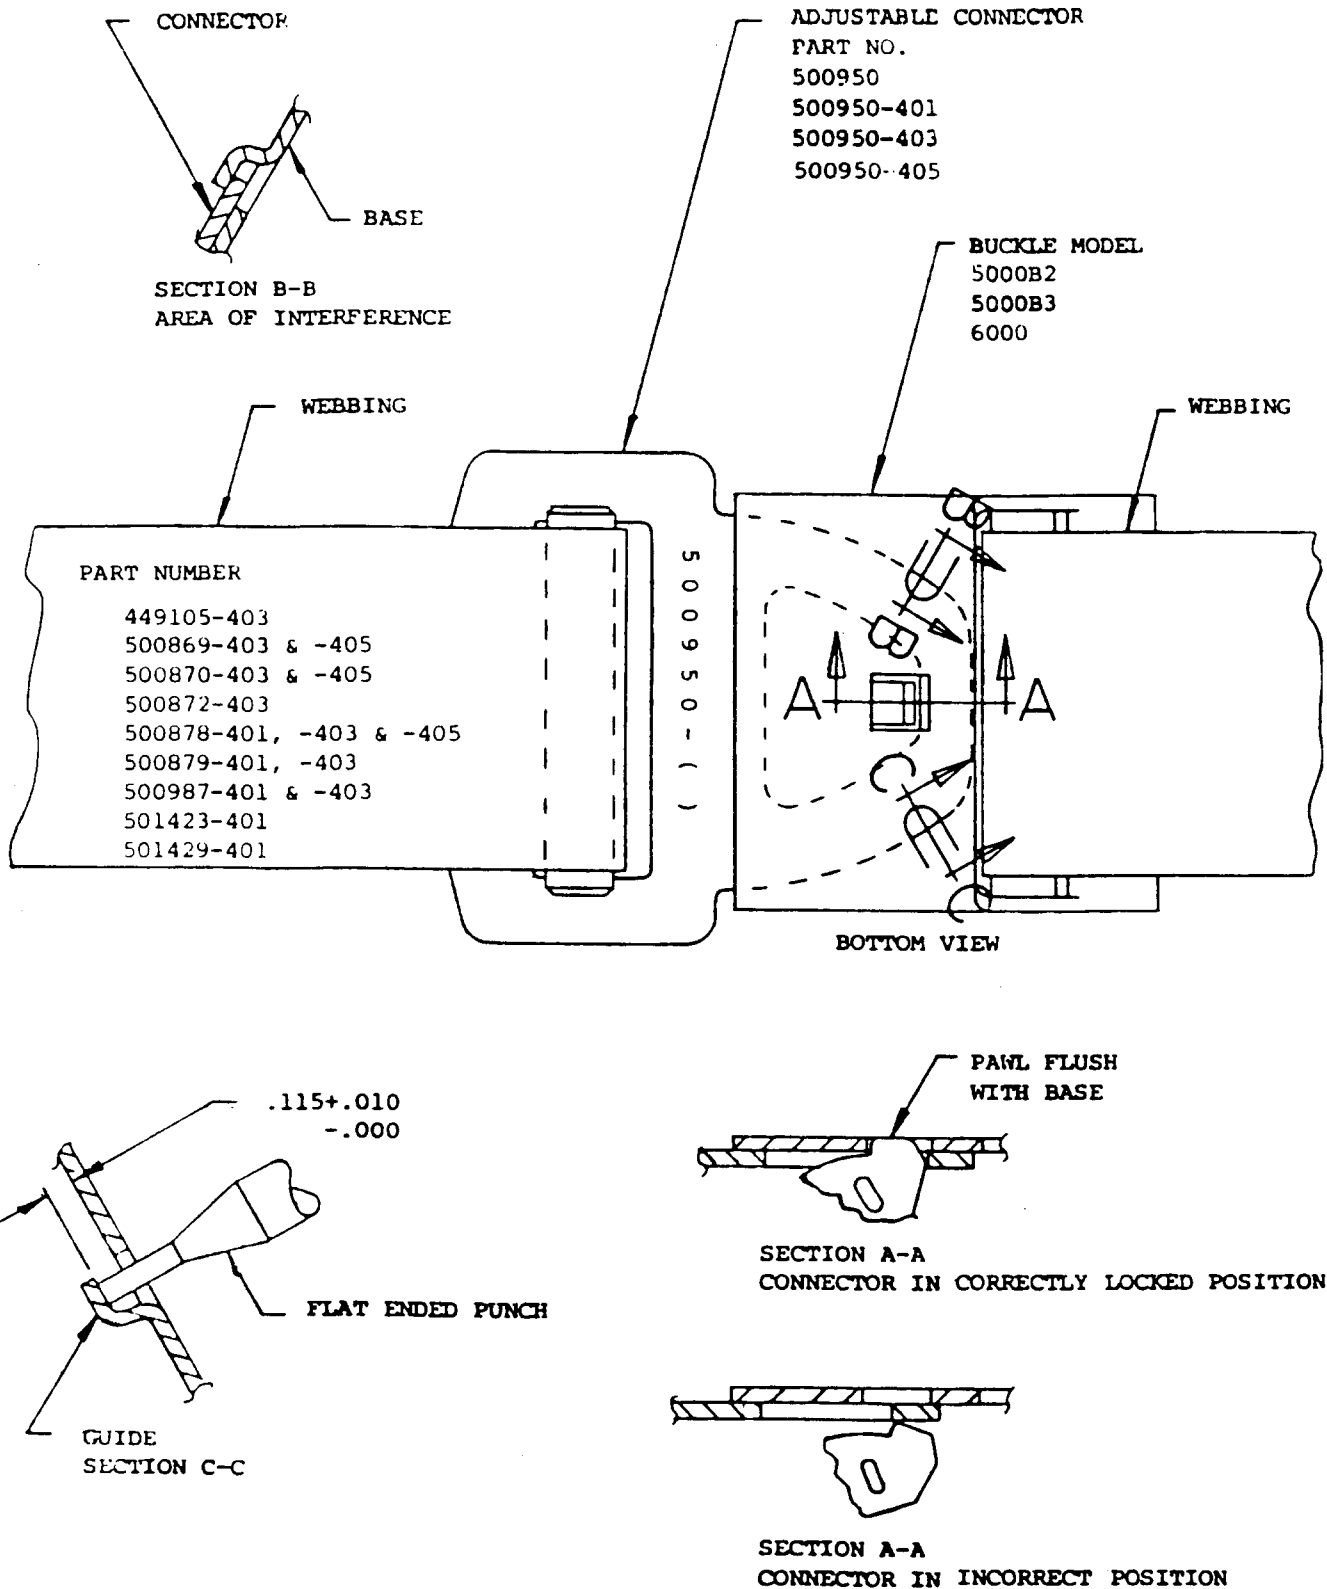
PRODUCT IDENTIFICATION: 1. All buckles and connectors are identified by their respective model or part numbers. The model number of the buckle is on the underside of the base. The location of the connector part number is shown on Figure 1.

EXPLANATION: There is a possibility that some lap belt assemblies due to the thickness of the connector may have interference. See Section B-B of Figure 1. This condition makes it possible for the connector to be pushed in and retained in the buckle without being locked. See Section A-A of Figure 1.

Step 1: Remove connector from buckle.

Step 2: Using a flat punch, strike each of the two guide of Figure 1 until the guide dimensions meet .115/.125 inches as shown in Section C-C of Figure 1.

Step 3: Verify dimension with thickness (feeler) gauge.
