**HUGHES  
SERVICE INFORMATION  
NOTICE**

NOTICE NO. HN-82.1\*

SUBJECT: INSPECTION/REPAIR, AFT FUSELAGE SKIN CRACKS

MODELS AFFECTED: 369HE Helicopter Serial No. 0101E through 0215E.  
369HS Helicopter Serial No. 0001S through 0661S.  
369HM Helicopter Serial No. 0001 through 0004;  
0005M through 0260M.

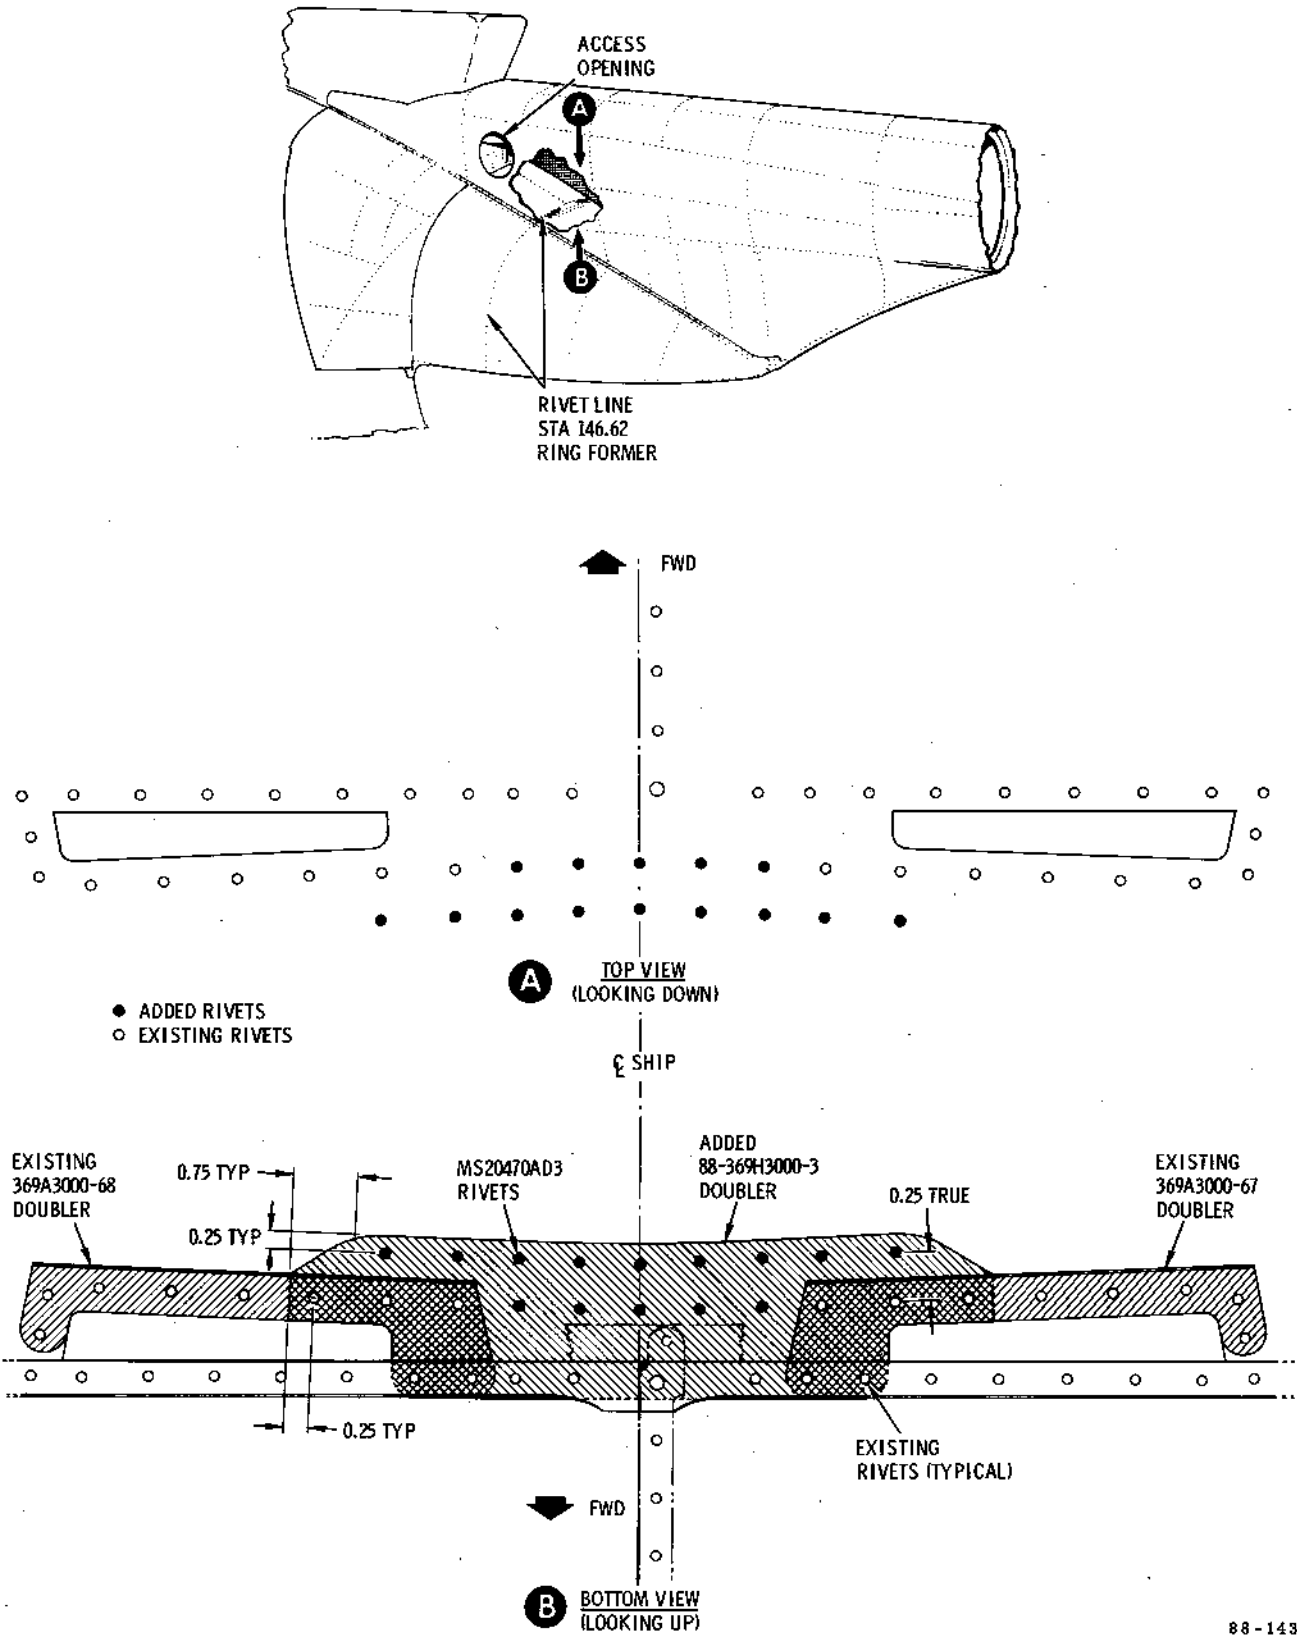
Figure 1. Fuselage Doubler Repair

PREFACE: Inspection has revealed incidents of cracking of the skin adjacent to  
369A3000-67 and -68 Doublers.

This area is non-critical for either static or fatigue loads. The existing doublers are being replaced by the 369H3000-45 Doubler on production aircraft. This Service Information Notice lists a procedure for inspection of the affected parts and if required, repair by installation of the -3 Doubler, serial number affectivity as noted.

- a. Determine that all electrical power is OFF.
- b. Remove tail rotor control bellcrank access door from left side of fuselage boom fairing.
- c. Using light source and mirror, visually inspect fuselage skin adjacent to Doublers for evidence of cracks. (See figure 1.)
  1. If no cracking is found proceed with steps d. and subsequent.
  2. If cracking is found perform Part II., Repair Procedure.
- d. Replace boom fairing access door.

- c. Gaining access through boom fairing access door and using angled drill motor and appropriate bit; drill out manufactured head of four rivets each securing -67 and -68 Doublers.

- d. Drill out four rivets, each to left and right of aircraft centerline securing aircraft skin to station 146.62 ring former flange.
- e. Stop-drill all cracks.

- f. Slide 88-369H3000-3 Doubler between station 146.62 ring former and fuselage skin equal distance on either side of aircraft centerline.
- g. Adjust Doublers to align with existing rivet pattern.

- h. Using angle drill and appropriate bit, drill Doubler to match existing rivet pattern; deburr holes and remove chips as required.
- i. Using wet zinc chromate, rivet gun and rivets, secure Doublers, former and skin. Install rivets from inside engine compartment.
