**HUGHES
SERVICE INFORMATION
NOTICE**

NOTICE NO. HN-83

DATE April 15, 1975

SUBJECT: INSPECTION - ROOT FITTINGS OF METAL TAIL ROTOR BLADES
PN 369A1613-BASIC and -3

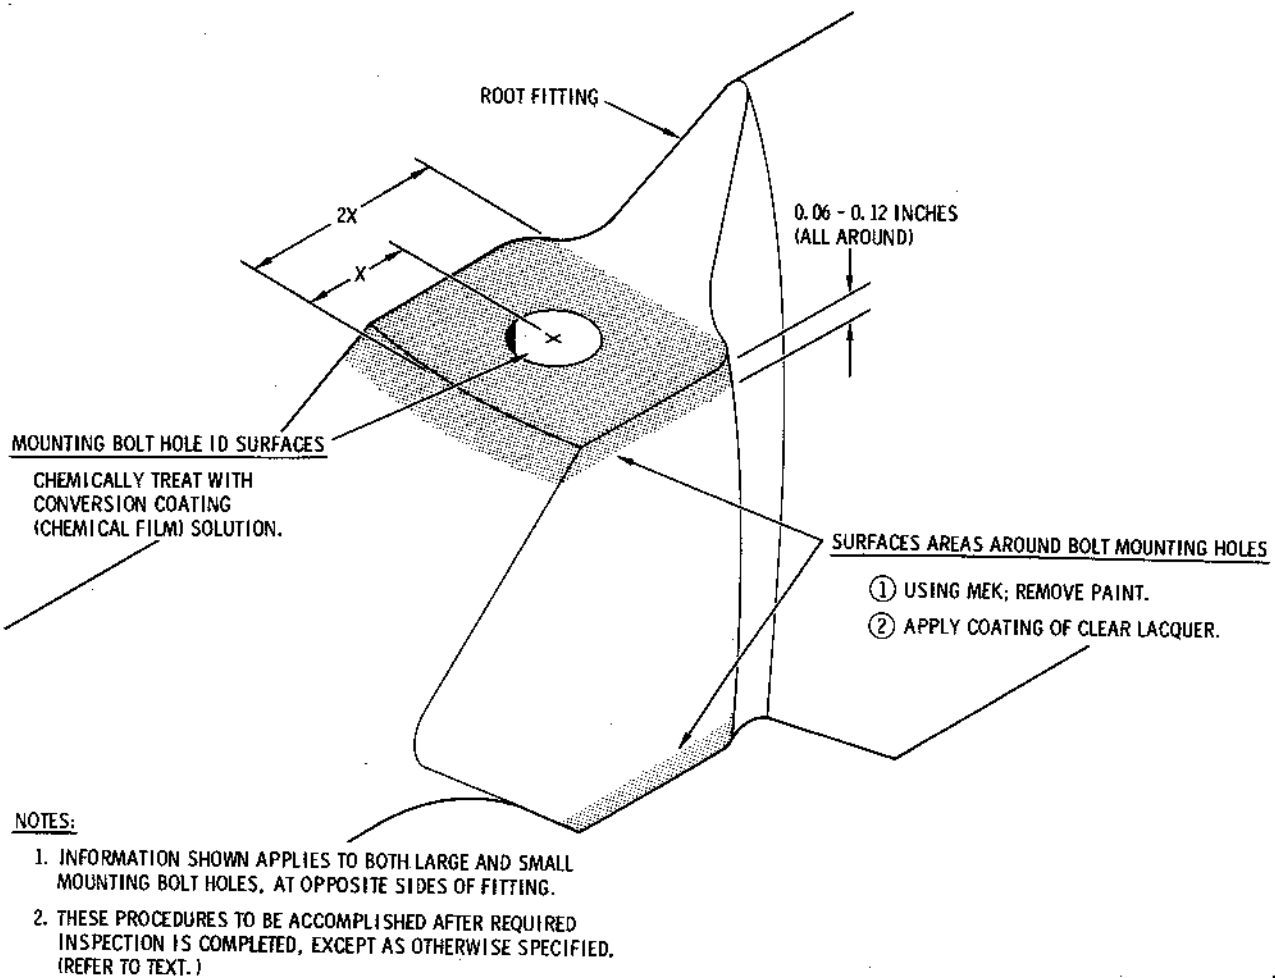
Figure 1. Paint removal and lacquer areas - root fitting of metal tail rotor blade

(4) Using flashlight, inspect ID surfaces of bolt mounting holes for cracks, scratches or corrosion; use 3 or 5 power magnifying glass as practical. Using 3 or 5 power magnifying glass, inspect edges of mounting holes and flat surfaces around holes for cracks. Any crack requires scrapping of blade.

(5) If no cracks are visible, dye penetrant inspect ID surfaces of mounting bolt holes, and flat surfaces around the holes for cracks. If any crack exists the blade is not serviceable.

(3) Using bristle brushes and Stoddard solvent and or cloth, remove zinc chromate from ID surfaces of bolt mounting holes and hole edges; dry hole surfaces thoroughly. Using MEK, remove paint and paint primer from the surfaces on root fitting around the bolt mounting holes as shown in Figure 1.

c. After determining that no cracks are visible, prepare ID surfaces of mounting holes and surfaces on root fitting (Figure 1) as follows:

(2) Chemically treat ID surfaces and edges of mounting holes with conversion coating (chemical film) solution (Iridite, Alodine or equivalent) and allow to dry.

(3) Apply a coating of clear lacquer on surfaces around both bolt holes; allow to thoroughly dry.

- a. For an installed blade, remove blade according to Part I of this Notice. Scrap removed bolt, nut and sleeve bushing.
- b. Using MEK, remove any paint from surfaces on root fitting around mounting bolt holes as shown in Figure 1 of Part I.

- c. Apply a coating of clear lacquer on surfaces around bolt holes as shown in Figure 1; allow to thoroughly dry.
- d. If the blade is to be reinstalled, reinstall the blade on the tail rotor assembly as instructed in Part I, using new MS 21250-06032 blade attachment bolt, new HS610PS6244R375X675 sleeve bushing, new FN22M-624 nut and required attachment hardware.
- e. As applicable, repeat above procedures for remaining blade on tail rotor assembly.
