SERVICE BULLETIN

INSPECTION - TALL ROTOR DRIVE SHAFT DAMPER, PN 369A5506

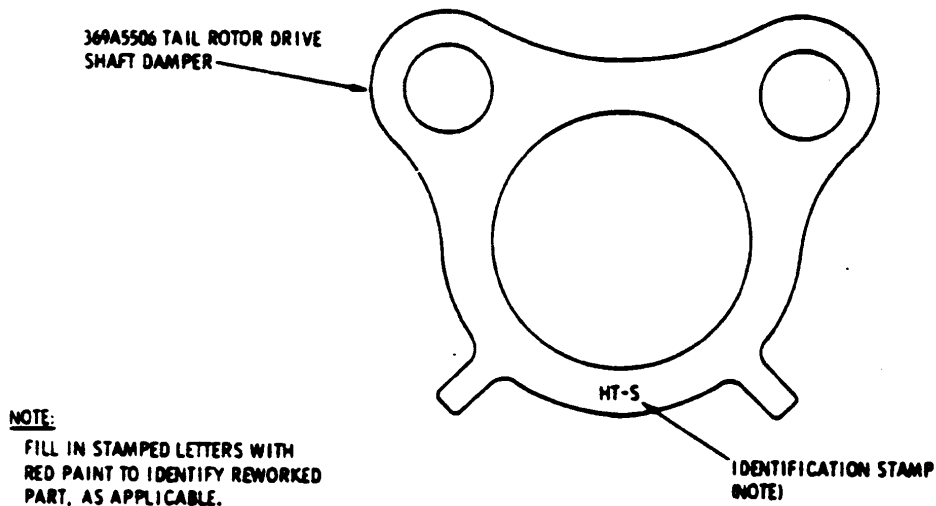
Figure 1. Inspection - Tail Rotor Drive Shaft Damper, PN 369A5506

Field reports indicate that limited number of the subject damper block did not receive a sufficient amount of heat stabilization to assure normal service life,

- (1). Remove tail rotor, tail rotor transmission, tail rotor drive shaft and tail rotor drive shaft damper assembly, per Basic HMI
- (2). Visually inspect drive shaft damper as follows:
 - (a). Damper block identified with stamp "HT-S", or a heat lot number on opposite side from "HT" stamp, is acceptable for continued service (see Figure 1).
 - (b). Damper block not having letter "S" in identification stamp, or not having heat lot number on opposite side from "HT" stamp, must be reworked or replaced.

- (1). At each 10 hours of helicopter operation:
 - (a). Displace damper so that it touches drive shaft.
 - (b). Using wire gage, measure damper to shaft clearance 180° from the contact point. Minimum acceptable clearance is 0.010 inch.
 - (c). Repeat measurement at 90° intervals from initial check point.
- (2). Record compliance with Part II of this Notice in Compliance Record of helicopter Log Book.

- (3). Using any oven with thermostat control, preheat oven to 350°F; place damper block on flat metal sheet and bake block for two hours at 350 deg. F. Turn oven off and allow block to cool to approximate room temperature.
- (4). Measure inside diameter of damper block bore.

- (5). Machine bore out-of-tolerance damper block to 2.905/.2.910 inches diameter. Use slow feed; finish block bore to a surface finish of 32.
