SERVICE BULLETIN

INSPECTION/MODIFICATION OF BREEZE CORPORATION INC HOIST, PN BL-16600-12

500 Model 369H Series Helicopter equipped with rotorcraft hoist system.

Breeze Corporation Inc. Engineering Bulletin BEB-162-8.

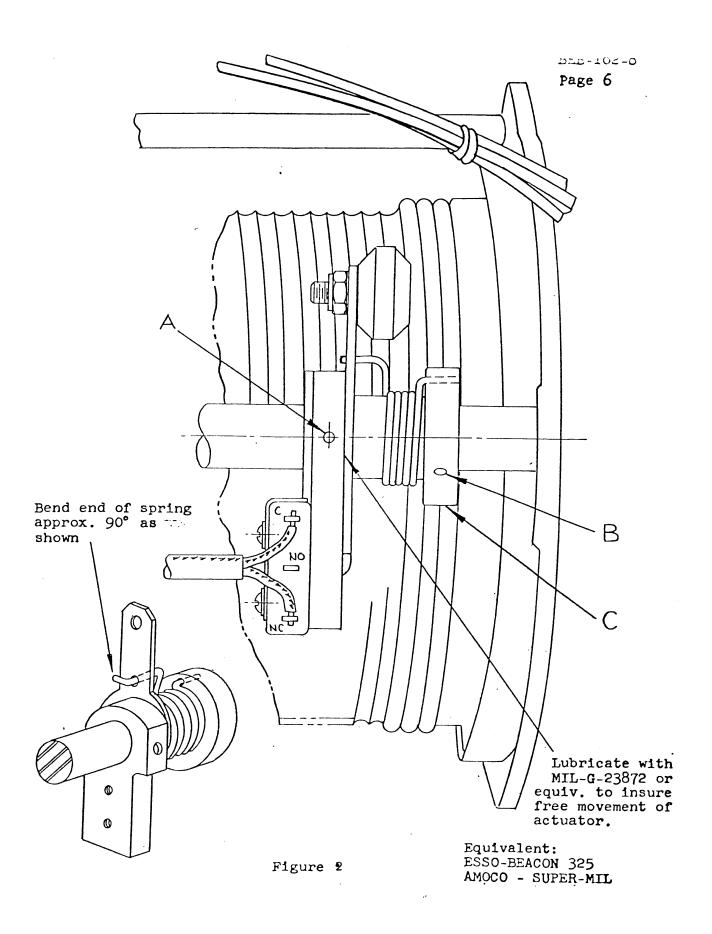
FIGURE 1 EQUIVALENT:
ESSO-BEACON 325
AMOCO - SUPER-MIL

- Switch assembly must be positioned on cross bar so as to allow switch roller to contact grooved surface of drum immediately adjacent to inactive cable wraps (2 1/2 to 3 1/2 wraps). This may be accomplished by loosening both sets of socket head screws (A and B, Fig. 1) in both collar assemblies. The switch assembly may then be slid across the bar to the desired position. Tighten the socket head screws to 4 in. lb. End clearance in the assembly must be maintained at .002 to .005 to allow proper movement of roller arm. (C, Fig. 1)

- With roller resting on grooved portion of drum adjacent to the proper number of inactive turns (2 1/2 to 331/2) loosen socket head screws (A, Fig. 1) and rotate switch until it can be heard to actuate. Tighten socket head screws to 4 in. lb. Again, end clearance must be .002 to .005 for proper operation.

- 3. Bend end of spring per Fig. 1.
- Check hoist for satisfactory operation.
