SERVICE BULLETIN

DATE: 22 JULY 1977

INSPECTION AND MODIFICATION OF OIL COOLER DUCT, PN 369H8301 OR 710108 (KIT PN M50451)

369HS Helicopter Serial No. 0201S thru 0874S
369HM Helicopter Serial No. 0201M thru 0292M

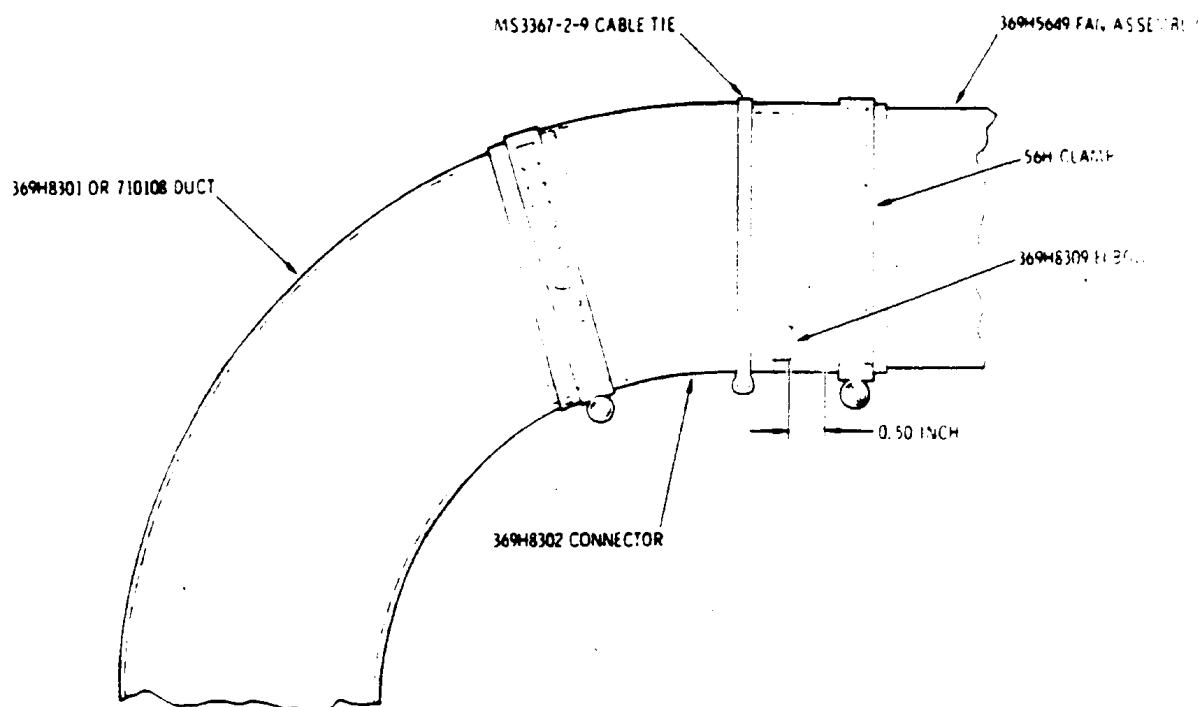
The information given in this Service Information Notice lists a procedure for field inspection and modification, if required, of the subject oil cool duct.' The notification consists of a fiberglass elbow for reinforcement to prevent collapse of the duct and/or 369H8302 flexible connector due to excessive clamping pressure at installation with subsequent restriction of the air flow from the blower fan to the oil cooler assembly.

Figure 1. Modification of oil cooler duct (M50451)

- (1). Remove two 56H clamps securing 3691H8302 connector to oil cooler duct and blower fan assembly. (See Figure 1.)
- (2). Remove four bolts, spacers, washers, and nuts securing duct to oil cooler; remove engine oil cooler duct assembly.

- (3). Install new 369H8309 elbow into duct with minimum of 0.75 inch overlap of elbow into duct. (See Figure 1.)
- (4). Reinstall duct assembly on oil cooler. using existing hardware and spacers. Rotate elbow to obtain optimum fit with minimum gap of 0.50 inch to allow for mismatch between elbow and fan assembly.

- (5). Reinstall duct connector with existing two clamps.
- (6). Secure elbow and connector with cable tie as shown. (See Figure 1.)
- (7). Check modification of oil cooler duct for discrepancies.
- (8). Perform operational check of oil cooler blower and duct system.
- (9). Record compliance with Part II of this Notice in Compliance Record of helicopter log book.
