HN-212.2\*  
DN-153.2\*  
EN-43.2\*  
FN-32.2\*

# SERVICE BULLETIN

**SUBJECT:** ONE-TIME INSPECTION AND REPLACEMENT OF TAIL ROTOR FORK BOLT (369A1602).

**MODELS AFFECTED:** All MD Helicopters, Inc. (MDHS) 369H Series helicopters, including 369A (OH-6A), 369D, 369E and 369F/FF Series helicopters equipped with uninscribed or 369A1602-BSC tail rotor fork bolts. All tail rotor fork bolts and tail rotor assemblies in Spares inventories.

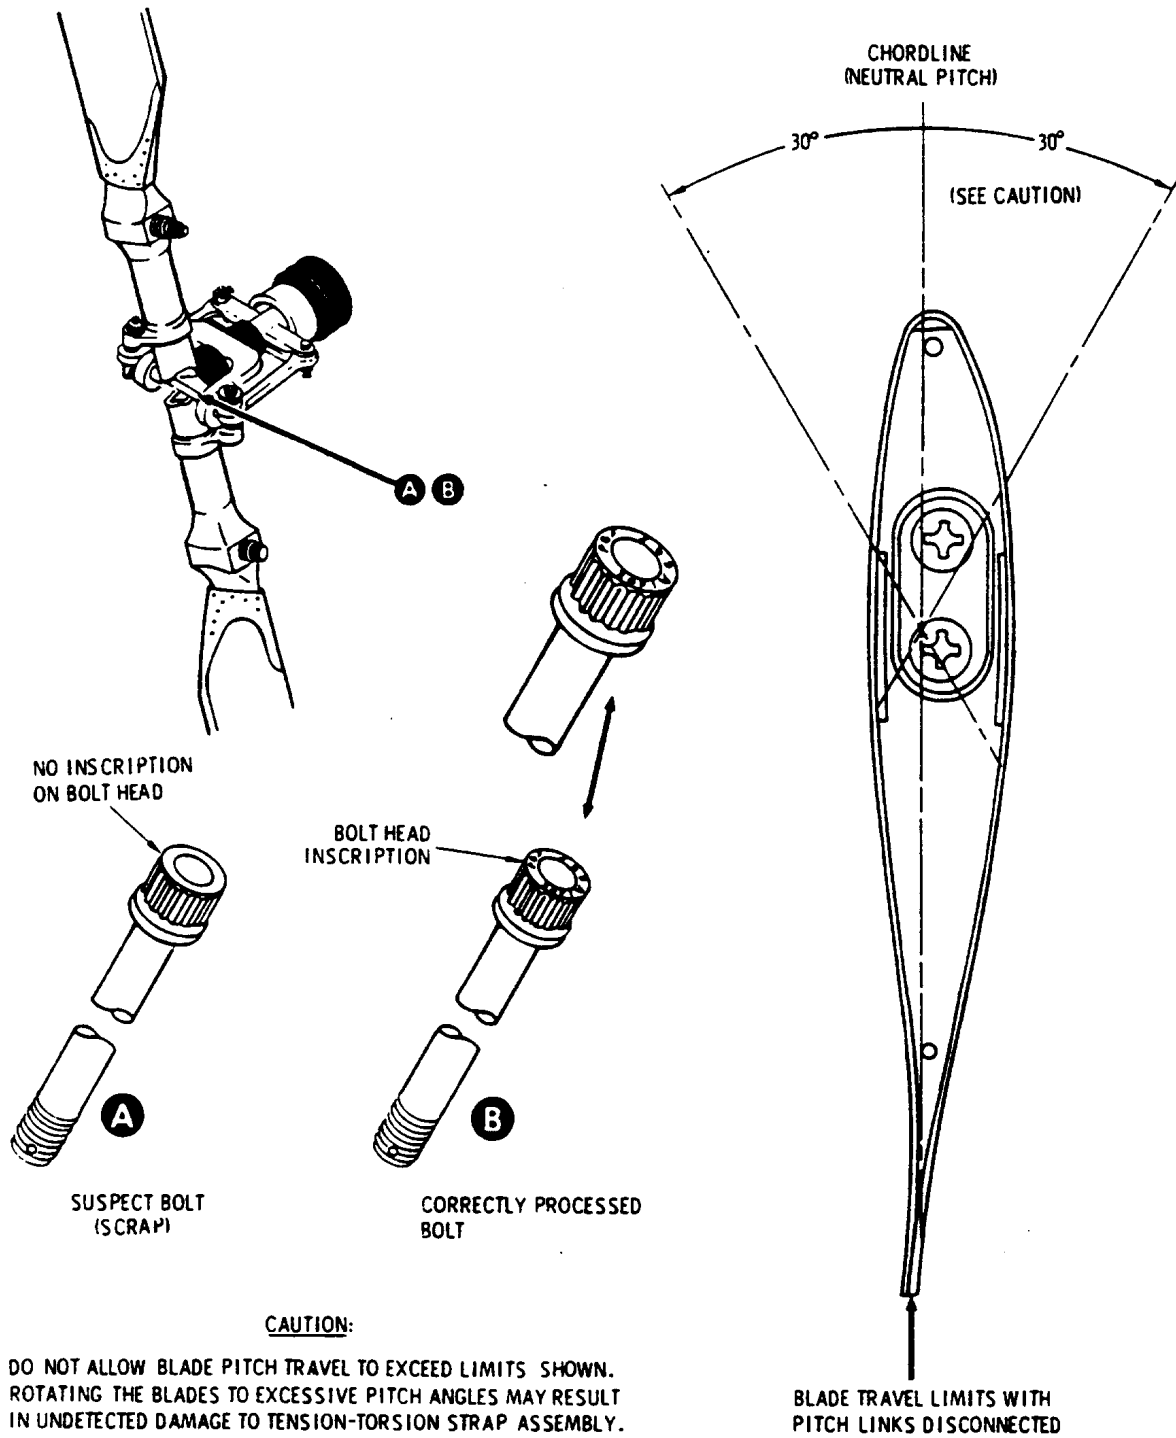
Figure 1. Inspection of Tail Rotor Fork Bolt.

**PREFACE:** **Part I** – The possibility exists that some 369A1602 tail rotor fork bolts, manufactured between April 8, 1986 and August 28, 1986, did not receive proper processing at the manufacturer. Inadequate processing of these bolts can result in cracking and eventual bolt failure. This Notice provides instructions to identify and replace those uninscribed bolts with properly inscribed bolts.

- a. Visually inspect all Spares inventories and tail rotor fork bolts installed on helicopters and tail rotor assemblies for proper inscription on the head of the bolt (see Figure 1 ).

- Uninscribed tail rotor fork bolts on helicopters shall be replaced, proceed to **Part II**.
- Remove all uninscribed tail rotor fork bolts from Spares inventories and scrap those fork bolts.

- A MS21206C4 washer must be installed with a 369A1602-3 tail rotor fork bolt.
4. Install a 369A1602-3 fork bolt along with a MS21206C4 washer with the countersunk side towards the bolt head and reassemble hub and fork unit (HMI Appendix C and Component Overhaul Manual, Part VII).
  5. Perform testing and balancing procedures (HMI Appendix C, Part VIII and Component Overhaul Manual, Part VII).
- b. Record compliance with Part II of this Notice in the Compliance Record section of the helicopter Log Book.
