SERVICE BULLETIN

DATE: 8 DECEMBER 1978

INSPECTION AND REWORK OF TAIL ROTOR HUB, PN 369A1725 AND 369A1725-5; INSPECTION OF TAIL ROTOR BLADE ATTACHMENT BOLTS, PN MS21250-06040

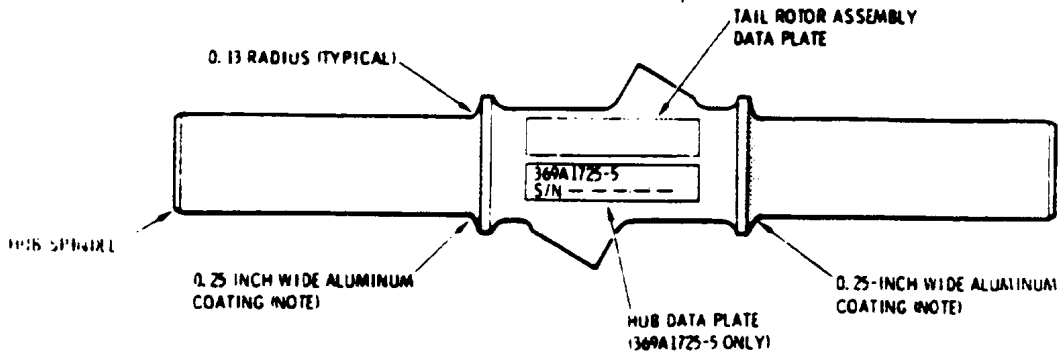
Figure 1. Rework of Tail Rotor Hub Assembly

Field reports indicate that corrosion pitting in the root radii of the PN 369A1725 and 369A1725-5 rotor hub has occurred in service. Part I and Part II of this Service Information Notice provide instructions for identification and inspection of the hubs affected, and application of a corrosion resistant coating at the radius area between the spindles and center portion of the hub.

(3). Using 10X glass, inspect hub for cracks, corrosion or other damage. Pay particular attention to area of 0.13 radii between the spindles and center portion of the hub. (See Figure 1.)

(b). Brush a thin (0.0002 to 0.0005 inch) even coat onto cleaned surface of 0.13 radius areas on both sides of hub. (See Figure 1.) Limit width of aluminum coating to 0.25 inch to prevent contact with feathering bearings.

(6). To denote rework of 369A1725-5 hub, add letter "Z" following serial number on hub data plate; to denote rework of 369A1725 hub, add letter "Z" following part number on tail rotor assembly data plate. (See Figure 1.)

NOTE:
LIMIT WIDTH OF ALUMINUM COATING
TO 0.25-INCH TO PREVENT CONTACT
WITH FEATHERING BEARINGS.
