HN-211.6\*  
DN-51.8\*  
EN-42.6\*  
FN-31.6\*

# SERVICE BULLETIN

DATE: 3 JANUARY 2000  
PAGE 1 OF 7

## INSPECTION OF MAIN ROTOR BLADE ROOT FITTING ASSEMBLIES; INSPECTION OF MAIN ROTOR HUB LEAD-LAG LINK ASSEMBLIES.

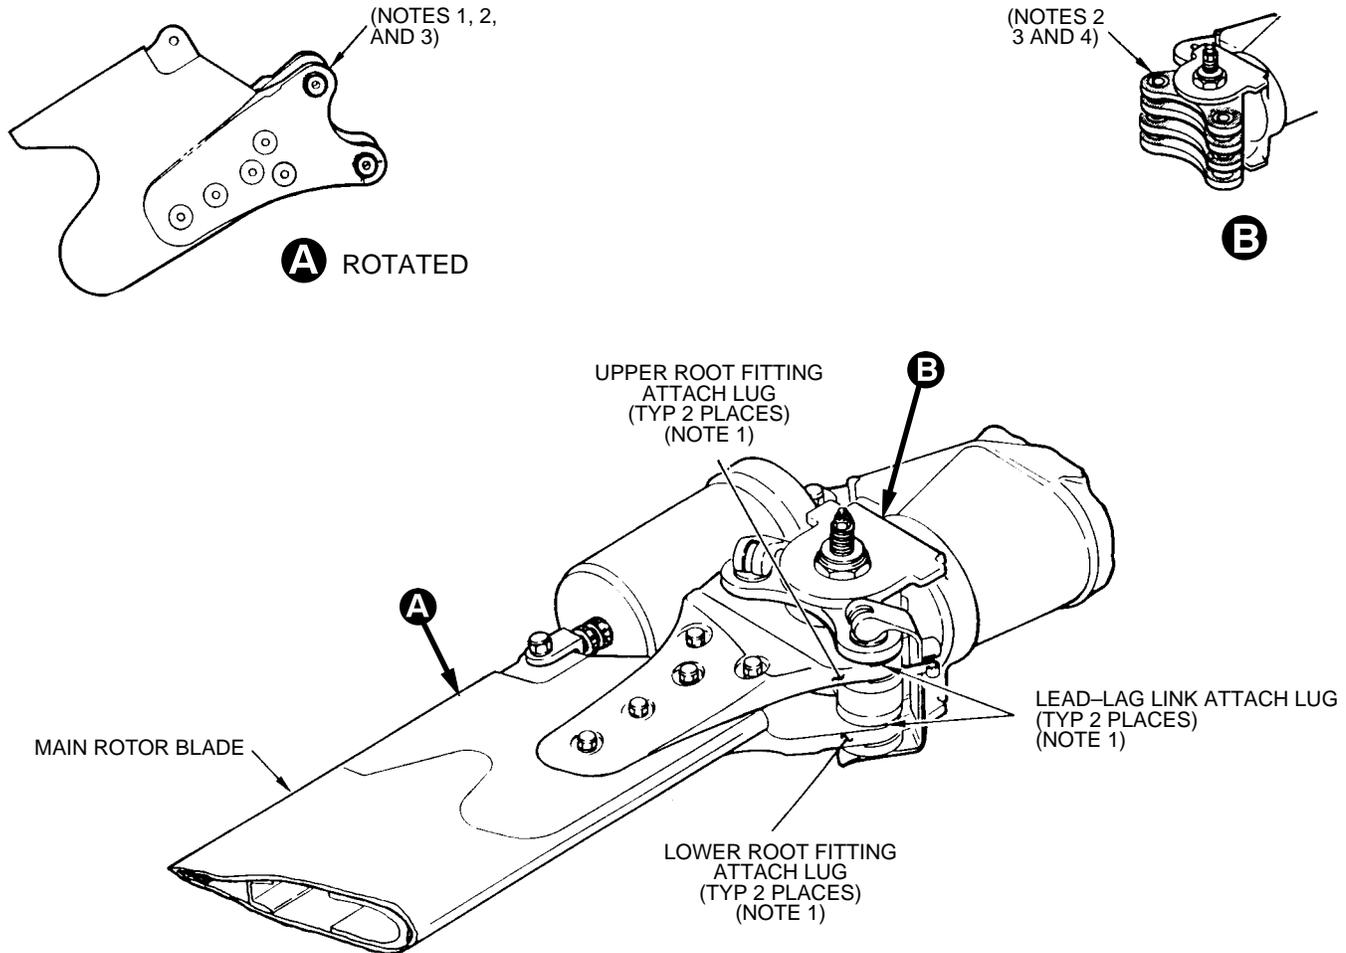
**Figure 1. Inspection of Main Rotor Blade Root Fitting Attach Lugs and Main Rotor Hub Lead-Lag Link Assemblies**

Operators of 369 Series helicopters have experienced cracks in the lug area of the main rotor blade root fittings and lead-lag links.

Failure to follow this Service Bulletin could result in loss of main rotor blade. Movement of the bushings within the lug could lead to cracking of the root fitting. Therefore, all of the above listed main rotor blades shall be inspected for cracks in the area of the root fittings and lead-lag links and for movement of the bushings in the root fittings.

1. VISUALLY INSPECT AREAS OF ALL ROOT FITTINGS AND LEAD-LAG ATTACH LUGS FOR CRACKS OR BREAKS. INSPECT BLADE ATTACH BUSHINGS FOR LOOSENESS. IF LOOSE, REPLACE LEAD-LAG LINKS (REFER TO TEXT).
2. PAY PARTICULAR ATTENTION TO AREA AROUND ATTACH PIN HOLES IN LUGS.
3. SEAL ALL JUNCTIONS BETWEEN BUSHINGS AND ATTACH LUGS WITH SEALER OR PRIMER (REFER TO MATERIALS TABLE).
4. LEAD-LAG LINK ASSEMBLIES ARE SUBASSEMBLIES OF THE MAIN ROTOR HUB ASSEMBLY.

- (1). Remove affected main rotor blades per applicable HMI.
- (2). Using a bright light and 5X magnifying glass, visually inspect the attach lugs of all affected main rotor blade upper and lower root fittings and main rotor lead-lag links for broken or cracked lugs, corrosion or other damage to the lug areas (Ref. Figure 1). Pay particular attention to area around attach pin hole bushings in the lugs. Pay particular attention to the cross-hatch areas shown in Figure 2. If slippage marks have already been applied, inspect the root fitting for any indication of movement of the bushings. No movement is allowed. Return main rotor blades that have root fitting bushing movement to MDHI for possible rework. If slippage mark is degraded, reapply per steps (5) and (6). (Ref. Figure 2).

- If a cracked or broken lug is noted in main rotor blade upper or lower root fittings, replace main rotor blade **before further flight**.
  - If a cracked or broken lug is noted in main rotor lead-lag links, replace or repair main rotor hub per the applicable HMI **before further flight** (see note below).
  - If a crack is suspected in either the main rotor blade or lead-lag link attach lug, perform dye penetrant inspection per MIL-I-25135 of the lug. If a crack is noted, replace main rotor blade or replace or repair main rotor hub per applicable HMI **before further flight** (see note below).
- (3). Inspect lead-lag link blade attach pin hole bushings for any indications of movement of the bushings in the links. If any of the bushings have movement, replace the link.

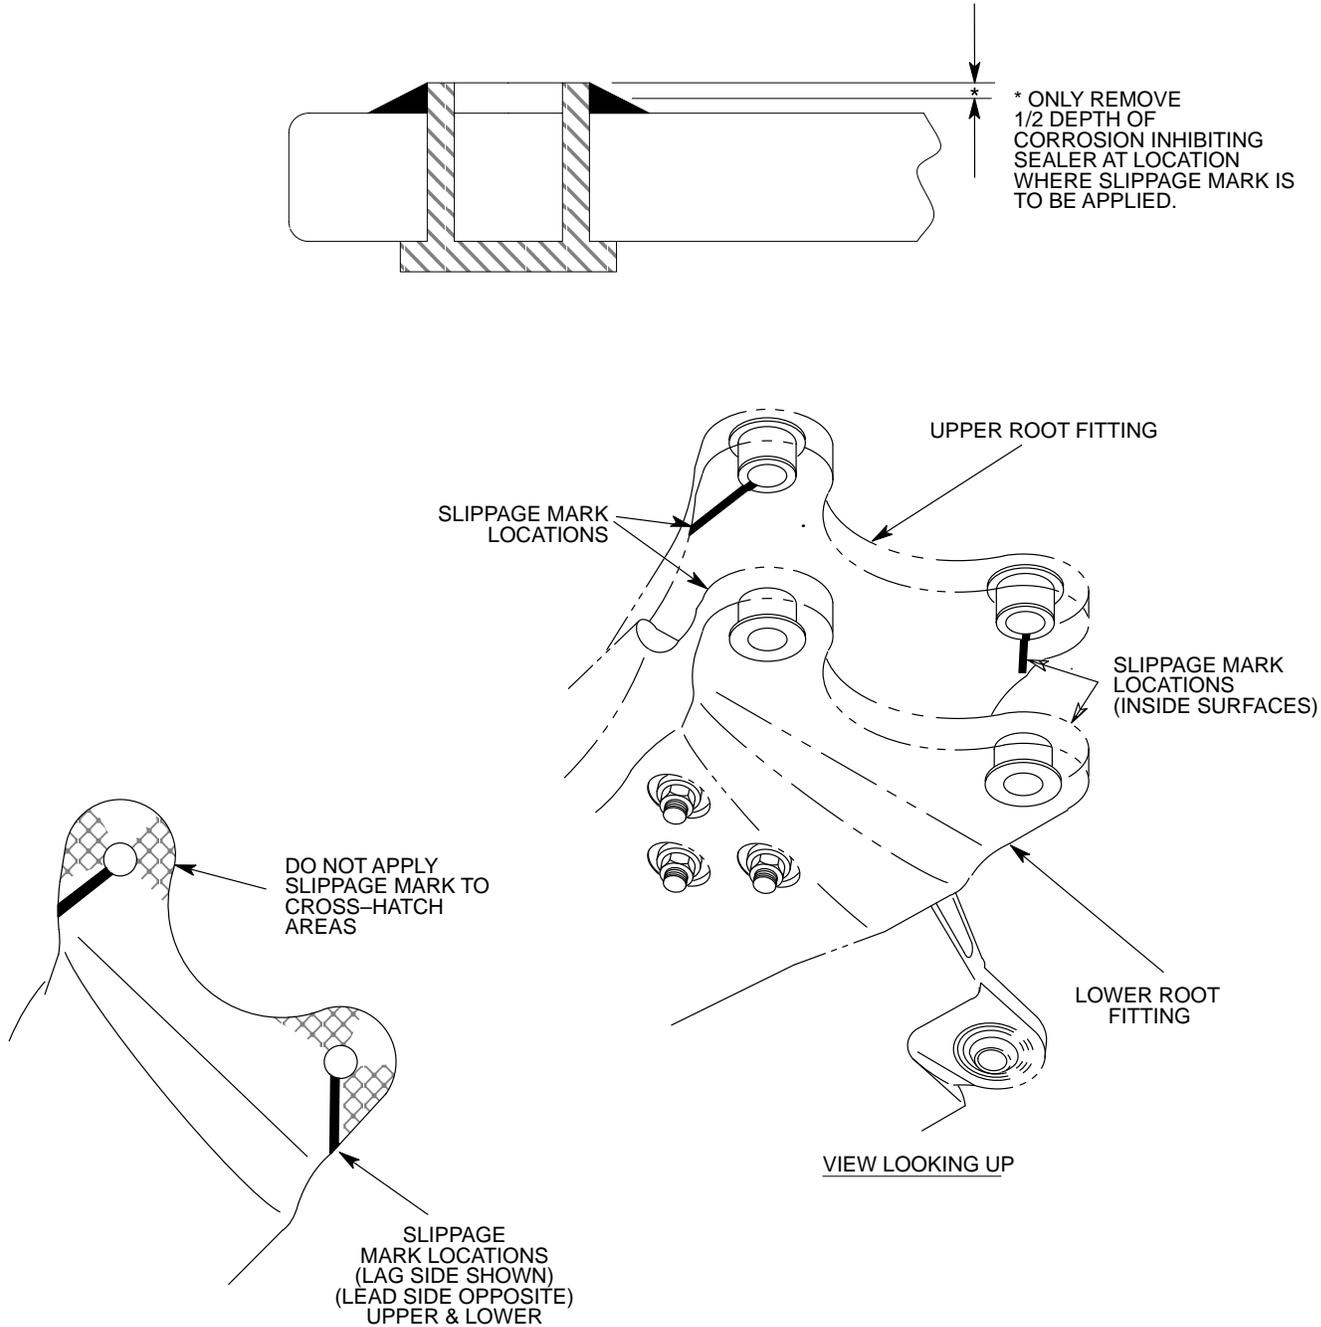
**Figure 2. Application of Slippage Mark to M/R Blade Bushings and Root Fittings**

This revision reduces the time of compliance for PART II from 25 hours to 15 hours for the 369A1234, 369A1203-BSC, -3 and -7, and 369H1203-BSC and -21 lead-lag links with greater than 500 hours. The previous revision added procedures to apply a slippage mark to root fitting bushings and lug surfaces and to periodically inspect those slippage marks to aid operators in accurately detecting bushing movement. Movement of the bushings may cause or be caused by root fitting cracking.

- Locate slippage mark in a position that can be viewed at subsequent inspections with main rotor blade installed in the hub.
- Ensure that slippage mark is applied to bushing and upper and lower root fitting inside surfaces as shown in Figure 2.

(6). Apply epoxy paint slippage marks to four locations as shown in Figure 2.

- DO NOT use torque seal.
  - Ensure that slippage mark can be observed for inspection when the blades are installed. Slippage marks should not be applied to cross-hatch areas shown in Figure 2 to preclude masking possible cracks.
- (7). Install main rotor blades per applicable HMI.
- (8). Record compliance with PART I of this Notice in the Compliance Record section of the helicopter Log Book.

- (1). Visually inspect exposed portion of all installed main rotor blade upper and lower root fitting attach lugs, and main rotor hub lead-lag link attach lugs, for broken or cracked lugs, corrosion or other damage to the lug areas. Using a bright light, inspect slippage marks on the root fitting bushings to ensure there has been no movement of the bushings. If bushings have moved, replace main rotor blade **before further flight** (Ref. Figure 2). Return those main rotor blades where bushing movement has occurred to MDHC for possible rework.
