SERVICE BULLETIN

DATE: 4 JANUARY 1982

INSPECTION OF PN 369A1200 SERIES MAIN ROTOR HUB ASSEMBLY INSPECTION OF PN 369A1220 MAIN ROTOR BLADE LEAD-LAG PIVOT BOLT (VERTICAL HINGE PIN)

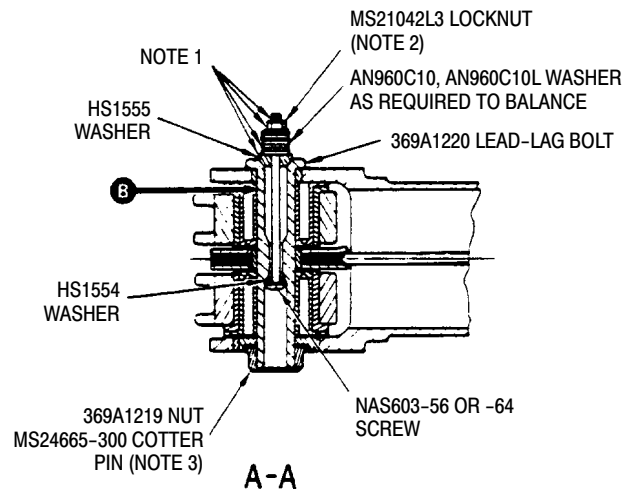
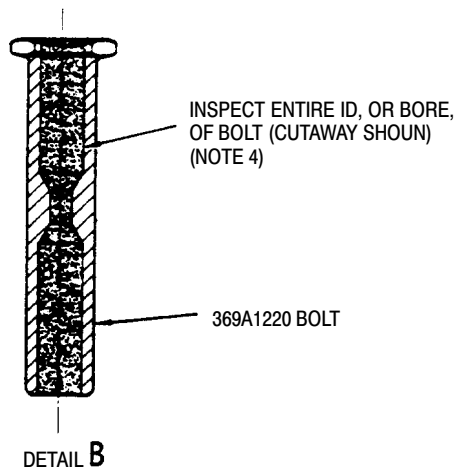
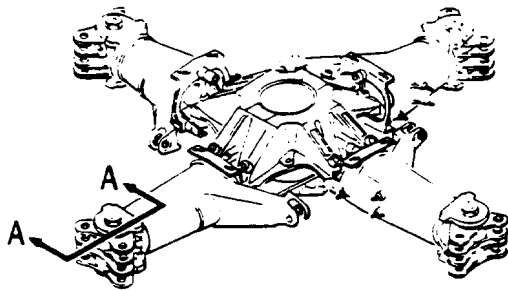
Figure 1. Lead-Lag Bolt and Balance Hardware

- (3). Using bright light and 5X magnifying glass, closely inspect interior surface or bore of each lead-lag bolt for evidence of cracks or corrosion.
 - (a). If no cracking or corrosion is noted in bore of bolts, swab entire ID of each bolt with unthinned zinc chromate primer.

- (b). If surface corrosion in bore of bolt is noted, remove corrosion with grade 180 abrasive cloth and finish with grade 400 abrasive cloth. Swab cleaned surface with MEK and apply coat of unthinned zinc chromate primer to entire ID of bolt

- (c). If corrosion pitting is noted in bore of bolt, corrosion is more than superficial. Remove hub from service and return to HHI. Install new main rotor hub.

- (d). If cracking is noted in bore of bolt, remove hub from service and return to HHI. Install new main rotor hub.
- (4). Reinstall original hardware (and balance hardware as applicable) and torque locknut per Figure 1. Coat screw threads, washers and nuts with PR-1436-G sealant.

- (1). Remove cotter pin securing nut at lower end of lead-lag bolt. Do not disturb torque on nut or remove nut from bolt. (see Figure 1.)
- (2). Remove screw, washers, and balance hardware if installed, lead-lag bolts. (Refer to Section 7 of Basic HMI.)

1. COAT SCREW THREADS, NUT AND WASHERS WITH PR-1456-G, CLASS B-2 SEALANT.
2. TORQUE MS21042L3 LOCKNUT TO 30 - 60 INCH-POUNDS.
3. DO NOT REMOVE OR DISTURB TORQUE ON 369A1219 NUT.
4. COAT ENTIRE ID, OR BORE, OF BOLT WITH UNTHINNED ZINC CHROMATE PRIMER.
