SERVICE BULLETIN

DATE: 12 SEPTEMBER 1977

INSPECTION OF PN 369A3511 – 15 AND 369A3511 – 17 TAILBOOM BRACKET ASSEMBLIES, TAIL ROTOR TRANSMISSION ATTACHMENT

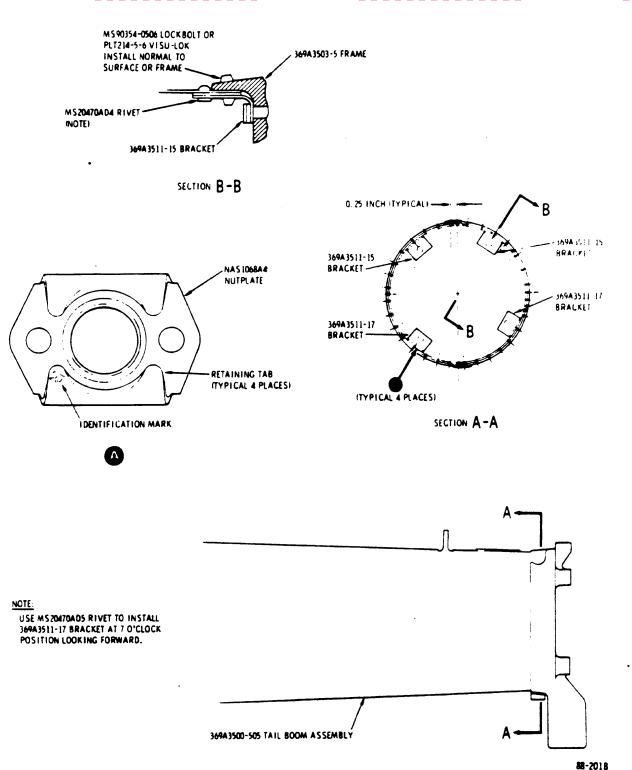
Figure 1. Rework of Tailboom - Replacement of 369A3511-15 and 369A3511-17 Brackets.

The information given in this Service Information Notice lists a procedure for field inspection and replacement, as required, of the subject brackets installed on the aft end of the tailboom. Field reports indicate that cracks have occurred in the anchor nut incorporated in the bracket assembly, resulting in loss of torque on the tail rotor transmission attach bolt.

(2). Using dental mirror and high intensity light, inspect each of the four tail-boom brackets for an identification mark "R" impression stamped on one of the NAS1068A4 nut plate retaining tabs. Check all tabs on each nut plate. (See Figure 1.)

1. If an identification mark "R" is noted on nutplate of any tailboom bracket, replace **CAUTION** bracket as follows:

NOTE: Do not confuse scratches, riveting marks, etc. as identification mark. If any doubt exists, replace tailboom bracket.

(a) Locate and identify existing lockbolt and rivet securing B69A3511-15 or 369A3511-17 bracket to tailboom. (See Figure 1.)

NOTE: MS90354-0506 lockbolts (or Visu- Loks PLT21 4- 5-6) are used to install brackets to 369A3503-5 tailboom frame and 369A3500-23 doublet. An MS20470AD5 rivet is used to install the 369A3511-17 bracket to the -?-3 doublet at the 7 o' clock position, looking forward. MS20470AD4 rivets are used at the other three bracket locations.

- (b) Remove existing lockbolts and rivets securing the tailboom bracket; remove and discard bracket.
- (c) Mate replacement bracket with existing holes in frame and doublet, and install with lockbolts (or Visu-Loks) and rivets as shown with zinc chromate primer.
- (d) For Visu-Lok installation only, predrill holes with #25 drill and ream holes to 0.164/0.163 inch diameter. Torque check (CCW) to 4 inch-pounds maximum; do not over torque.
- (3). As applicable, reinstall tail rotor drive shaft, tail rotor transmission and tail rotor assemblies, per Basic HMI.
- (4). Record compliance with this Service Notice in Compliance Record of helicopter Log Book. Record rework per this Notice of affected serial numbered tailboom assembly in Component Record of helicopter Log Book.
