SERVICE BULLETIN

INSPECTION OF PN 369A7003-3 SWASHPLATE BEARING

All 500 Model 369H Series Helicopters.

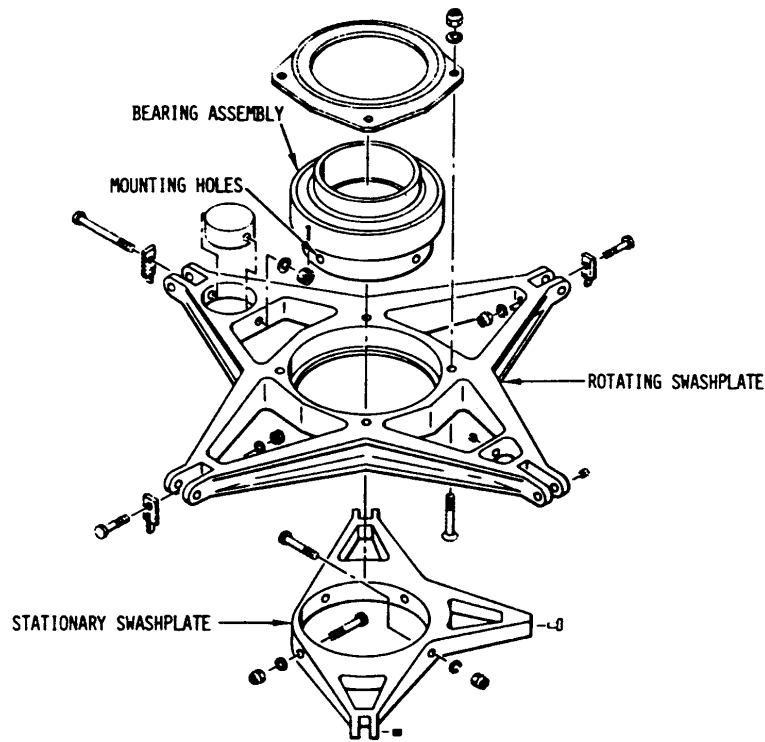
Figure 1. Inspection of Swashplate Bearing

The information given in this Service Information Notice lists a procedure for inspection of PN 369A7003-3 bearing assembly for cracks around mounting holes in the bearing sleeve.

- a. Remove swashplate assembly from helicopter (refer to Basic HMI, Section 7).
- b. Remove PN 369A7003-3 bearing assembly from swashplate assembly and clean (refer to Basic HMI, Appendix C, Part VI, Section 2).
- c. Inspect subject bearing assembly for cracks using the dye penetrate method, with special attention to area of bearing sleeve around four mounting holes where bearing assembly bolts to stationary swashplate.

- d. If cracks are found in bearing assembly, it must be replaced with a new bearing assembly and installed per steps f. and g. below.
- e. If no cracks are found in bearing assembly, it may be reinstalled per steps f. and g. below.

1. Bolts may be installed with heads facing inward by installing one PN 369A1605-5 washer under head of each bolt.
2. Bolts may be installed with heads facing outward by installing PN AN960PD416L washers as required (two maximum) under bolt head to maintain 1.5 to 2 exposed threads of bolt and a minimum of 0.100-inch distance between ball and bolt.
