# SERVICE BULLETIN

## INSTRUMENT CLUSTER 3-PACK CONVERSION – AC TO ROCHESTER

500 Model 369HS Helicopter, Serial No. 0411 through 08741

500 Model 369HM Helicopter, Serial No. 0248 through 0292

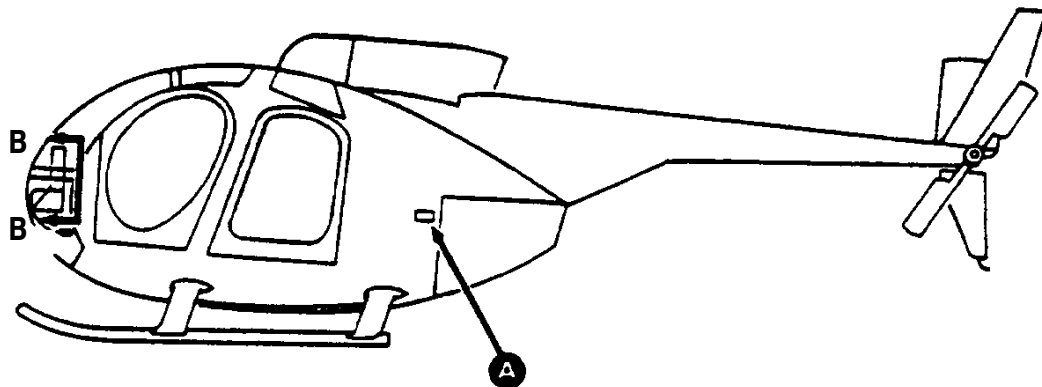
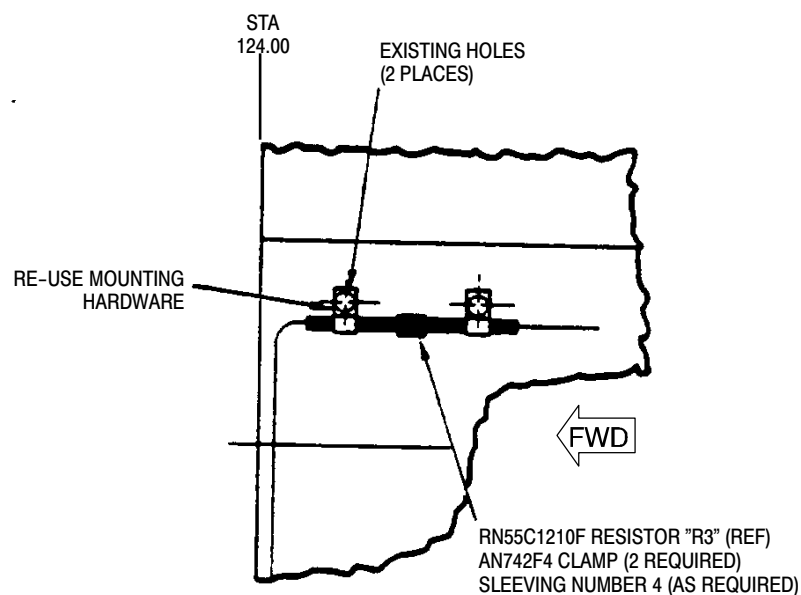
**Figure 1. Instrument Cluster 3-pack Conversion (Sheet 1 of 2)**

The information given in this Service Information Notice lists a procedure for conversion from AC to Rochester instrument cluster 3-pack assembly. The AC instrument cluster 3-pack assembly is no longer available from the manufacturer. Therefore, when replacement becomes necessary, it must be replaced with a Rochester instrument cluster 3-pack assembly.

EXISTING RESISTOR "R3" NUMBER 3730  
R.H. SIDE OF ENGINE COMPARTMENT

- (1). Turn off electrical power.
- (2). Replace resistor R3 as follows:
  - (a). Open engine compartment access doors. (Refer to Section Basic HMI)
  - (b). Locate existing resistor R3 in engine compartment, right-hand side. Remove and retain mounting hardware. (See Figure 1)
  - (c). Unsolder wires D505C20 and D510B20 from resistor R3 and discard resistor.

- (d). Install new resistor R3. Lap solder wires to resistor and cover with sleeving. (See Figures 1 and 2.)
- (e). Install clamps with hardware retained above. (See Figure 1)
