SB369D-200 SB369F-078

SERVICE BULLETIN

DATE: 7 APRIL 2000

LANDING GEAR STRUT INSPECTION AND FAIRING MODIFICATION

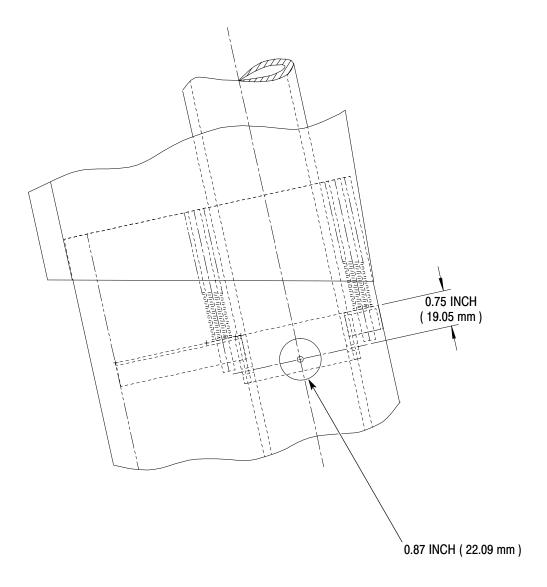
Figure 1. Landing Gear Strut Inspection Hole

- (2). Remove 369H6200-23 and -24 support assemblies.
- (3). Clean and dye penetrant inspect 0.125 inch (3.18 mm) diameter hole in inboard surface of 369H6001-31, -32, -51, or -52 strut assemblies as shown in CSP-IPC-4, Section 32-10-00 and Figure 1.

- (4). If a crack is found, replace strut assembly. If no crack is found, continue with rework.
- (5). Ream hole to 0.132 inch (3.35 mm) diameter to provide smooth (63 RMS) surface. Leave hole open and apply chemical coating to bare metal.

- (6). Drill 0.87 inch (22.09 mm) diameter hole through aft fairing in line with 0.132 inch (3.35 mm) diameter hole in strut as shown in Figure 1.
- (7). Seal exposed edges of composite fairings using adhesive. Touch-up finish to match aircraft finish. Install HS4248-C56 button plug in hole.
