# SERVICE BULLETIN

DATE: 9 APRIL 2015

## MAIN ROTOR HUB LEAD LAG LINK ASSEMBLY INSPECTION AND DAILY PRE-FLIGHT CHECK

SB369H-254R1 SB369D-212R1  
SB369E-107R1 SB369F-093R1  
SB500N-047R1 SB600N-057R1

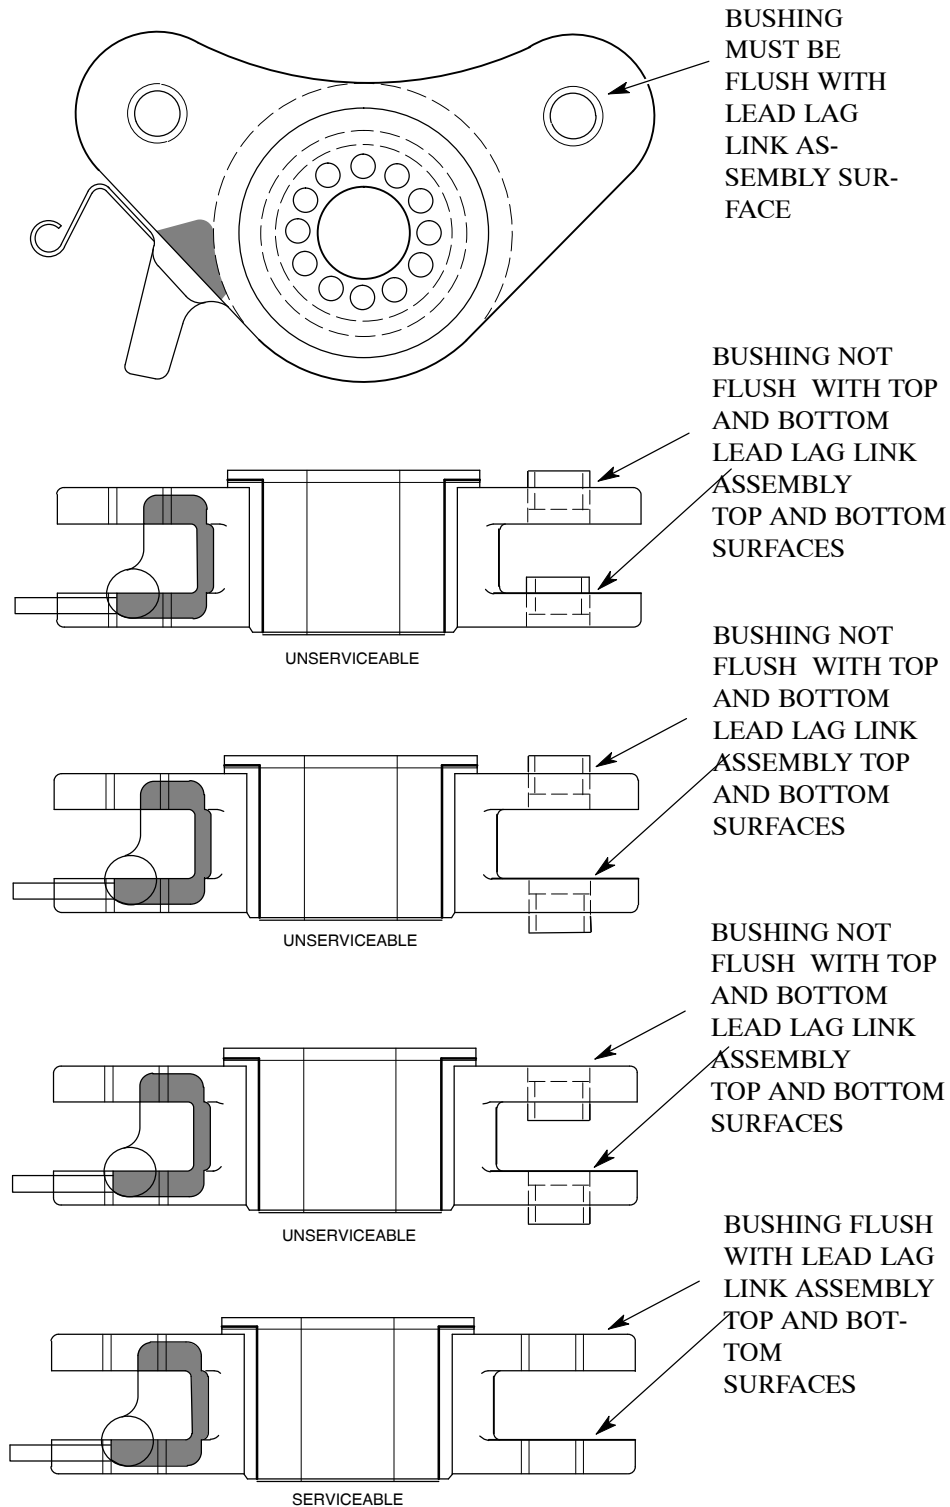
**Figure 1. Examine Main Rotor Hub Lead Lag Link Assembly Bushings**

Some operators have reported that the bushings installed in one or more main rotor hub lead lag link assemblies, PN 369H1203-51, -53, with a serial number prefix code of 5009-XXXX, have become loose, moved and are no longer flush with the surface of the main rotor hub lead lag link assembly.

**NOTE:** Lead lag link assembly bushings are coated with blue coat. When correctly installed, the blue coat coating should not be visible.

- (2). Examine each installed lead lag link assembly for bushings that moved and are not installed flush with the top and bottom surfaces of the lead lag link assembly (Ref. Figure 1) and have blue coat visible.

- (3). If any lead lag link assembly has bushings that have moved and are not flush with the lead lag link assembly top and bottom surfaces, suspend flight operations. Contact MDHI Field Service Department at MDHI, Mesa, Arizona. Telephone 1-800-388-3378 or 480-346-6387. DATAFAX: 480-346-6813, or your local Field Service Representative.

- (4). If any lead lag link assembly bushings have blue coat visible, suspend flight operations. Contact MDHI Field Service Department at MDHI, Mesa, Arizona. Telephone 1-800-388-3378 or 480-346-6387. DATAFAX: 480-346-6813, or your local Field Service Representative.
