### SERVICE BULLETIN

**DATE: 01 MAY 1972**

# MODIFICATION AND ALIGNMENT CHECK –ROTOR BRAKE INSTALLATION

All 369H Series Helicopters With P/N 3691190123 Series Rotor Brake Kit Installed

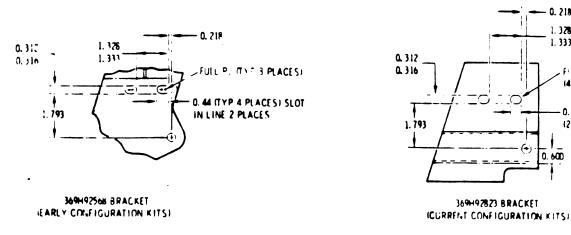
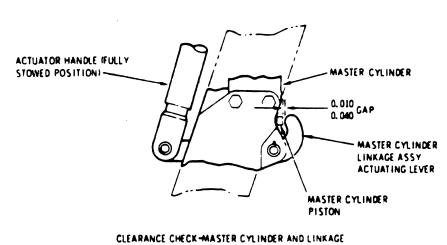
Figure 1. Modification and Clearance Check - Rotor Brake Kit Installation

Part I of this Service Information Notice lists a procedure for modifying the master cylinder mounting bracket to provide positive clearance between the actuator lever and the master cylinder. Elongation of mounting bracket attachment holes allows for adjusting position of master cylinder assembly to obtain 0.010/0.040-inch gap between actuator lever and master cylinder piston. The gap prevents lever from depressing piston and ensures proper bleed-off of hydraulic pressure, when actuator handle is secured in the stowed position.

- a. Remove cover from master cylinder actuating assembly.
- b. Using feeler gage, check that 0.010 to 0.040-inch clearance exists between master cylinder piston and actuator lever (See fig. 1).

- c. Remove crew compartment trim panels to gain access to work area and/or prevent damage or soiling.
- d. Remove master cylinder assembly (Refer to HMI App. A, Group 12).
- e. Using drill guide, drill motor and bit, elongate attachment holes of master cylinder mounting bracket, per dimensions shown in Figure 1.

- f. Coat slotted holes with zinc chromate primer.
- g. Replace existing master cylinder vent tube assembly with new 369A8010-673 vent tube assembly (new vent tube is longer).
- h. Reinstall master cylinder assembly; position cylinder assembly to provide 0.010 to 0.040-inch clearance between master cylinder piston and actuating lever, with lever in fully stowed position.
