SERVICE BULLETIN

DATE: 11 SEPTEMBER 1970

MODIFICATION FOR DOORS – OFF FLIGHT – CANOPY UPPER WINDSHIELD ASSEMBLIES, P/N 369A2405–3 AND 369A2405–4

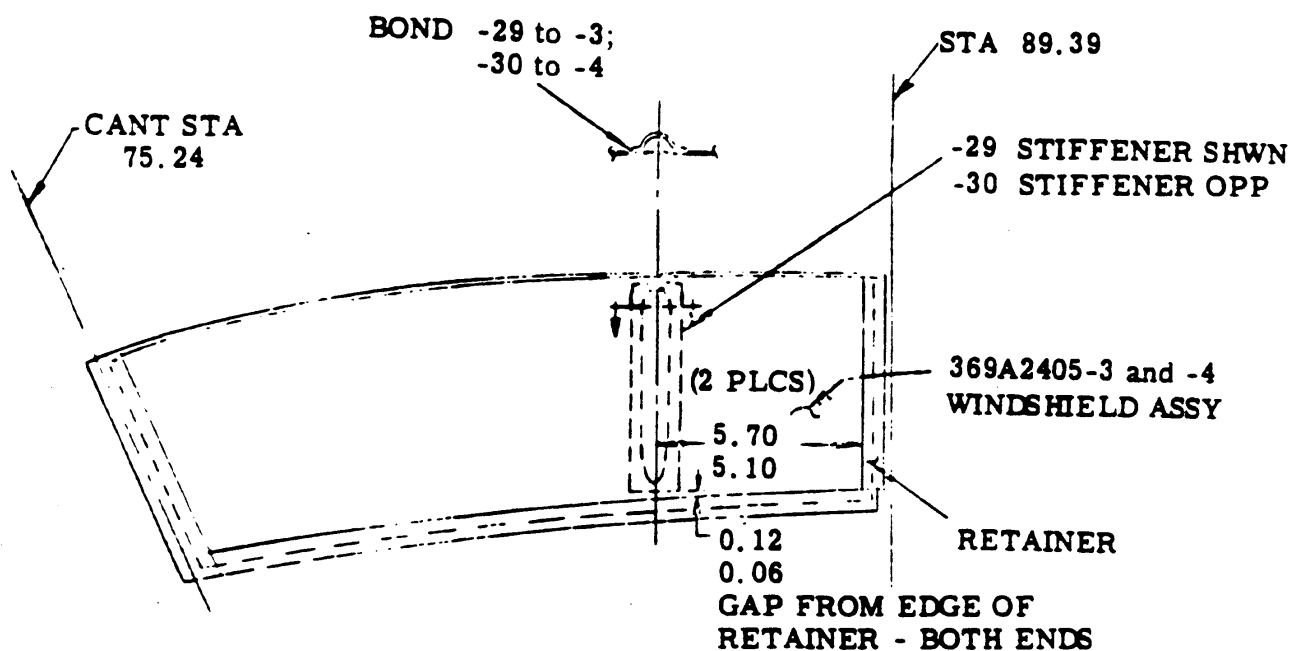
Figure 1. Modification - Canopy Upper Windshield Assembly

The information given in this Service Information Notice lists a procedure for modifying and strengthening the canopy upper windshield assemblies on the above affected helicopters, to permit doors-off flight with forward speeds in excess of 85 knots (98 mph) IAS.

- a. Thoroughly clean faying surfaces of -29 and -30 acrylic stiffeners and inboard area of upper windshield assemblies; rub lightly with clean flannel cloth or equivalent dampened with aliphatic naphtha to remove all dirt, grease, etc. (See Figure 1 for bonding location and dimensions)
- b. Mask windshield areas adjacent to faying surfaces with masking tape. Large areas may be masked with cellophane sheet or Kraft paper held in place with masking tape or with strips of masking tape.

1. During bonding operation, cement should not be allowed to seep under edges of tape.
 2. Apply masking tape to within 1/8-inch of faying surface.
 3. If several strips of tape are used, overlap each strip approximately 1/2-inch.
- c. Prepare cement in accordance with manufacturer's instructions.
 - d. Apply mixed cement at one or both surfaces to be joined; immediately assemble stiffeners to windshield with contact pressure at dimensions shown in Figure 1.

- e. Apply light pressure on stiffeners to press out any air bubbles; remove any excess cement by scraping it onto masking tape, then remove tape.
- f. Secure stiffeners to windshields with masking tape; cure for 24 hours and remove masking tape.
- g. Check upper windshield assembly modification for discrepancies.
- h. Record compliance with this Service Information Notice in Compliance Record of helicopter Log Book.
