TECHNICAL BULLETIN

DATE: 18 MAY 1971

MODIFICATION KIT (M50436) – ENGINE–OUT WARNING HORN SUPPORT

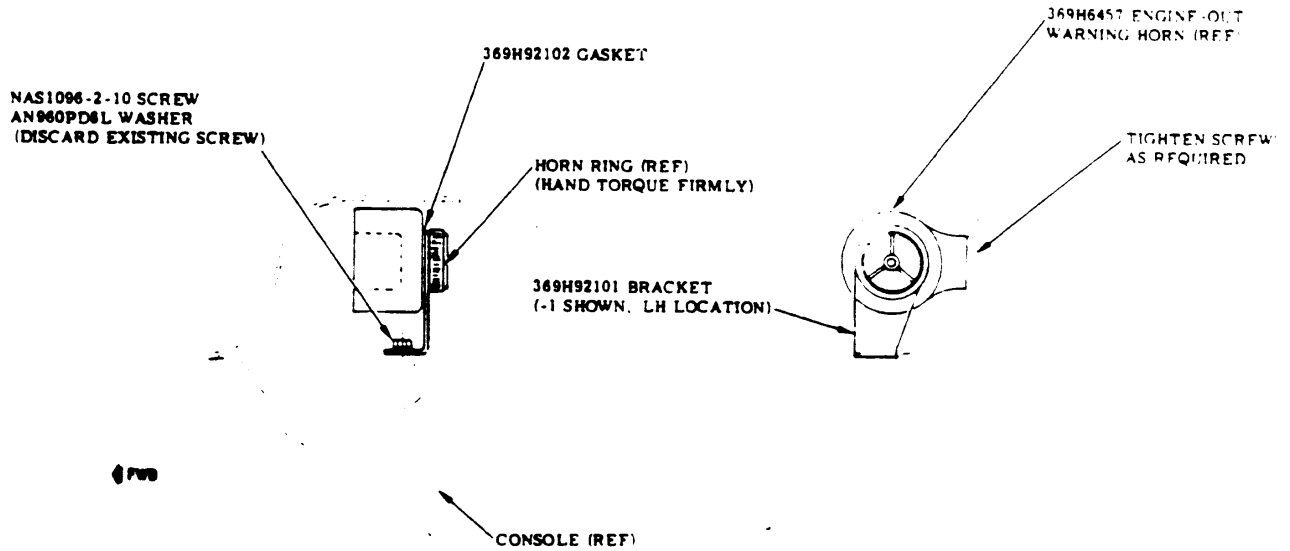
369H92101 SUPPORT BRACKET
(-1 SHOWN, LH LOCATION; -2 OPPOSITE, RH LOCATION)

The information given in this Service Information Notice lists a procedure for installation of a support bracket to minimize vibration of the engine–out audible warning unit.

- a. Check that all electrical power is OFF.
- b. Back off and remove ring on horn assembly. (See Figure I)
- c. Install gasket and -1 or -2 support bracket as applicable; secure loosely with horn ring.
- d. Install bracket to instrument console side fairing with new screw and washer; discard existing screw.
- e. Hand torque ring on horn to secure bracket firmly.
- f. As required, tighten screws securing horn to center fairing (remove center fairing with warning unit, per Section 17 of Basic HMI, to gain access to attachment screws).
- g. Check new support bracket installation for discrepancies.
- h. Perform operational check of engine-out audible warning unit.

MAKE FROM: (AL ALY SH 2024-T3; QQ-A-250 5,
TEMP T3; FINISH PAINT BLK NO. 37038 FED STD 595)
