SERVICE BULLETIN

DATE: 27 OCTOBER 1995

MAIN ROTOR BLADE ROOT END INSPECTION

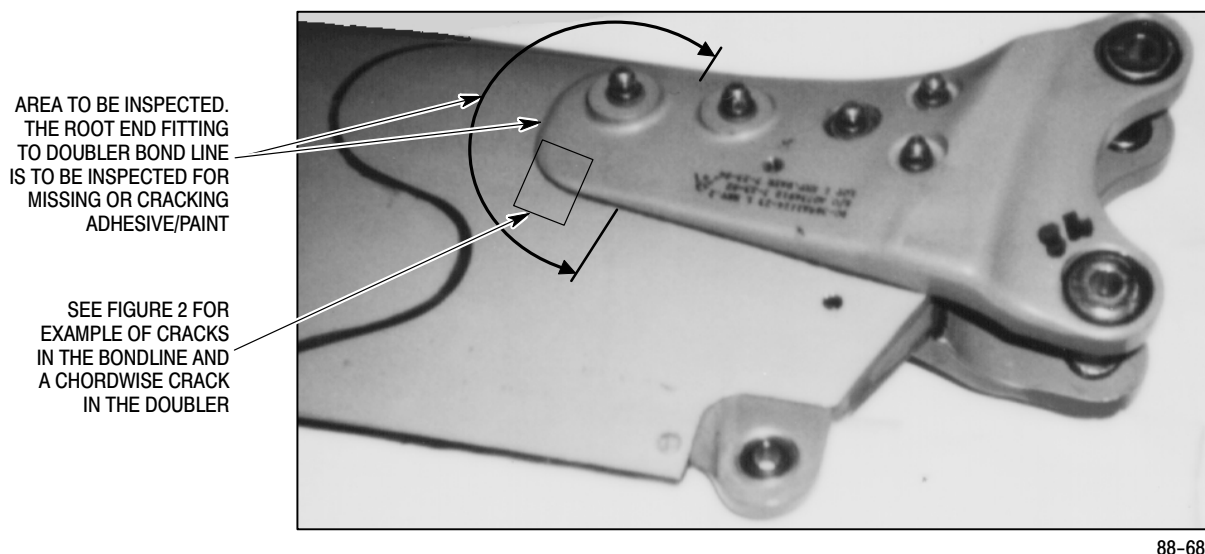
Figure 1. Main Rotor Blade Root Fitting Inspection.

- (1). With the main rotor blade lifted off of the droop stop, observe the area shown in Figure 1 for any indications of chordwise cracking emitting from the root fitting edge on the blade doubler and skin. Cracking can travel toward both the leading and trailing edges of the blade. **NOTE:** Based on field reports, chordwise cracking is most likely to be found in line with the outermost bolt. If any chordwise cracking is noted, the blade is unserviceable. Operators should contact their local Field Service Representative for disposition of unserviceable blades. If no cracking is noted, proceed to Step A.(2).

- (2). With the main rotor blade lifted off the droop stop, inspect for missing or cracked adhesive/paint at the root end to doubler bonding line in the area shown in Figure 1. If there is any missing or cracked adhesive/paint in the root end fitting to doubler bond line, proceed to Step B. If no cracking is evident, further operation is allowed.

- (1). Remove main rotor blade.
- (2). Using a 10X magnifying glass, inspect the area shown in Figure 1 for any indications of chordwise cracking emitting from the root fitting edge on the blade doubler and skin. Cracking can travel toward both the leading and trailing edges of the blade. **NOTE:** Based on field reports, chordwise cracking is most likely to be found in line with the outermost bolt. If any chordwise cracking is noted, the blade is unserviceable. Operators should contact their local Field Service Representative for disposition of unserviceable blade. If no cracking is noted, proceed to Step B.(3).
- (3). Inspect blade for missing or cracked adhesive/paint at the root end fitting to doubler bonding line in the area shown in Figure 1. If there is any missing or cracked adhesive/paint, proceed to step B.(4). If no cracking is evident, skip step B.(4). thru B.(6).

- (4). Loosen but **DO NOT remove** the root end fitting outboard bolt and nut.
- (5). Using a .004 inch thick piece of Mylar/viewfoil (stapled to this Notice), attempt to insert the corner of the Mylar in between the lower root fitting and the doubler surface in the area shown in Figure 1. If Mylar can be inserted, contact a MDHS Field Service Representative for disposition of the blade. If the Mylar can be inserted .10 inch or greater, remove the blade from service. **NOTE:** Measurement of insertion is from the edge of the root fitting. If the Mylar cannot be inserted, the blade is serviceable, proceed to step B.(6).

- (6). Ensure that a minimum run-on drag torque of 3.5 inch pounds can be achieved when re-torquing the outboard nut. If the minimum drag torque cannot be achieved, the self-locking nut must be replaced with a serviceable nut. Apply a torque of 60-65 inch pounds to the outboard nut.

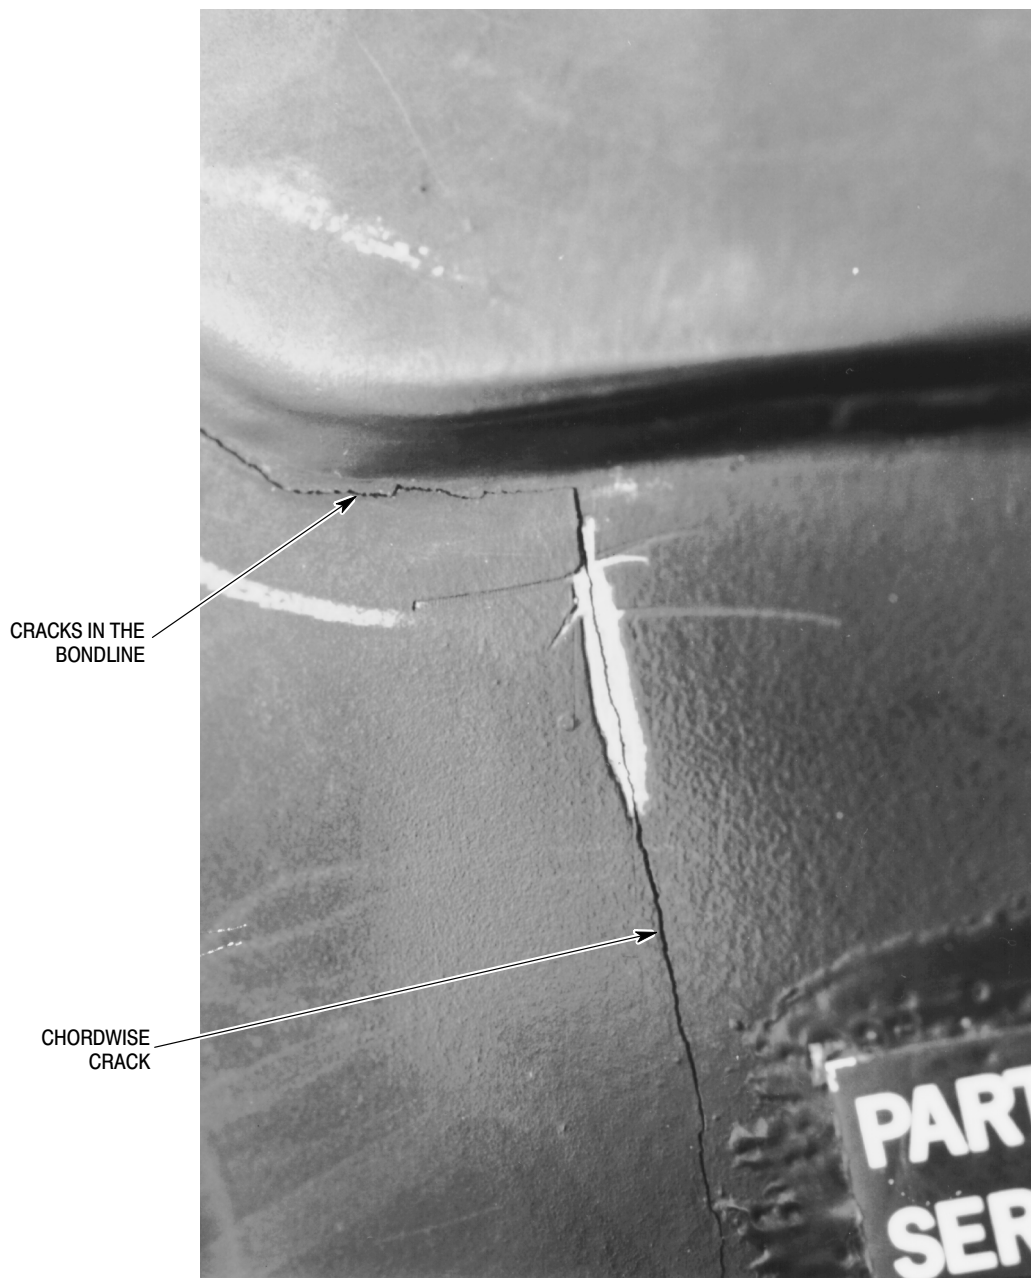
Figure 2. Example of Main Rotor Blade Root End Cracking.
