# SERVICE BULLETIN

DATE: 15 JANUARY 1988  
PAGE 1 OF 9

**SUBJECT:** MAIN ROTOR HUB ASSEMBLY STRAP PACK LAMINATION INSPECTION AND TRI-FLOW WASH PROCEDURE OF THE MAIN ROTOR HUB ASSEMBLY AND STRAP PACK LAMINATES.

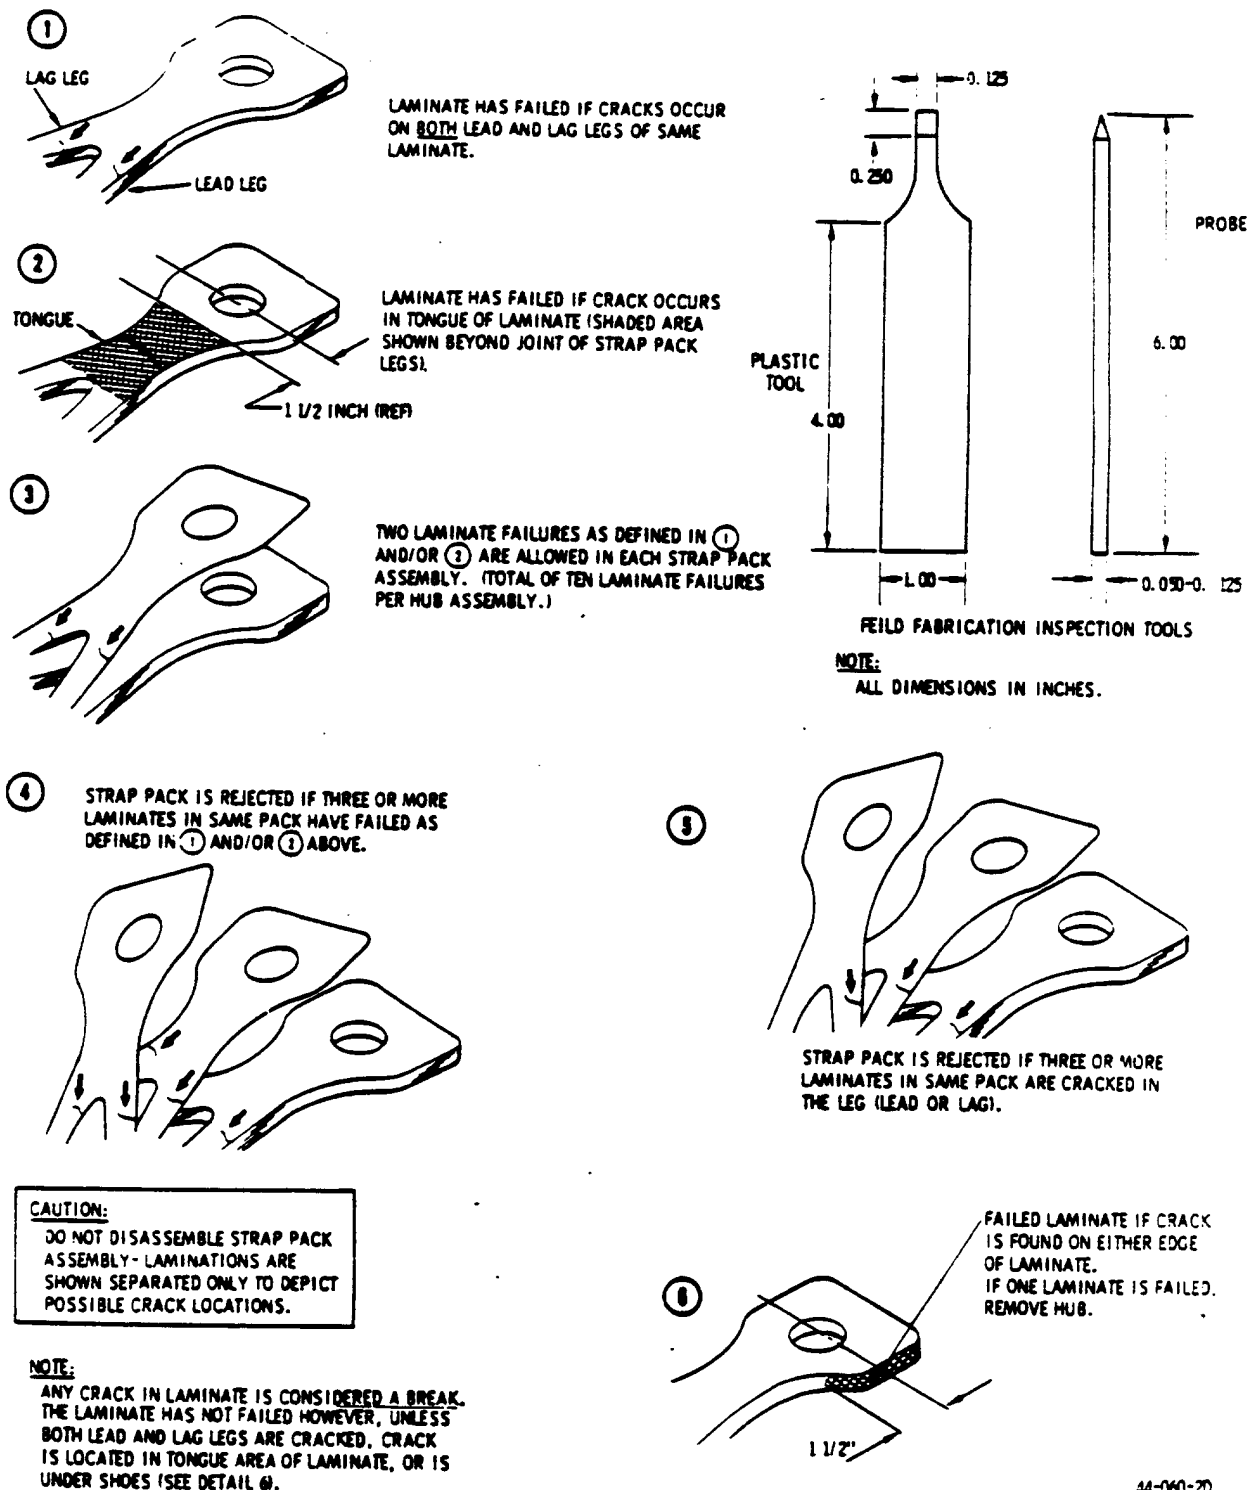
Figure 1. Main Rotor Hub Strap Assembly Inspection

It is acceptable to operate a helicopter with a hub assembly having a strap pack with up to two failed laminates in any one leg of the strap assembly (see Figure 1 ). When a laminate in the strap assembly fails, the remaining laminates pick up and carry the load. This increased load causes slightly more elongation in the remaining laminates of that leg thus shifting the mass of the rotor system. Anytime a vibration develops or there is an increase in vibration level over a short period of time, the main rotor strap pack assembly should be inspected for cracked or failed laminates per Part I of this Notice.

- d. Using a light and mirror, visually inspect each of the four (369H, 369A/OH-6A) or five (369D,E,F/FF) main rotor strap pack assemblies for evidence of cracks or breaks in strap pack laminates in the areas of the outboard shoes and pitch housing assemblies. Each strap pack assembly consists of 15 (369H, 369A/OH6A) or 16 (369D,E,F/FF) corrosion resistant steel strap laminates. (See Figure 1.)
- e. Using a 10X magnifying glass, visually inspect the edge of strap pack laminates on both sides at outboard end of blade pitch housing (area between outboard shoes). (See Figure 1, Item 6.)

- Remove main rotor blades per Section 7 of applicable Basic or Vol. I HMI.
- Trim teflon from edges of laminates as shown in Figure 2.
- Field fabricate plastic tool per Figure 1. Run plastic tool in both directions along each laminate, feeling for a "catch" from a crack on a single laminate.

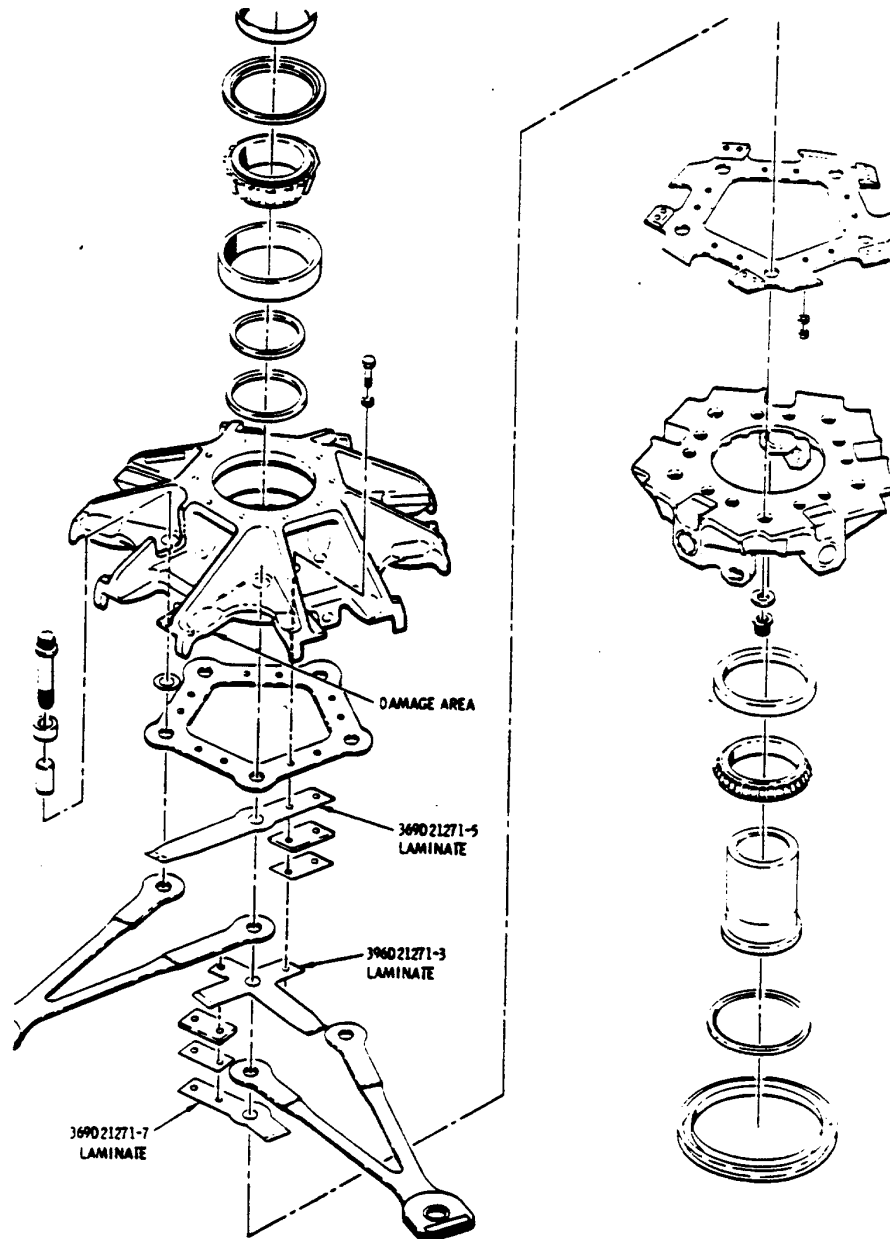
Figure 3. Main Rotor Hub Laminate Inspection

- h. Inspect upper (369D21271-5), lower (369D21271-7) and center (369D21271-3) laminates for cracks and breaks. (See Figure 3.)

Cracks, breaks or other noticeable damage to the laminate/shims require main rotor hub overhaul/replacement.

Do not disassemble strap pack or hub assembly. Hub assembly is shown separated only for clarification of location of possible cracks and damage.
