SB369H-243R3 SB369D-195R3  
SB369E-088R3 SB369F-075R3  
SB500N-015R3 SB600N-007R2

# SERVICE BULLETIN

DATE: 13 JULY 1998  
PAGE 1 OF 6

## MAIN ROTOR BLADE ROOT END INSPECTION AND TERMINATION ACTION FOR SUSPECT MAIN ROTOR BLADES

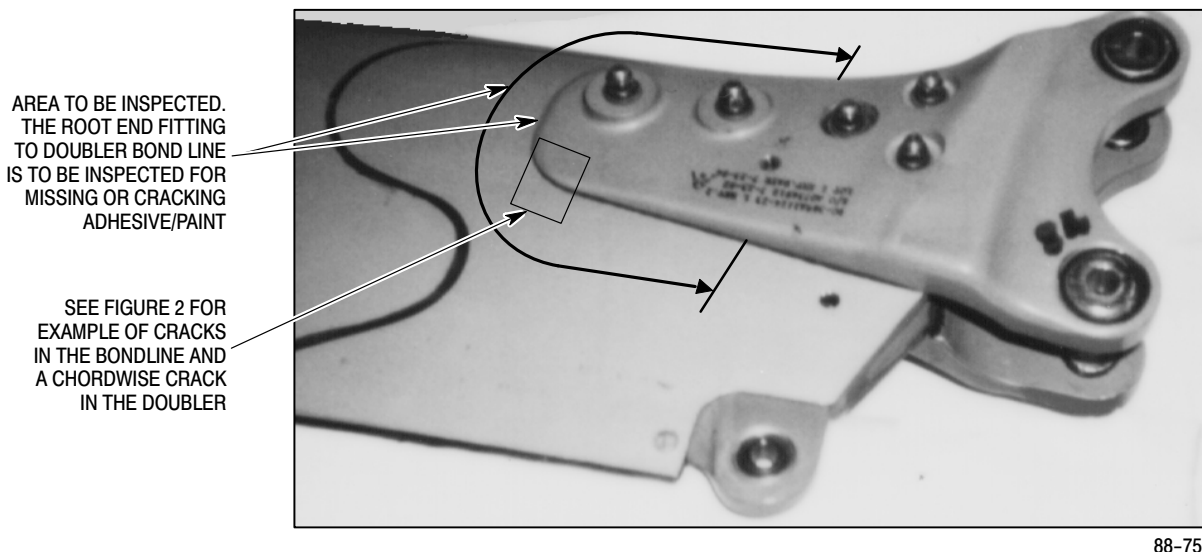
**Figure 1. Main Rotor Blade Lower Surface Root Fitting and Doubler Inspection.**

- (3). With the main rotor blade lifted off of the droop stop, observe the area shown in Figure 1 for any indications of chordwise cracking emanating from the root fitting edge on the blade lower surface doubler and skin or cracks on the doubler adjacent to the root end fitting. Cracking can travel toward both the leading and trailing edges of the blade.

**NOTE:** Based on field reports, chordwise cracking, if present, is most likely to be found in line with the two outermost bolts and the outermost end of the lower root fitting. If any chordwise cracking is noted, the blade is unserviceable. Operators should contact their local Field Service Representative for disposition of unserviceable blades. If no cracking is noted, proceed to Step 4.

- (4). With the main rotor blade lifted off the droop stop, inspect the lower surface for missing or cracked adhesive/paint at the root end fitting to doubler bonding line in the area shown in Figure 1. If there is any missing or cracked adhesive/paint in the root end fitting to doubler bond line, proceed to Service Information Notices HN-239, DN-188, EN-81, FN-67 and NN-008 and perform the required inspections contained in that Bulletin.
