HN-232
DN-179
EN-70
FN-57

SERVICE BULLETIN

DATE: 27 SEPTEMBER 1991
PAGE 1 OF 5

ONE-TIME ADDITION OF RIVETS TO TAIL ROTOR ABRASION STRIP

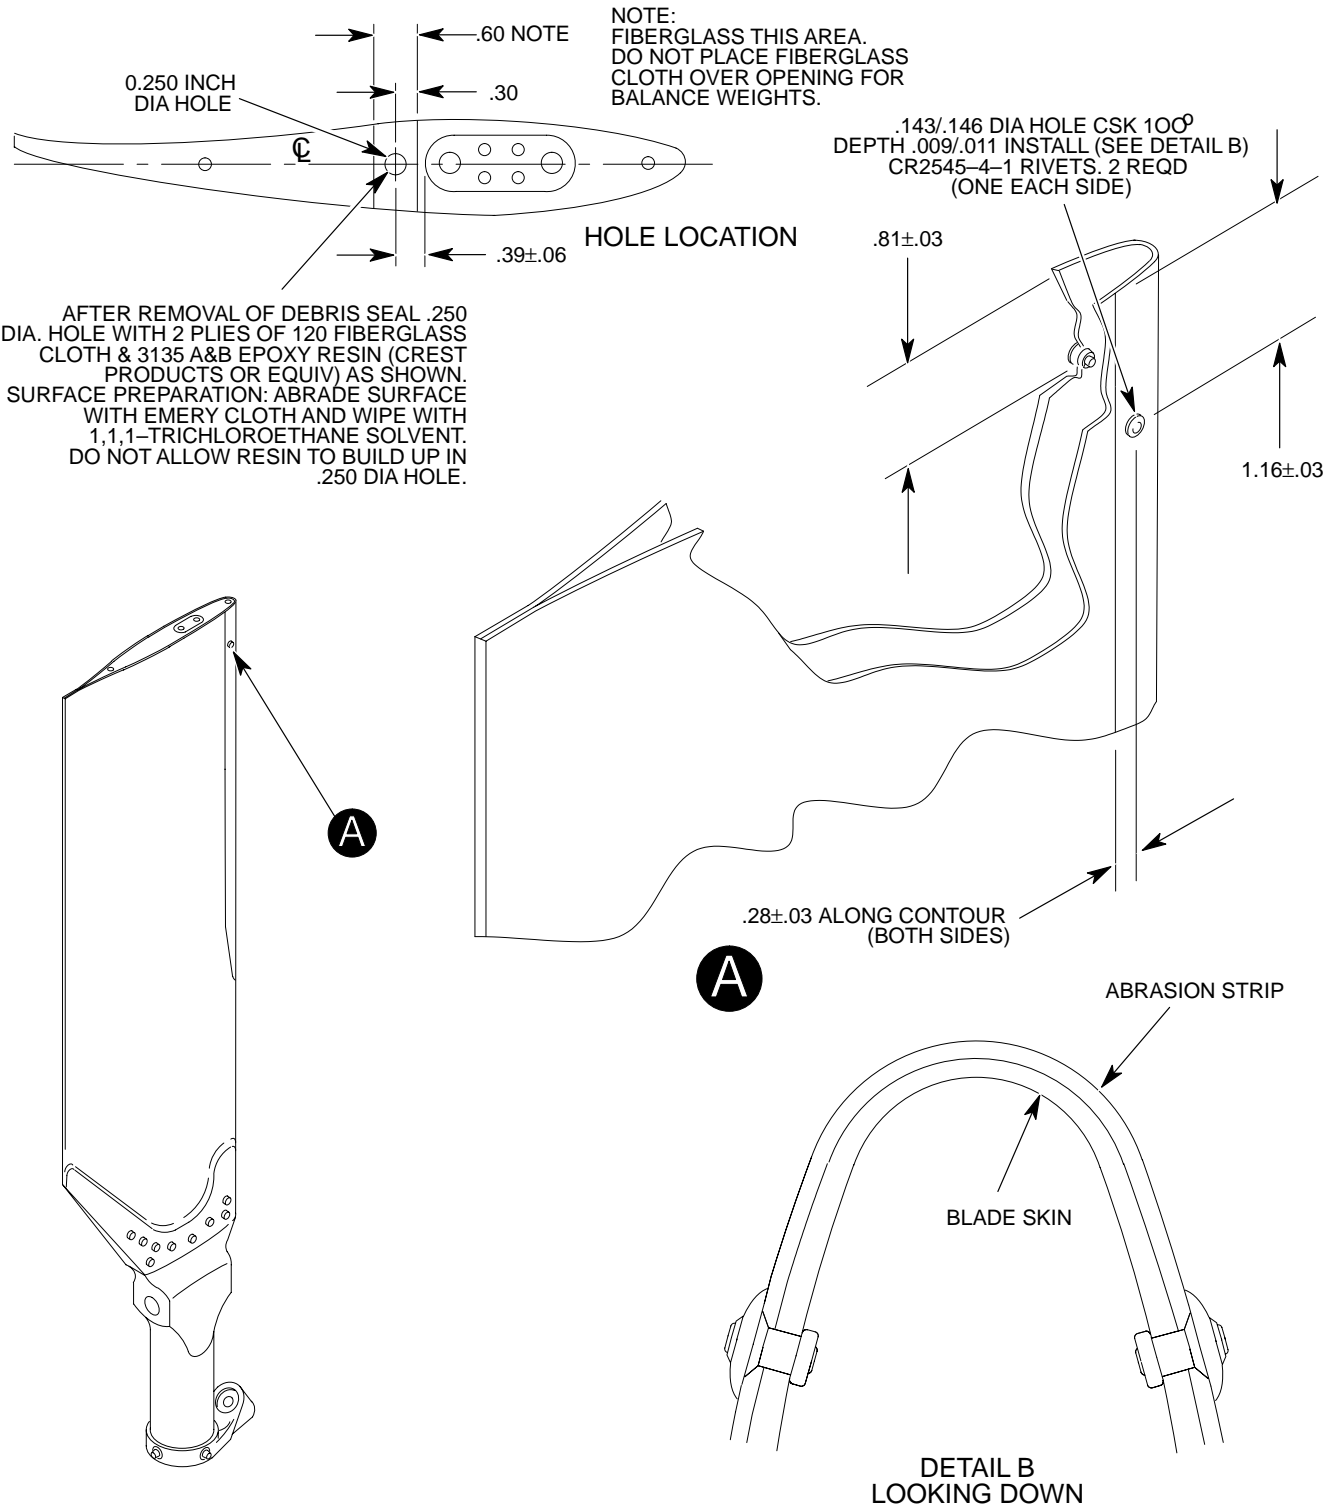
Figure 1. Addition of Rivets to Tail Rotor Abrasion Strip, FOD Removal from Blade Interior.

PURPOSE: To provide a secondary failsafe method of attachment of the tail rotor blade abrasion strip.

- a. Remove the tail rotor blades from helicopter per the applicable maintenance manual.
- b. Carefully secure the tail rotor blade in a suitable holding fixture.
- c. Using a No. 27 Cobalt drill, drill holes (DIA. .143/.146) at the locations shown on Figure 1. (Light center punch prior to drilling is allowed.)

- e. Apply zinc chromate primer to holes and install CR2545-4-1 or CR3555-4-1 rivets in locations shown in Figure 1 while the zinc chromate primer is still wet.

- 1). Drill 0.250 inch diameter hole through tip-cap as shown in Figure 1.
- 2). Remove FOD from blade interior through hole (there is space at tip cap end for debris to pass aft of spar).
- 3). Return to step e. above and install new rivet(s).
