SERVICE BULLETIN

DATE: 21 JULY 1989

SUBJECT: INSPECTION AND REWORK OF MAIN AND TAIL ROTOR CONTROL TUBES (PNS 369A7007, 389A7009, 369A7011 AND 369A7012).

MODELS AFFECTED: All MD Helicopters, Inc. (MDHI) 369 Series helicopters, including the 369A (OH-6A) Series helicopters.

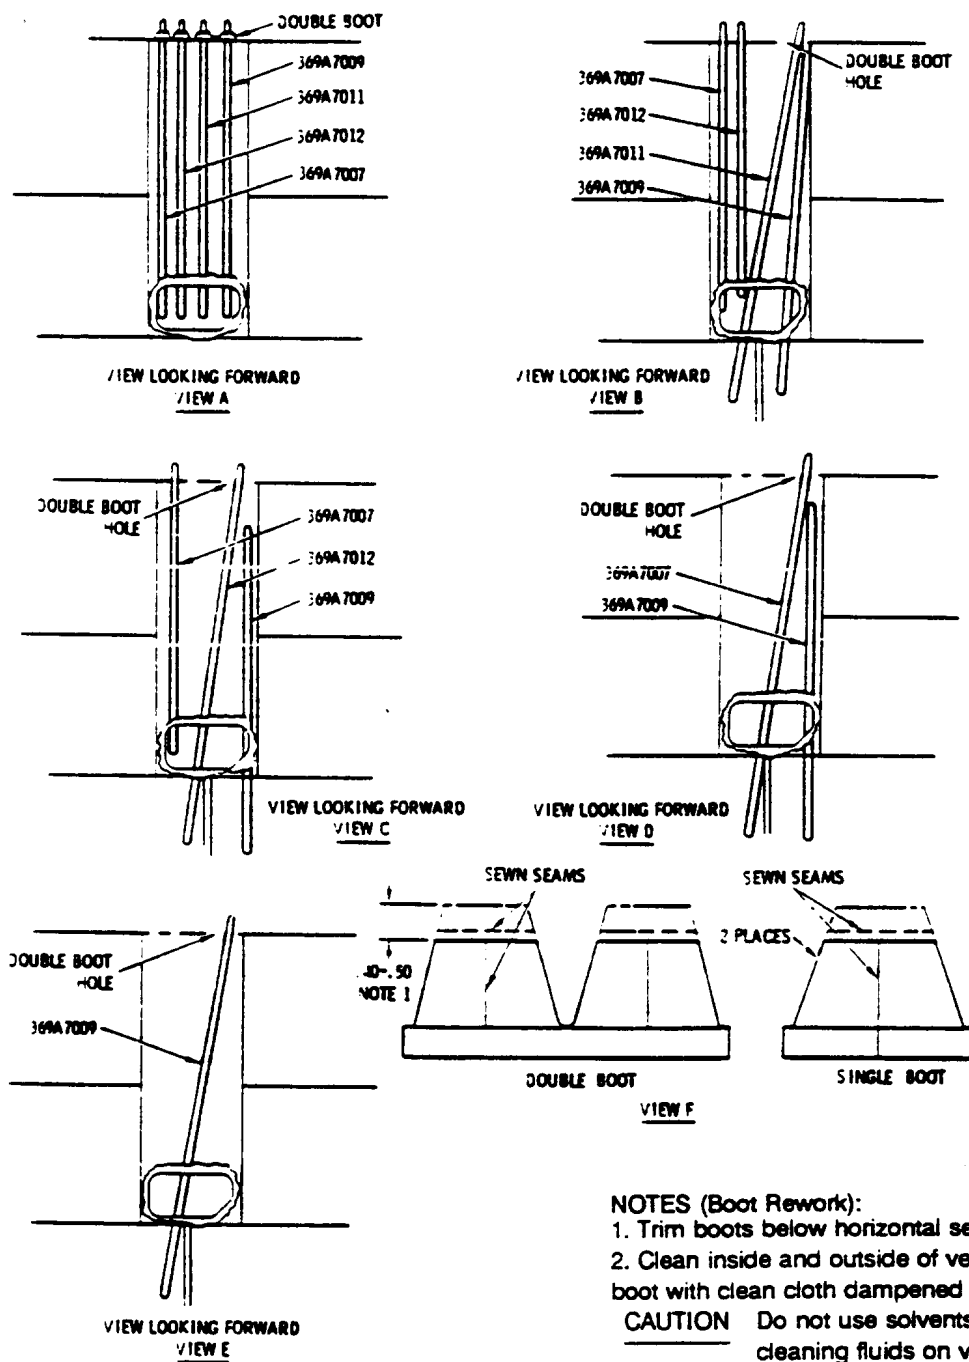
Figure 1. Control Tube Removal and Boot Rework

PREFACE: MDHI inspections have revealed internal and external cracks in the vertical Tunnel-Routed main and tail rotor control tubes. Therefore, MDHI is requiring all operators of affected helicopters to perform the following inspection and install reinforcing sleeves to each end of the control tubes. There have been no reported failures of the control tubes.

1. Align blue blade to right side of aircraft.
 2. Remove bolts from top of tubes.
 3. Remove double boot from the 11 and 09 tubes (ref. view A). All tubes will be removed through the double hole.

4. Move blue blade pitch housing down as far as it will go. This will allow the tubes to go past the housing.
 5. Remove bolts from bottom of 11 and 09 tubes.

6. Move cyclic controls so that the 12 tube moves to its highest point (ref. view B). Place 09 tube to the far right and lower out of the way. Lower 11 tube to the left side of center beam. This will allow 11 tube to angle up through the double hole.

7. Remove bolt from bottom of 12 tube and lower to belly of aircraft and angle up through the double hole (ref. view C).
 8. Remove bolts from bottom of 07 tube and lower to the belly of aircraft, then angle up through the double hole (ref. view D).

9. Move 09 tube to the other side of center beam and angle up through the double hole. To install tubes just reverse sequence (ref. view E).
- b. Using paint stripper (refer to HMI), remove paint approximately six inches back from end of each tube (tapered area of tube).

- s. Rework control tube boots per Figure 1, View F.
- t. Reinstall control tubes and boots in reverse order listed in Part I. Reinstall trimmed boots with vertical seam facing aft. If control tubes have not been accurately measured, flight controls will require rerigging.
- u. Check flight controls for interference or binding.
- v. Record compliance to this Service Information Notice in the Compliance Record section of the helicopter Log Book.

1. Trim boots below horizontal seam
2. Clean inside and outside of vertical seam and top of boot with clean cloth dampened with isopropyl alcohol.
CAUTION Do not use solvents or petroleum based cleaning fluids on vinyl boots.
3. Coat both sides of vertical seam with contact cement.
4. Apply thin coat of contact cement along trimmed edge and 1/8 to 1/4 inch down inside and outside surfaces of boots to prevent fraying.
