SERVICE BULLETIN

SUBJECT: ONE-TIME INSPECTION OF 369A5358 LOCKWASHER IN THE OVERRUNNING CLUTCH ASSEMBLY AND INSPECTION OF ENGINE OUTPUT DRIVE SPLINES.

MODELS AFFECTED: All MD Helicopters, Inc. (MDHI) 369A (OH-6A), 369H series, 369D, 369E, serial No. 0001E thru 0368E and 369F/FF, serial No. 0001F thru 0067FF, series helicopters.

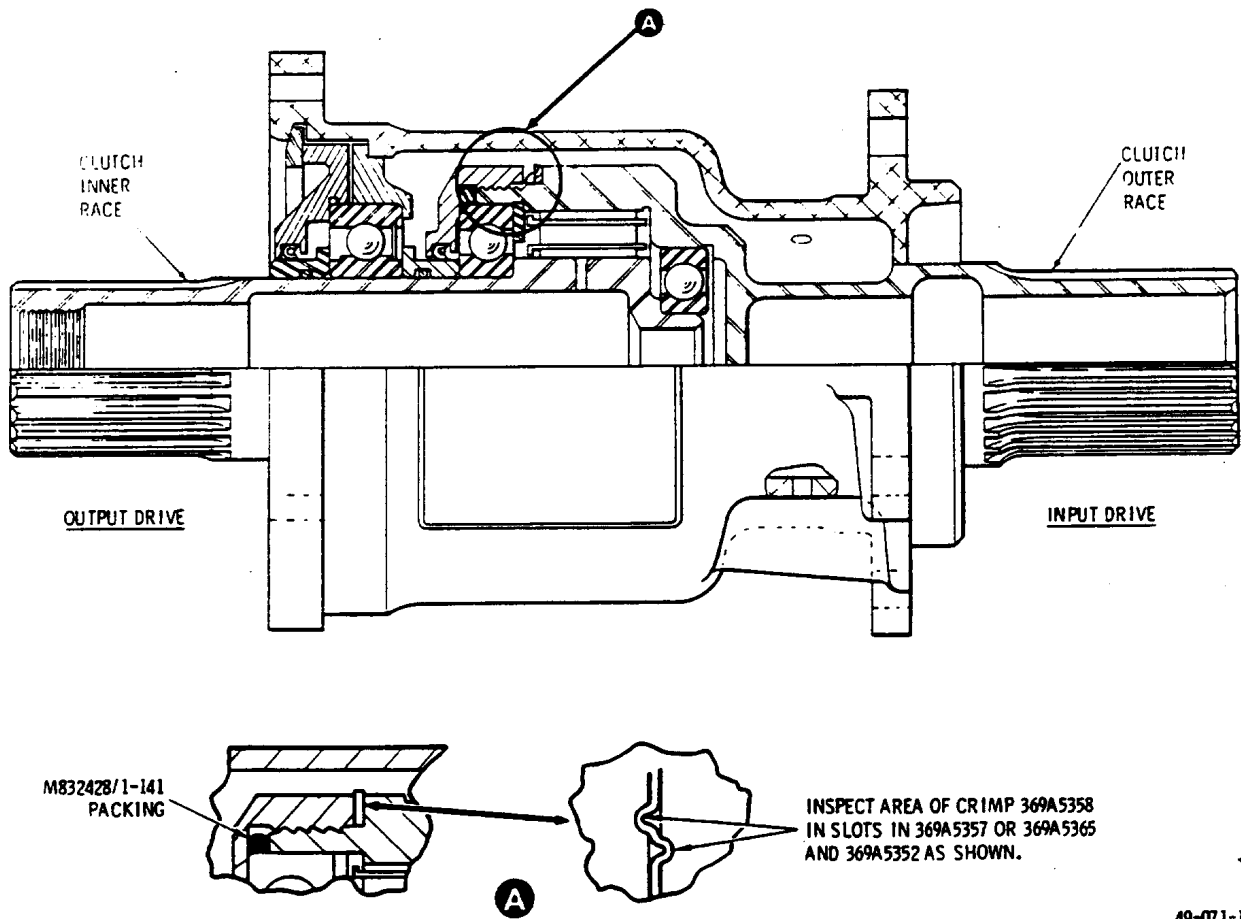
Figure 1. Inspection of Overrunning Clutch Assembly and Engine Output Drive Splines.

PREFACE: Several 369A5358 overrunning clutch lockwashers have been found cracked in service. As cracking may occur during the crimping operation at installation, MDHI is requiring operators to perform the following inspection to ensure the subject lockwasher is not cracked.

Additionally, excessive wear has been detected on the Allison engine output drive splines on some helicopters. Therefore, anytime the overrunning clutch sub-assembly is removed from the helicopter, the splines on the overrunning clutch and the output spline in the engine should be inspected for wear. Wear in the engine output splines can be detected by feeling for a "step" inside the splines. Operators are required to contact Allison for a disposition if any "step" in the area is felt/observed.

- b. Using a suitable light and a 10X magnifying glass, inspect lockwasher crimped area as shown in Figure 1 for any indications of cracking. Replace cracked lockwashers per the applicable COM.

Pay particular attention to the crimped portions of the lock-washer.

- c. Check the splines of the overrunning clutch for wear per the COM.
- d. Check the engine output drive splines using a sharp point scribe, lightly feel for a "step" in the spline length (see Figure 1) where the clutch input drive splines mesh with the engine output drive splines.

If a "step" is observed or felt using a sharp point scribe, contact Allison Gas Turbine Division of General Motors Corporation for disposition at (317) 230-2720.

- e. If a "step" is not felt/observed install overrunning clutch sub-assembly per applicable HMI.
