HN-197.2*
DN-130.2*
EN-19.2*
FN-17.1*

SERVICE BULLETIN

DATE: 23 MARCH 1987
PAGE 1 OF 4

INSPECTION OF TAIL ROTOR BLADE LEADING EDGE ABRASION STRIP BONDING.

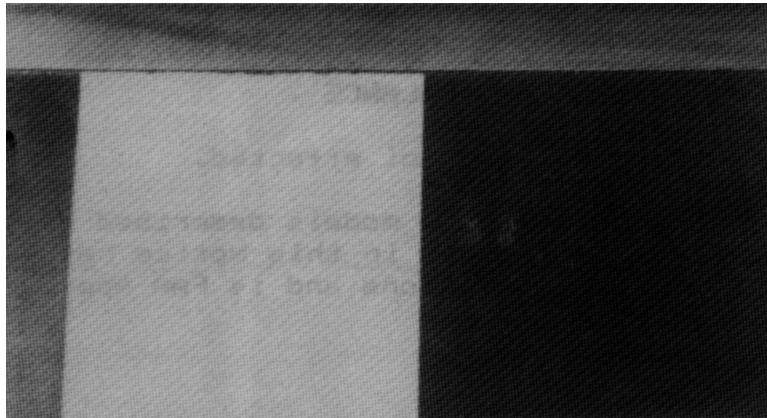
SHOWN ABOVE: UNBONDING OF EPOXY ADHESIVE AND ABRASION STRIP WITH SEPARATION BETWEEN ABRASION STRIP AND AIRFOIL SURFACE, BLADE UNACCEPTABLE FOR SERVICE.

B. Using a 10X magnifying glass, closely check along abrasion strip/airfoil bond line and at blade tip for any separation between epoxy adhesive and abrasion strip. Any separation between bonding adhesive and abrasion strip is cause for removal of blade from service. (See Figure 1.) If separation is suspected, but not confirmed, inspect per PART I of this Notice.

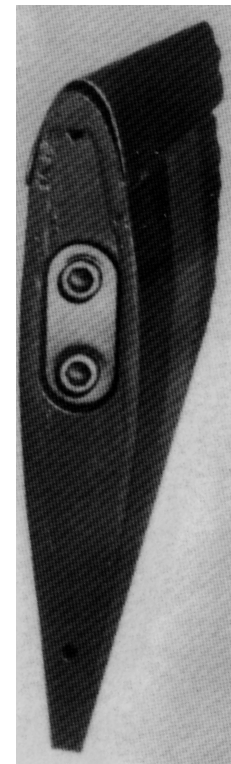
SHOWN RIGHT: UNBONDED AND DISPLACED ABRASION STRIP AT BLADE TIP; SEPARATION BETWEEN ABRASION STRIP/AIRFOIL SURFACE ALONG BOND LINE, BLADE UNACCEPTABLE FOR SERVICE.
