SERVICE BULLETIN

DATE: 15 JUNE 1990
PAGE 1 OF 3

SUBJECT: ONE-TIME REPLACEMENT OF POLYCARBONATE COVER ASSEMBLES (369A9817)

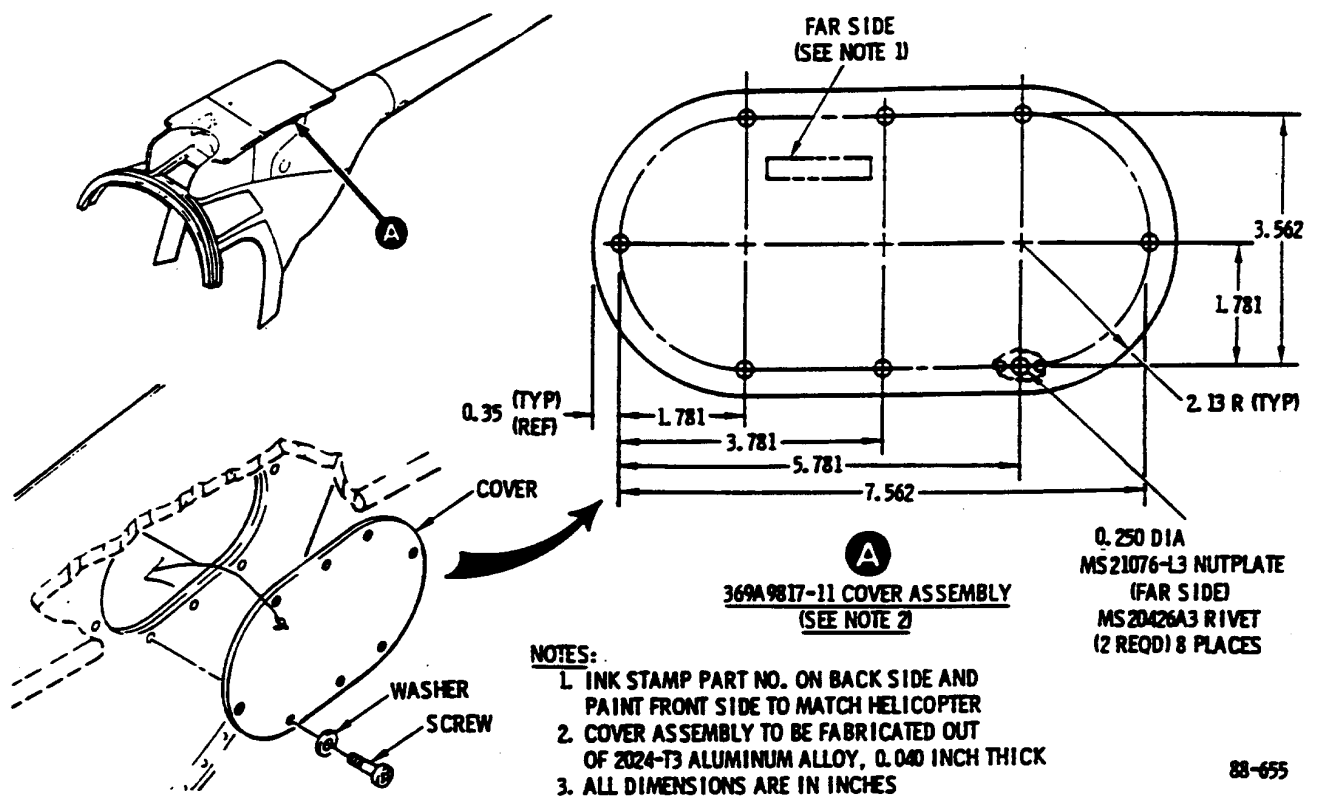
Figure 1. Fabrication of 369A9817-11 Cover Assembly.

SUMMARY: MD Helicopters, Inc. (MDHI) has received reports that some 369A9817 polycarbonate cover assemblies were found cracked by visual inspection.

Complete failure of the cover assembly could result in severe FOD damage to the engine.

- Cover engine air inlet with a suitable cover to prevent foreign objects from entering the engine.
- Remove the 369A9817 cover assembly from the engine air inlet Pairing (See Figure 1 for location).
- Verify which type of cover assembly is installed.

- Discard polycarbonate cover assemblies and procure a 369A981 7-11 cover assembly from MDHC Warranty and Repair Dept. or field fabricate a 369A981 7-11 cover assembly per instructions in Figure 1.

- Prime and paint cover assembly accordingly.
- Install aluminum cover assembly using existing screws and washers.
