SERVICE BULLETIN

SUBJECT: ONE-TIME REPLACEMENT OF TAIL ROTOR BLADE PITCH ARM BOLT ATTACHING NUTS.

MODELS AFFECTED: All MD Helicopters, Inc. (MDHI) 369 Series helicopters, equipped with metal tail rotor blades.

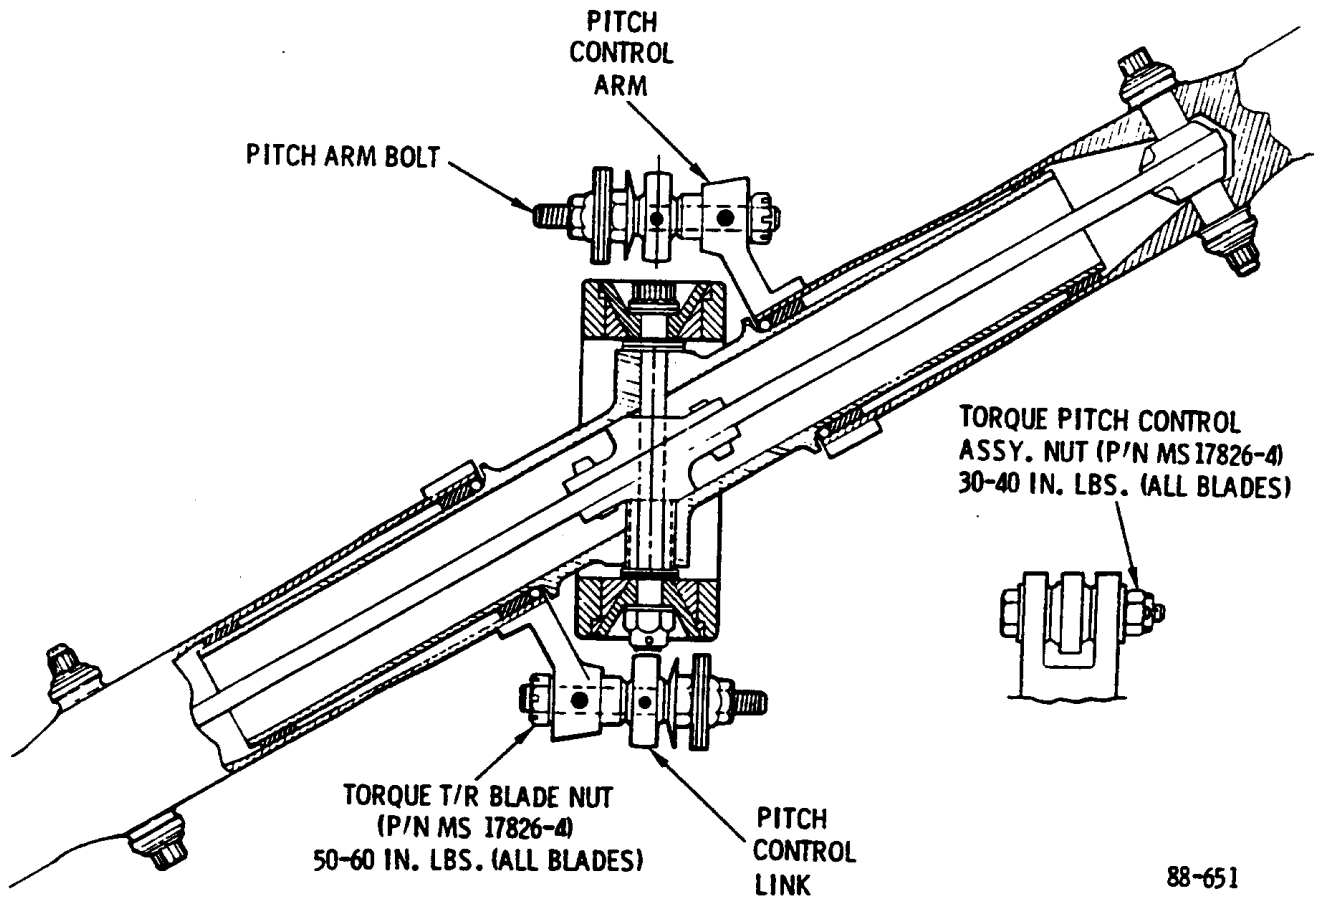
PREFACE: MDHI installation requirements were recently revised to lower the installation torque of the tail rotor pitch link nuts. Therefore, MDHI is requiring operators to replace the subject MS17826-4 nuts. MDHI will provide operators with replacement nuts, free of charge. Contact a MDHI Approved Service Center or Distributor for replacement nuts.

Figure 1. Replacement of Tail Rotor Pitch Link Nuts.

- a. Remove nuts at pitch control assembly and nuts at tail rotor blade pitch arm attachments. (Refer to Figure 1 .)
- b. Install new MS17826-4 nuts. Torque tail rotor blade nuts to **50 - 60 inch-pounds**. Torque nuts at pitch control assembly to **30 - 40 inch-pounds**.

DO NOT exceed 60 inch-pounds torque on the tail rotor blade nuts or 40 inch-pounds on the pitch control assembly nuts.

- c. Without exceeding torque limits, align cotter pin hole at the outboard and inboard ends of the pitch arm and install cotter pin.
