HN-231
DN-178
EN-69
FN-56

SERVICE BULLETIN

SUBJECT: ONE-TIME REWORK OF MAIN ROTOR TRANSMISSION OIL COOLING FAN MOUNTING BRACKET

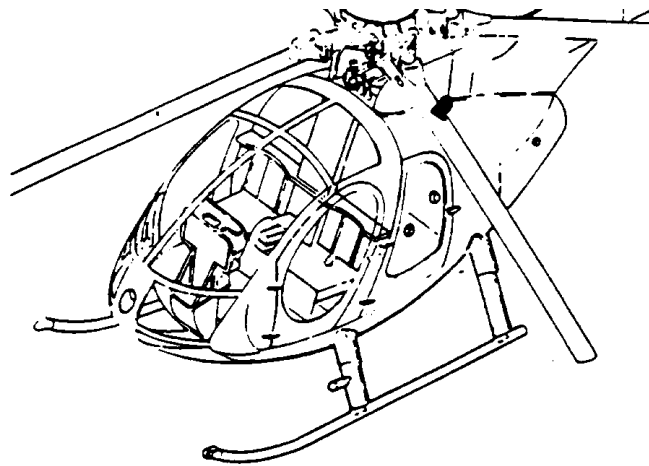
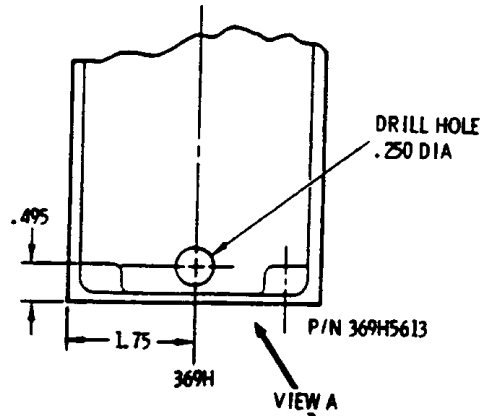
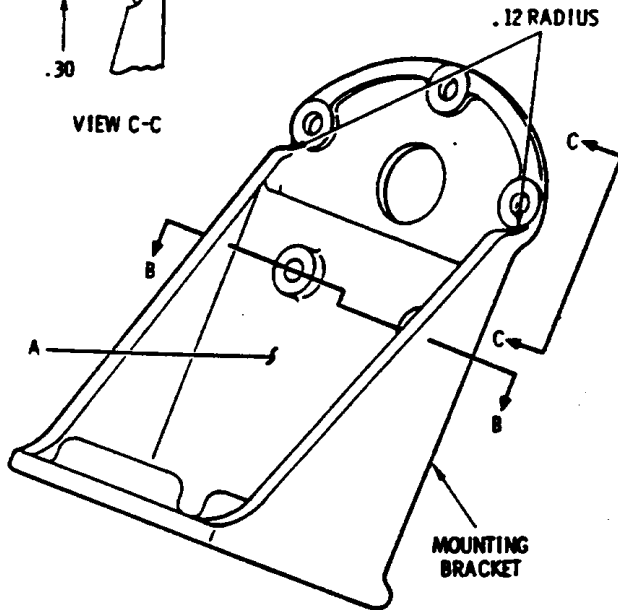
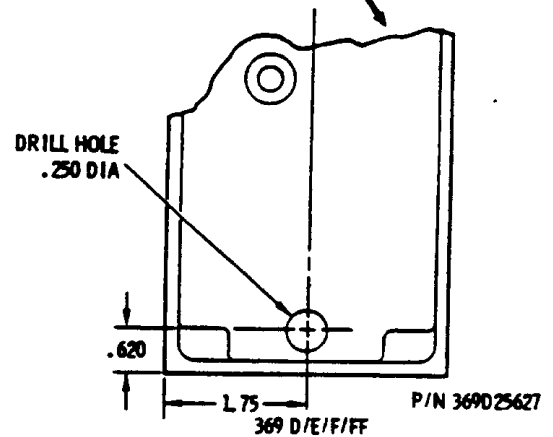
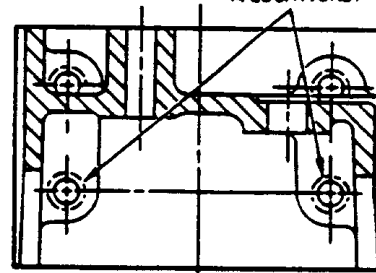
Figure 1. Rework of Oil Cooling Fan Mounting Bracket.

SUMMARY: The oil cooling fan mounting bracket is subject to galvanic corrosion. The following measures can be taken to help prevent the occurrence of galvanic corrosion.

- a. Gain access to oil cooling blower assembly using the applicable maintenance manual.
- b. Disassemble blower assembly and remove applicable 369D25627 or 369H5613 brackets. Drill a 0.250 dia. hole in bracket at location shown in Figure 1, view A.

Note the difference in hole location between the 369D25627 (369D/E/FF) and the 369H5613 (369H Series) brackets.

- c. Add 0.12 inch radius to locations shown in Figure 1, view C-C.
- d. Treat exposed magnesium with chromic acid solution per the applicable maintenance manual.
- e. Touch-up paint with zinc chromate primer.
- f. Reinstall 369D25627 or 369H5613 bracket using aluminum washers in place of steel washers. Apply PR1221 sealant across joint faying surfaces after assembly.
- g. Apply sealant around bolt holes and the open insert holes in the fan bracket shown in Figure 1, view B-B.
- h. Complete installation of the cooling fan assembly per the applicable maintenance manual.

APPLY SEALANT TO
 THESE SURFACES
 (4 LOCATIONS)
