HN-235  
 DN-182  
 EN-74  
 FN-61

# SERVICE BULLETIN

## ONE-TIME INSPECTION/REWORK OF ENGINE AIR INLET AREA

All MDHI 369 series helicopters.

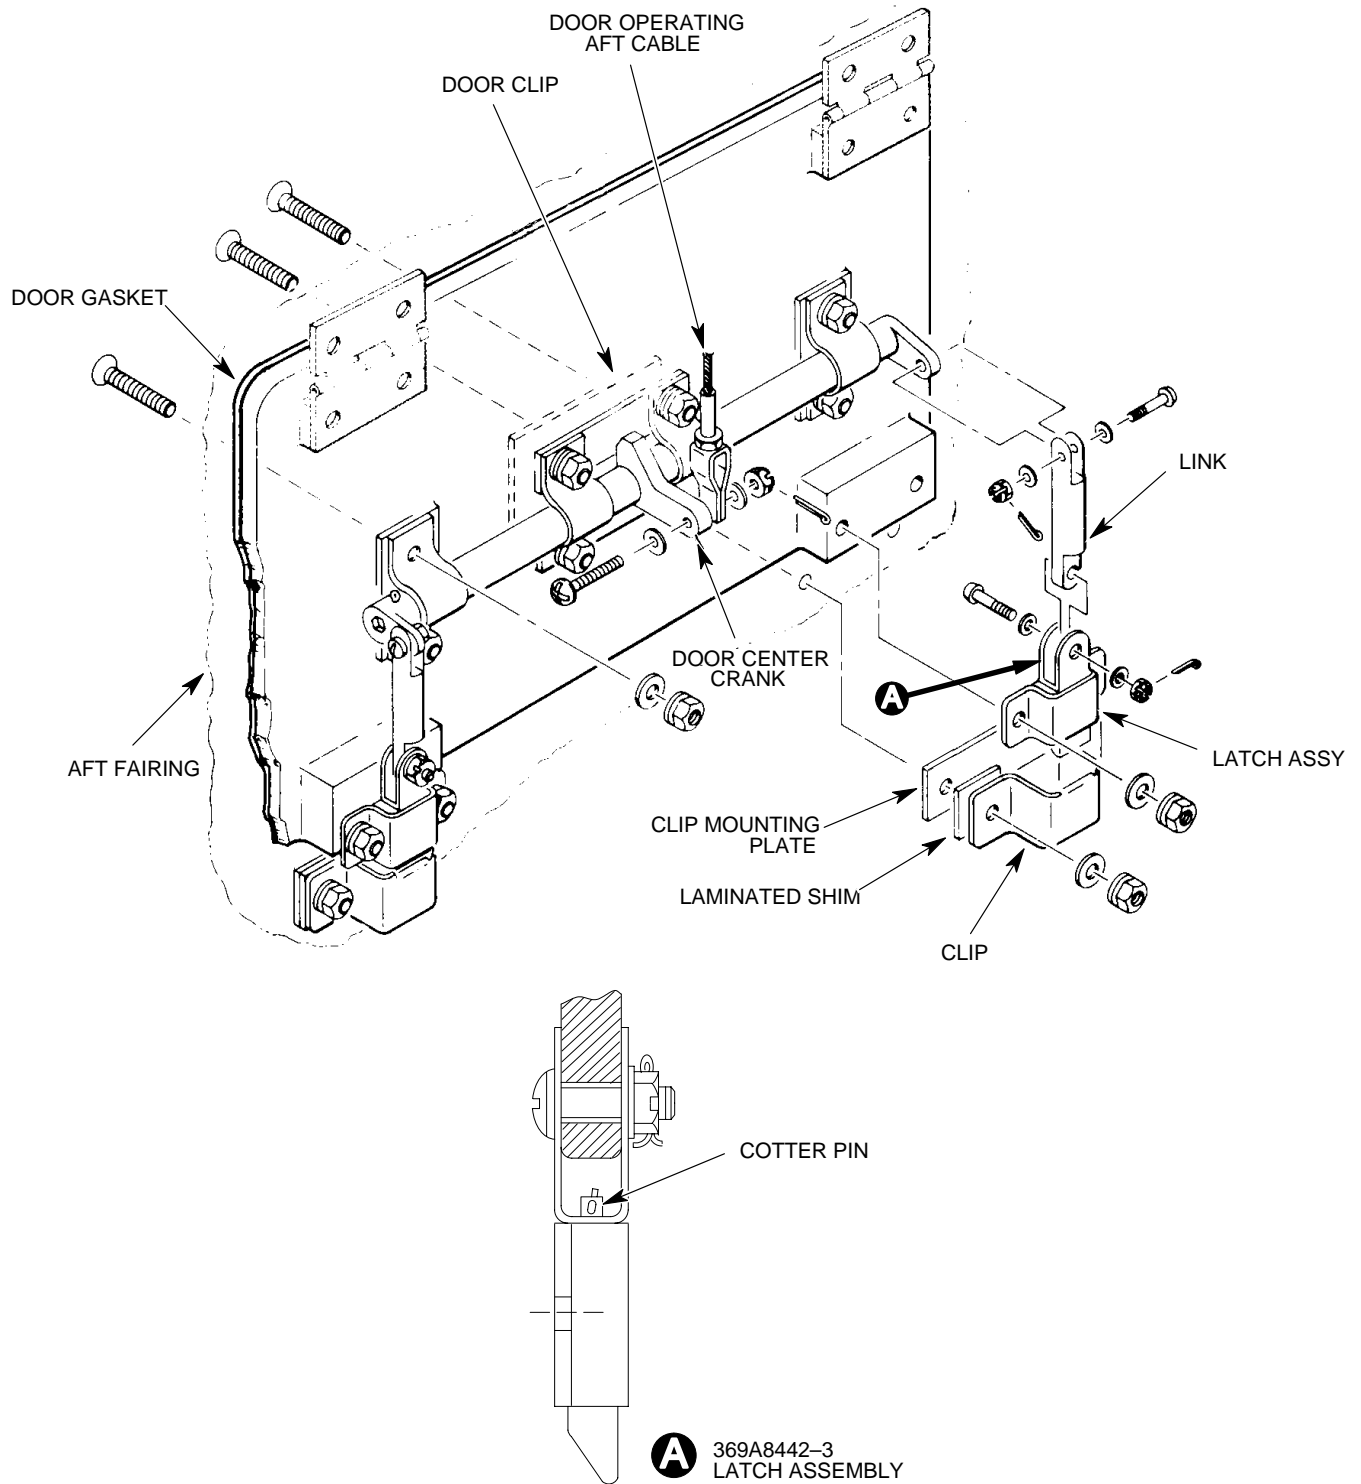
### FOR HELICOPTERS EQUIPPED WITH PARTICLE SEPARATOR BYPASS DOOR (FIG.1) P/N 369A2099 & 369D290134

Figure 1. Particle Separator Bypass Door Latch Cotter Pin Installation.

- a. Remove particle separator bypass door per the applicable maintenance manual.
- b. Inspect all latches, hinges, hardware, etc., for serviceability and security. Remove and replace any un-serviceable components.
- c. Remove and inspect the bypass door latch and replace the latch retention cotter pin located inside the attach cable "U" clamp (see Figure 1).
- d. Replace the 369A8442-3 latch assembly if any of the following limits are exceeded:
  - If cotter pin hole in the stem of the latch is elongated more than .080 inch in length.
  - If cotter pin has worn into the surface of the cable attach "U" clip more than 1/2 the thickness of the clip (.025 inch deep).
  - If the latch engagement faying surface is worn more than .050 inch below the original surface.
- e. Complete installation of particle separator bypass door.

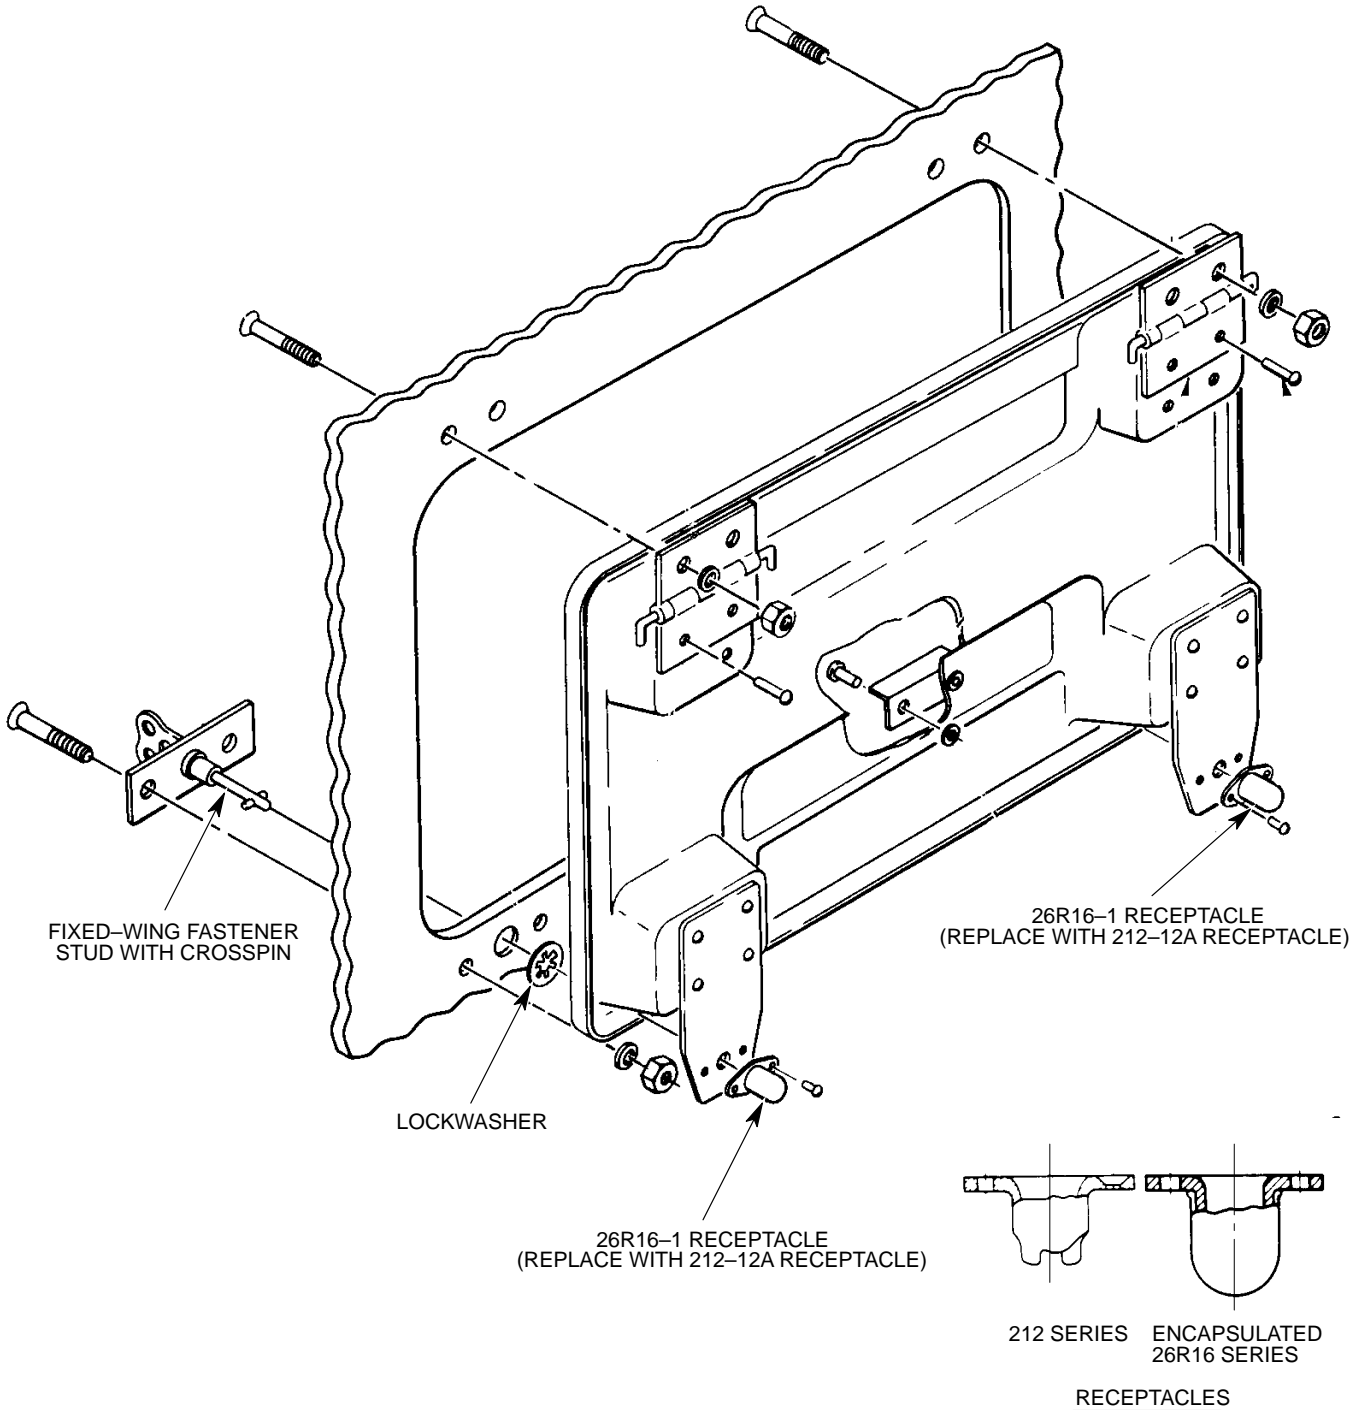
## FOR HELICOPTERS EQUIPPED WITH PLENUM CHAMBER ACCESS DOOR (FIG.2) P/N 369H2080

Figure 2. Plenum Chamber Access Door Inspection/Rework.

- a. Remove two 26R16-1 encapsulated receptacles and replace with 212-12A receptacles. (Refer to Figure 2.)

- b. Inspect fixed-wing fastener stud for serviceability and security paying particular attention to cross pin on stud and associated lockwasher (see Figure 2). Remove and replace any unserviceable components.

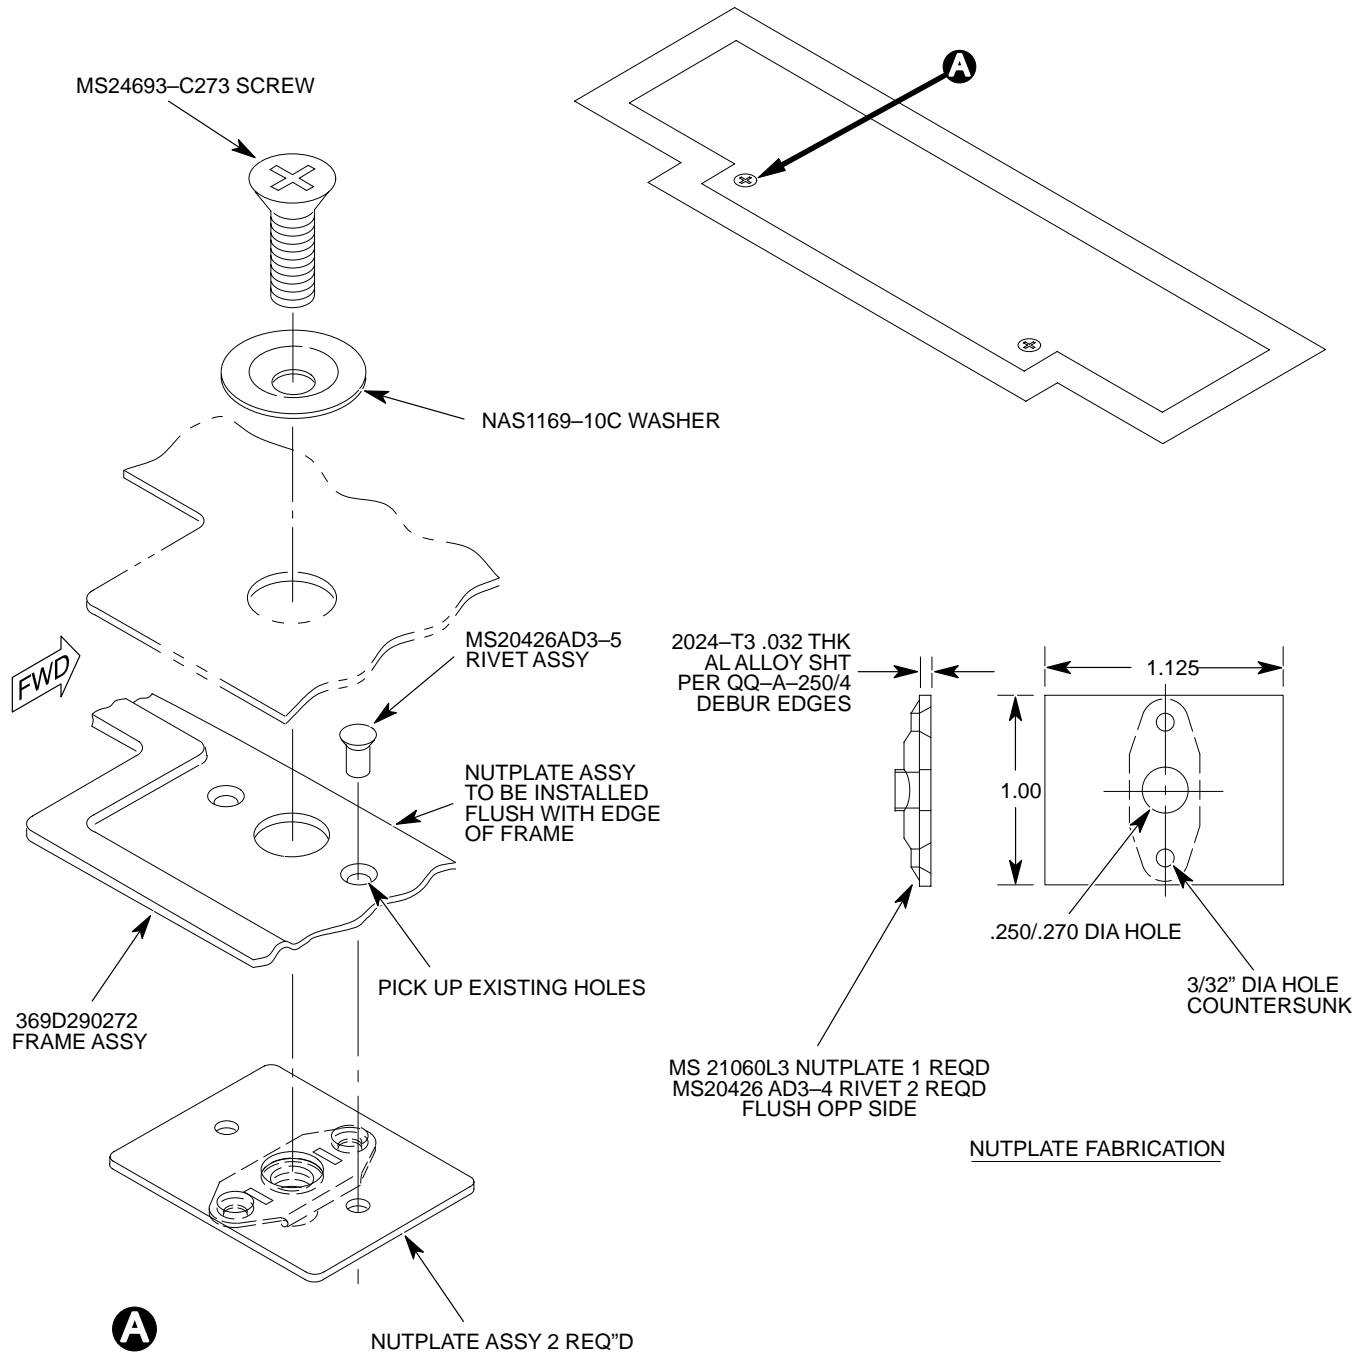
## FOR HELICOPTERS EQUIPPED WITH MIST ELIMINATOR ACCESS DOOR (FIG.3) P/N 369D290270

Figure 3. Replacement of Mist Eliminator Door Attaching Hardware.

- a. Remove mist eliminator door per the maintenance manual.
- b. Remove the two 2700-7 studs, 2600-LW lockwashers and 26R16-1 receptacles (Ref. CSP-IPC-4, Section 71-10-10).
- c. Field fabricate two nutplate assemblies as shown in Figure 3.
- d. Install nutplate assemblies onto bottom side of 369D290272 frame assembly making sure to center nutplate assembly over existing hole in frame assembly as shown in Figure 3.
- e. Complete installation of mist eliminator access door using MS24693-C273 screw and NAS1169-10C washer (two each required).

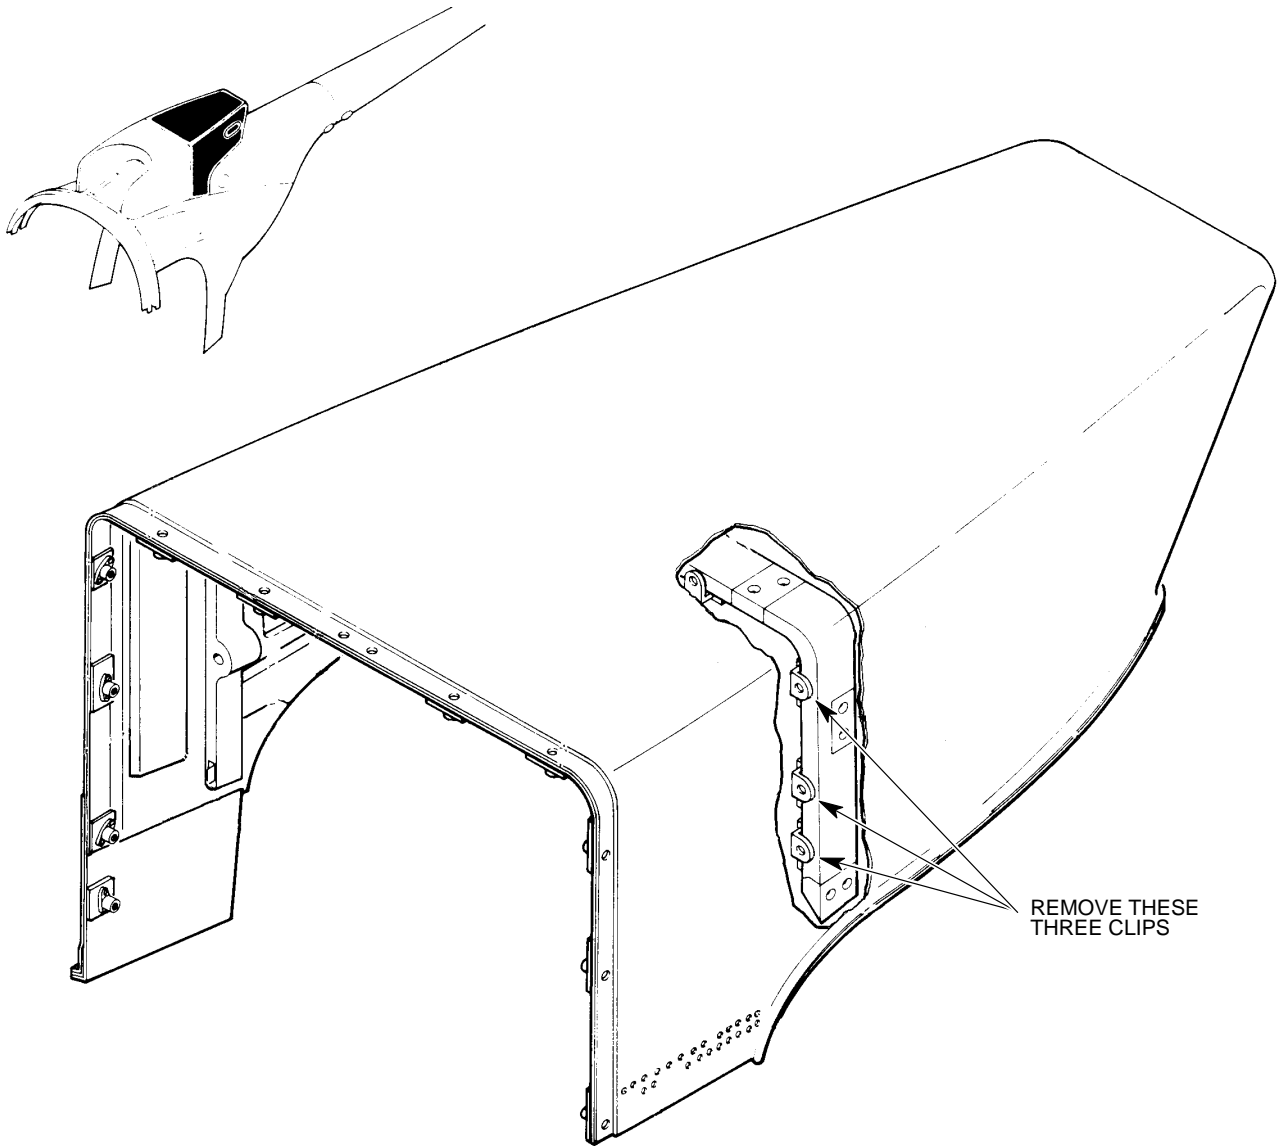
## FOR ALL HELICOPTERS (FIG. 4)

Figure 4. Removal of Clips and Other Hardware From Plenum Chamber.

- a. Remove any unused clamps, clips, brackets or other hardware from the engine inlet plenum area.
- b. Remove three clips shown in Figure 4 (clips are bonded and covered with (1) layer of glass cloth). Carefully cut glass cloth around edges of clip and then remove clips. Trim cut edges of glass cloth.
- c. Inspect entire inlet plenum area hardware, hinges, cables, latches, etc., for serviceability and security. Remove and replace any unserviceable components.
