SERVICE BULLETIN

DATE: 27 OCTOBER 1978

OVERRUNNING CLUTCH ASSEMBLY, PN 369A5350-603 – REWORK INSPECTION OF PN 369A5350-11 CLUTCH SUBASSEMBLY AND PN 369A5361 BALL BEARING PERIODIC INSPECTION OF PN 369A5350-21 CLUTCH SUBASSEMBLY

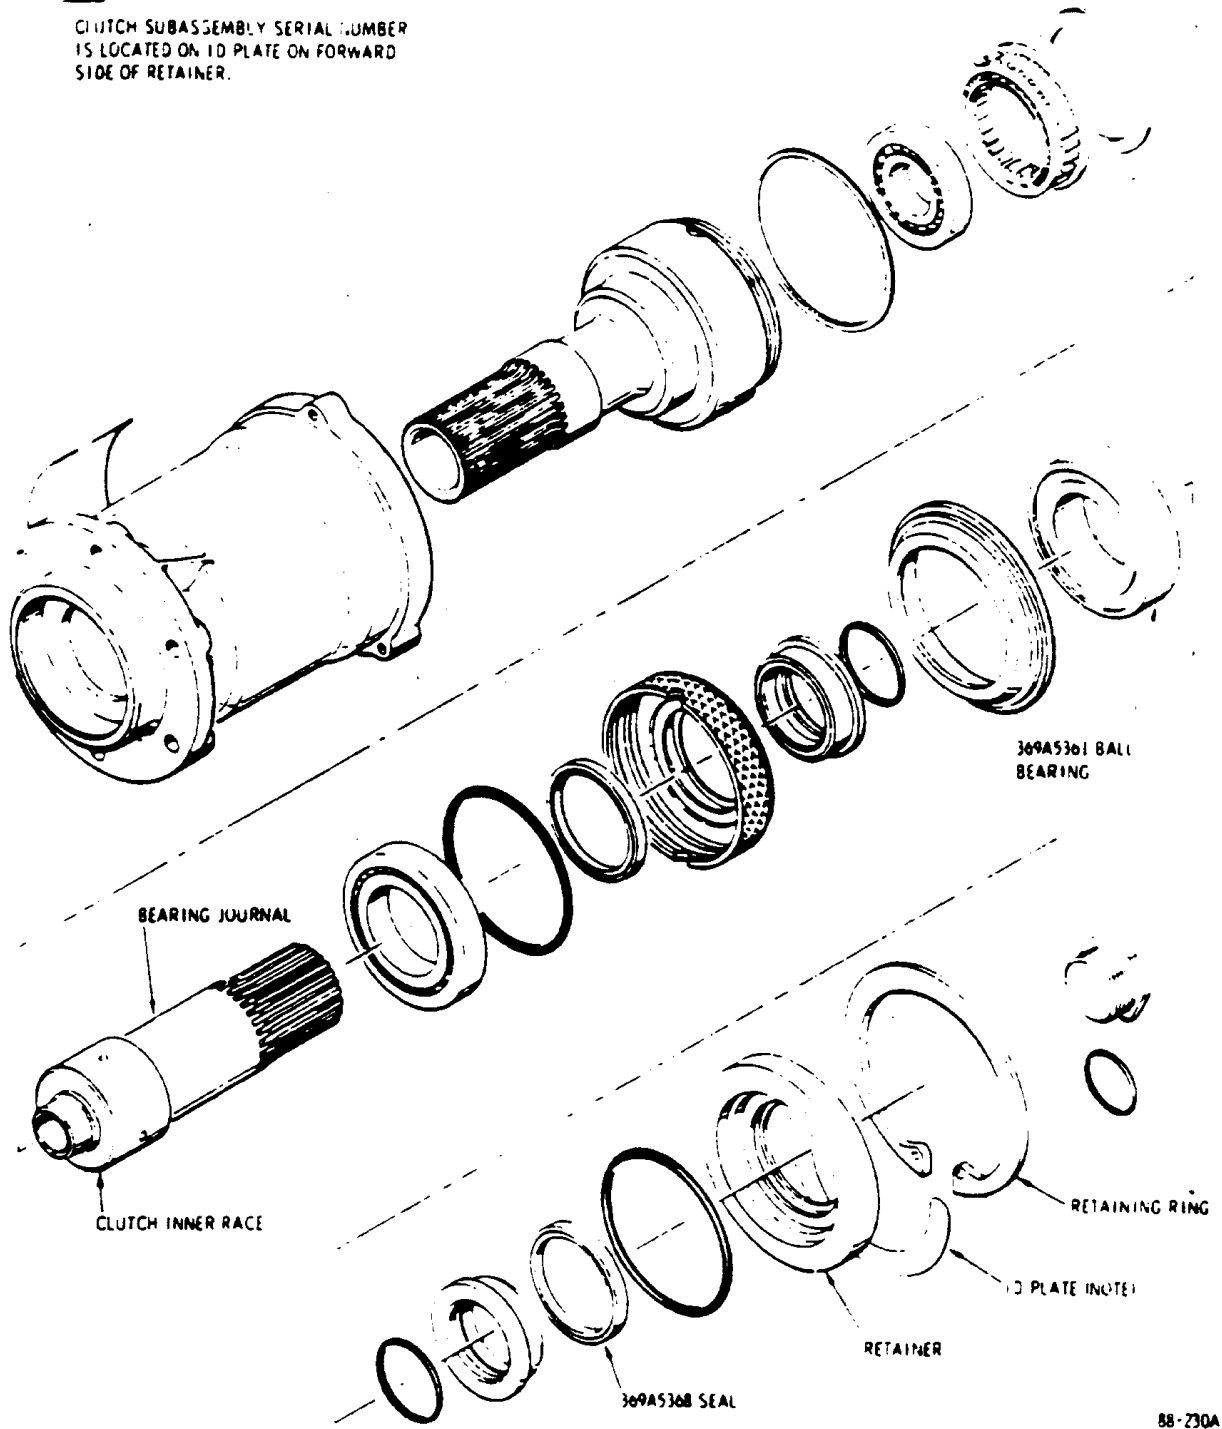
Figure 1. Overrunning clutch assembly.

(4). Check 369A5361 ball bearing for excessive loss of grease.

NOTE: If ball bearing is dry or grease is caked, inspect bearing as follows:

1. Inspect ball bearing for roughness pitting or scoring; or discoloration from overhearing. Replace bearing, if any of the above is noted.

2. Check for bearing preload. If no discernible radial play is noted in the bearing, remove bearing per HMI Appendix C and measure journal OD. If OD of journal exceeds 1. 2505 inches, return clutch subassembly to HH for rework.

CLUTCH SUBASSEMBLY SERIAL NUMBER
IS LOCATED ON ID PLATE ON FORWARD
SIDE OF RETAINER.

(3). Remove clutch retainer to expose 369A5361 ball bearing (See Figure 1).

- (5). Using solvent and brush, thoroughly remove existing grease—from both bearing and retainer. Do NOT use compressed air to remove grease from ball bearing. Inspect bearing for condition; if roughness, pitting or scoring is noted, replace bearing. Inspect 3(369A5368-3 seal in retainer; replace seal if cracked, broken, worn, or shows evidence of excess heating.

- (6). Repack bearing 50 percent to capacity with Aeroshell 22 or Mobil 28 grease by packing open side of bearing level without forcing grease through bearing cage.

- (7). Fill void in retainer 75 percent full with grease; reinstall retainer. Flat side of retainer faces unit; bevel side is out.
- (8). Coat clutch splines with Aeroshell 22 or Mobil 28 grease; carefully insert clutch subassembly into housing and secure with retaining ring.
