# SERVICE BULLETIN

DATE: 26 NOVEMBER 1979

**SUBJECT:** PN 369A1800 SERIES AND PN 369H1800 TAIL ROTOR PITCH CONTROL ASSEMBLY - SEATING OF BEARING INNER RACE; TORQUE INCREASE FOR PN 369A1817 LOCKNUT

**MODELS AFFECTED:** All 500 Model 369H Series Helicopters

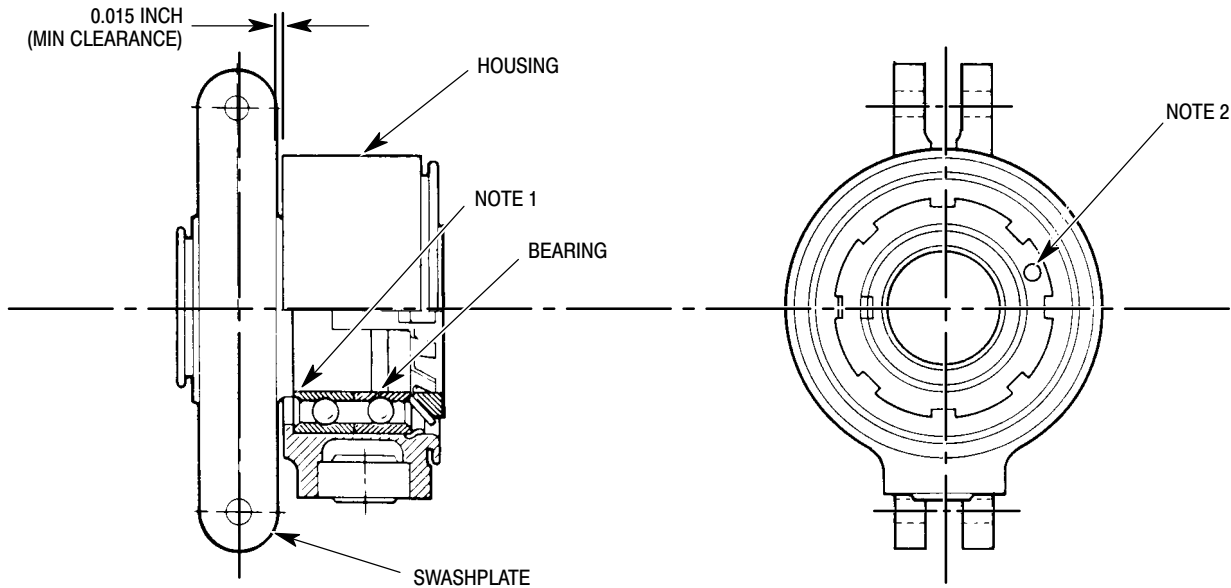
Figure 1. Tail Rotor Pitch Control Assembly - Seating of Bearing and Increased Torque for Locknut

**PREFACE:** The information given in this Service Information Notice lists a procedure for seating the double row ball bearing of the tail rotor pitch control assembly, to ensure that the bearing inner race is firmly in contact with the shoulder of the swashplate. At reassembly of the pitch control assembly, the locknut is torqued to 400 to 450 inch-pounds. Reseating of the bearing inner race and increasing the torque for the locknut is designed to prevent loosening of the locknut and premature wear of the bearing during tail rotor operations.

It is to be noted that PN 369A1800 Series and 369H1800 Pitch Control Assemblies identified with a white dot on the locknut (See Figure 1) are not affected by this Notice.

- 1. INNER RACE FIRMLY SEATED AGAINST SHOULDER OF SWASHPLATE
- 2. AFTER TORQUE, COLOR CODE WITH WHITE DOT (0.12 - 0.18 IN. DIA.)

- d. Place housing and swashplate assembly on arbor press bed with swashplate end down. Apply 2000 pounds of pressure to press inner race of bearing firmly in contact with shoulder of swashplate. Use suitable tube or sleeve to press INNER race of bearing only. Remove assembly from arbor press.

- e. Install new 369A1816 tang washer; reinstall locknut and torque locknut to 400 to 450 inch-pounds. Use wrench adapter and torque wrench while assembly is held in holding block, to tighten locknut.

- f. Check for sufficient clearance (0.015 inch minimum) between swashplate and housing (see Figure 1 ).
- g. Check for smooth easy and free rotation without binding.

- h. Bend a tang of the tang washer into bottom of any aligned slot on locknut.
- i. Paint a 0.12 to 0.18 inch white dot on locknut, as shown in Figure 1, to denote reseating of bearing and locknut torqued to 400 to 450 inch-pounds.
