# TECHNICAL BULLETIN

DATE: 23 AUGUST 1971

## PROVISIONS FOR DRAINAGE OF WATER ENTRAPMENT AREAS

All 369H Series Helicopters

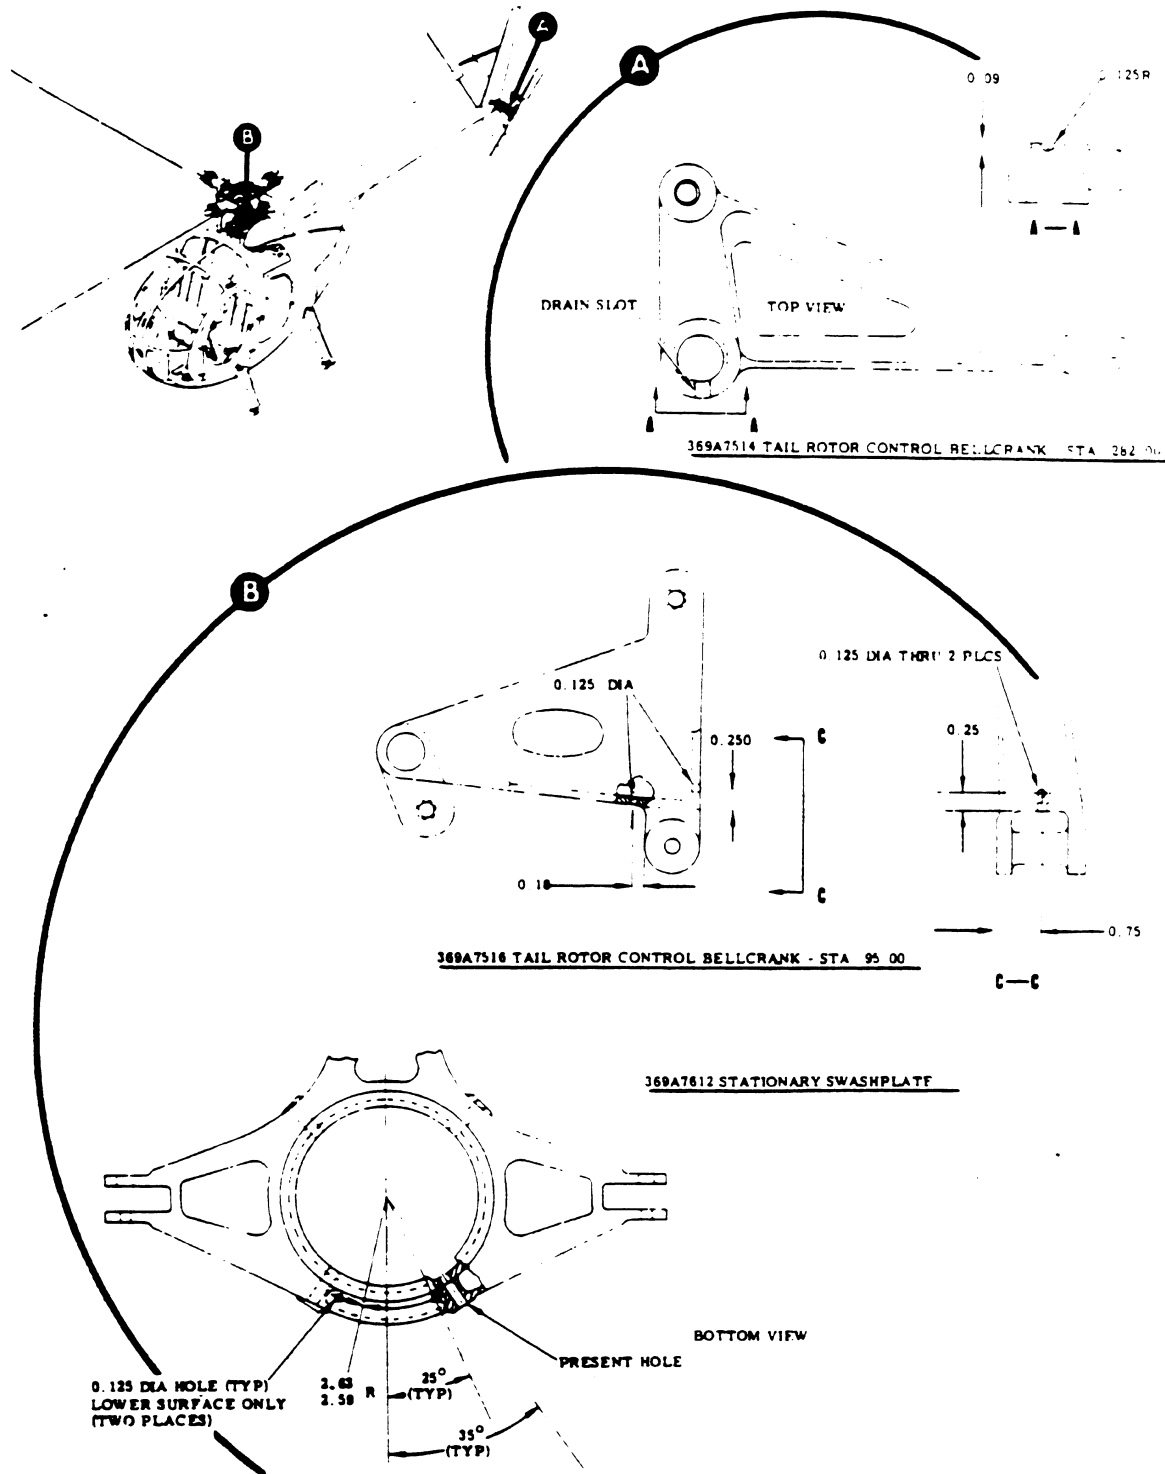
**Figure 1. Drainage Provisions - Water Entrapment Areas**

The information given in this Service Information Notice lists a procedure for incorporating drainage provisions in specified flight control components, to reduce the possibility of corrosion due to water entrapment.

- a. Remove Sta. 282 bellcrank, per Section 8 of Basic HMI
- b. Using arbor press and appropriate tool, press out 369A7951-25 pivot Do not apply pressure to bearing inner race.
- c. Using a rat tail file (1/4-inch diameter), file the slot to dimensions shown in Figure 1; remove any discernible file marks with 400 grit paper wrapped around a 1/4-inch diameter dowel.
- d. Provide magnesium surface touch up treatment, per Section 2 of the Basic HMI; and paint touch up, per applicable HMI Configuration Supplement.
- e. Replace the pivot bearing as follows:
  1. Clean faying surfaces of bearing and bellcrank with trichloroethane; do not allow trichloroethane to enter bearing face.

- a. Remove Sta, 95 bellcrank, per Section 8 of Basic HMI.
- b. Drill two 0.125 inch diameter holes at dimensions shown in Figure 1; deburr holes and remove any shavings.
- c. Provide magnesium surface touch up treatment, per Section 2 of Basic HMI; and paint touch up per Section 2 of applicable HMI Configuration Supplement.
- d. Reinstall Sta. 95 bellcrank, per Section 8 of Basic HMI.

- a. Remove stationary swashplate, per Section 7 of Basic HMI.
- b. Drill two 0.125 inch diameter holes at dimensions shown in Figure 1; deburr roles and remove any shavings.
- c. Provide magnesium surface touch up treatment, per Section 2 of Basic HMI; and paint touch up, per Section 2 of applicable HMI Configuration Supplement.
- d. Reinstall stationary swashplate, per Section 7 of Basic HMI.
