**HUGHES
SERVICE INFORMATION
LETTER**

LETTER NO. HL-49

SUBJECT: POWER TURBINE (N2) RUB OR LOCKUP IN 250-C20 ENGINE

MODELS AFFECTED: All Hughes 500 Model 369H Series Helicopters

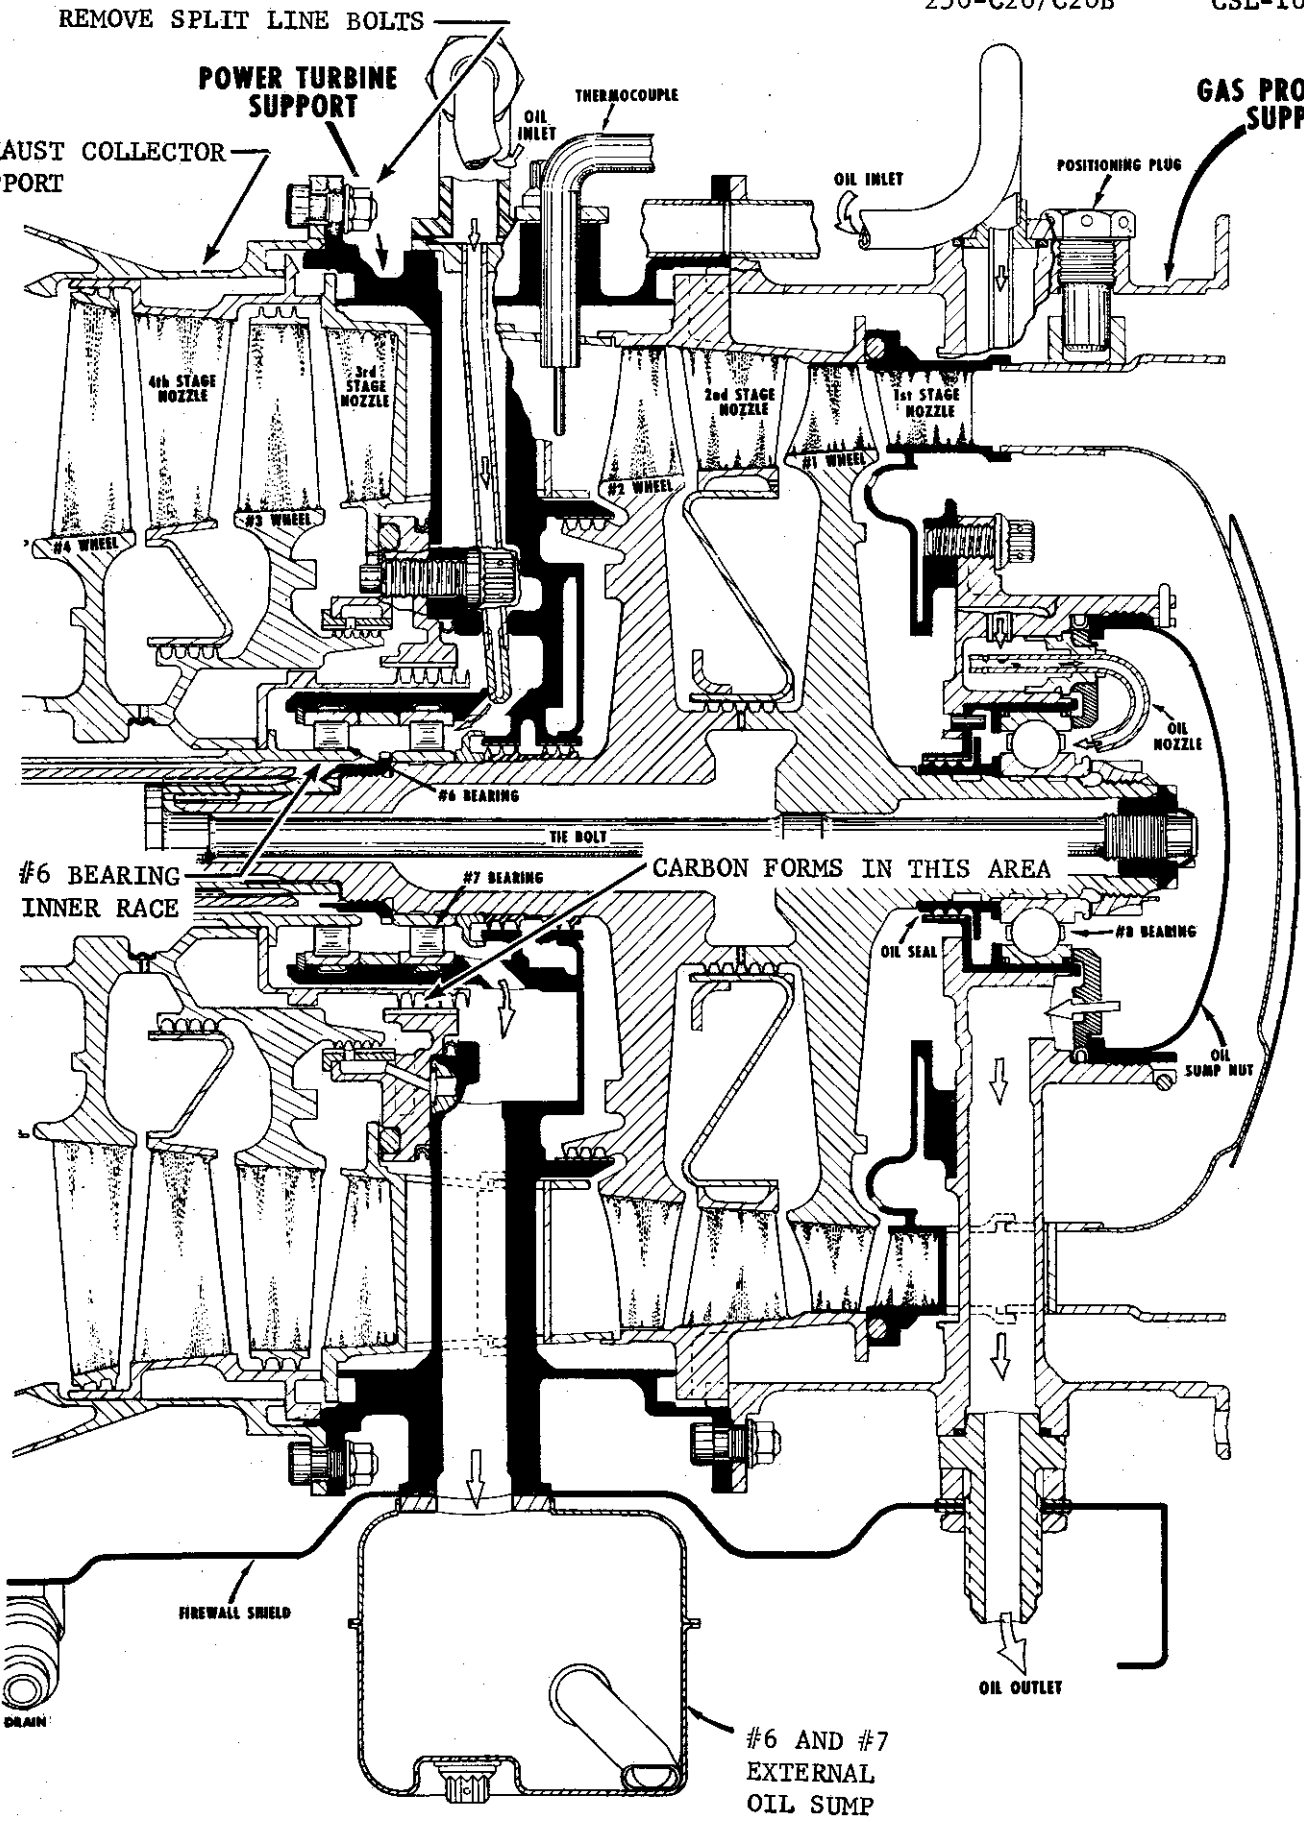
TYPICAL TURBINE
FIGURE 1

There have been instances wherein N₂ Turbine lockup has been the result of carbon buildup on the Rotating Labyrinth Seal of the Power Turbine Rotor. As a result of this condition, several engines have reportedly been removed from service.

1. Remove the Turbine Section from the Gearbox as outlined in the applicable Operations and Maintenance Manual.
2. Remove the No. 6 and 7 External Oil Sump (Ref. Figure 1), and the No. 8 Bearing Scavenge Oil fitting and discard the metallic crush type seal rings.

5. Remove the twenty-four (24) split line bolts between the Exhaust Collector Support and the Power Turbine Support, (Ref. Figure 1).
6. Separate the Power Turbine Support from the Exhaust Collector, being careful the Third Stage Turbine Nozzle does not come out of the Power Turbine Support.

CAUTION: Use care in assembling #6 Bearing inner race to #6 Bearing (Ref. Figure 1).

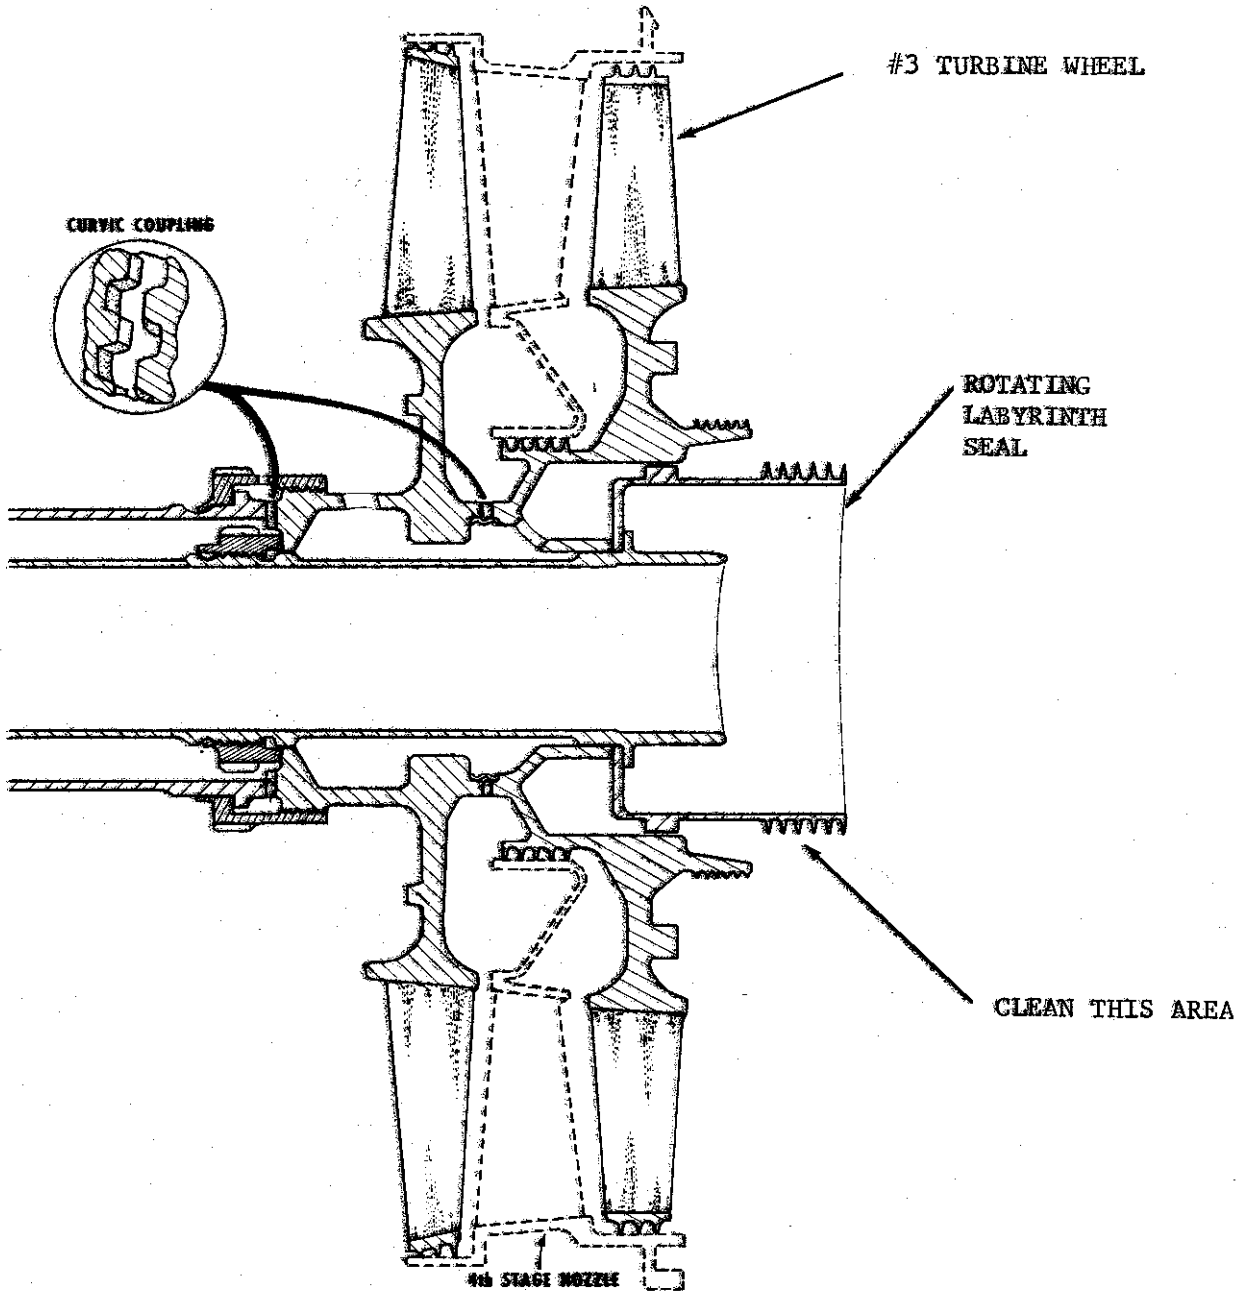
TYPICAL POWER TURBINE ROTOR
FIGURE 2

1. Carbon formation in the labyrinth seal between the small diameter of the power turbine support sump cover and the knives on the rotating seal attached to the aft side of the third-stage turbine wheel. During operation, the knives clear their path in the carbon. At rest after cooldown, the axial movement of the knives into the carbon causes seizure.

7. Using a stiff wire brush or equivalent and No. 26 City Service Carbon Solvent or equivalent, clean the carbon and/or varnish deposits from the Rotating Labyrinth Seal at the rear face of the Third Stage Turbine Wheel, (Ref. Figure 2).

CAUTION: Do not use carbon solvent on the stationary member seal surface.
