HN-230.1*
DN-177.1*
EN-68.1*
FN-55.1*

SERVICE BULLETIN

DATE: 01 MARCH 1991
PAGE 1 OF 5

SUBJECT: PRE-FLIGHT CHECK AND ONE-TIME INSPECTION OF TAIL ROTOR BLADES

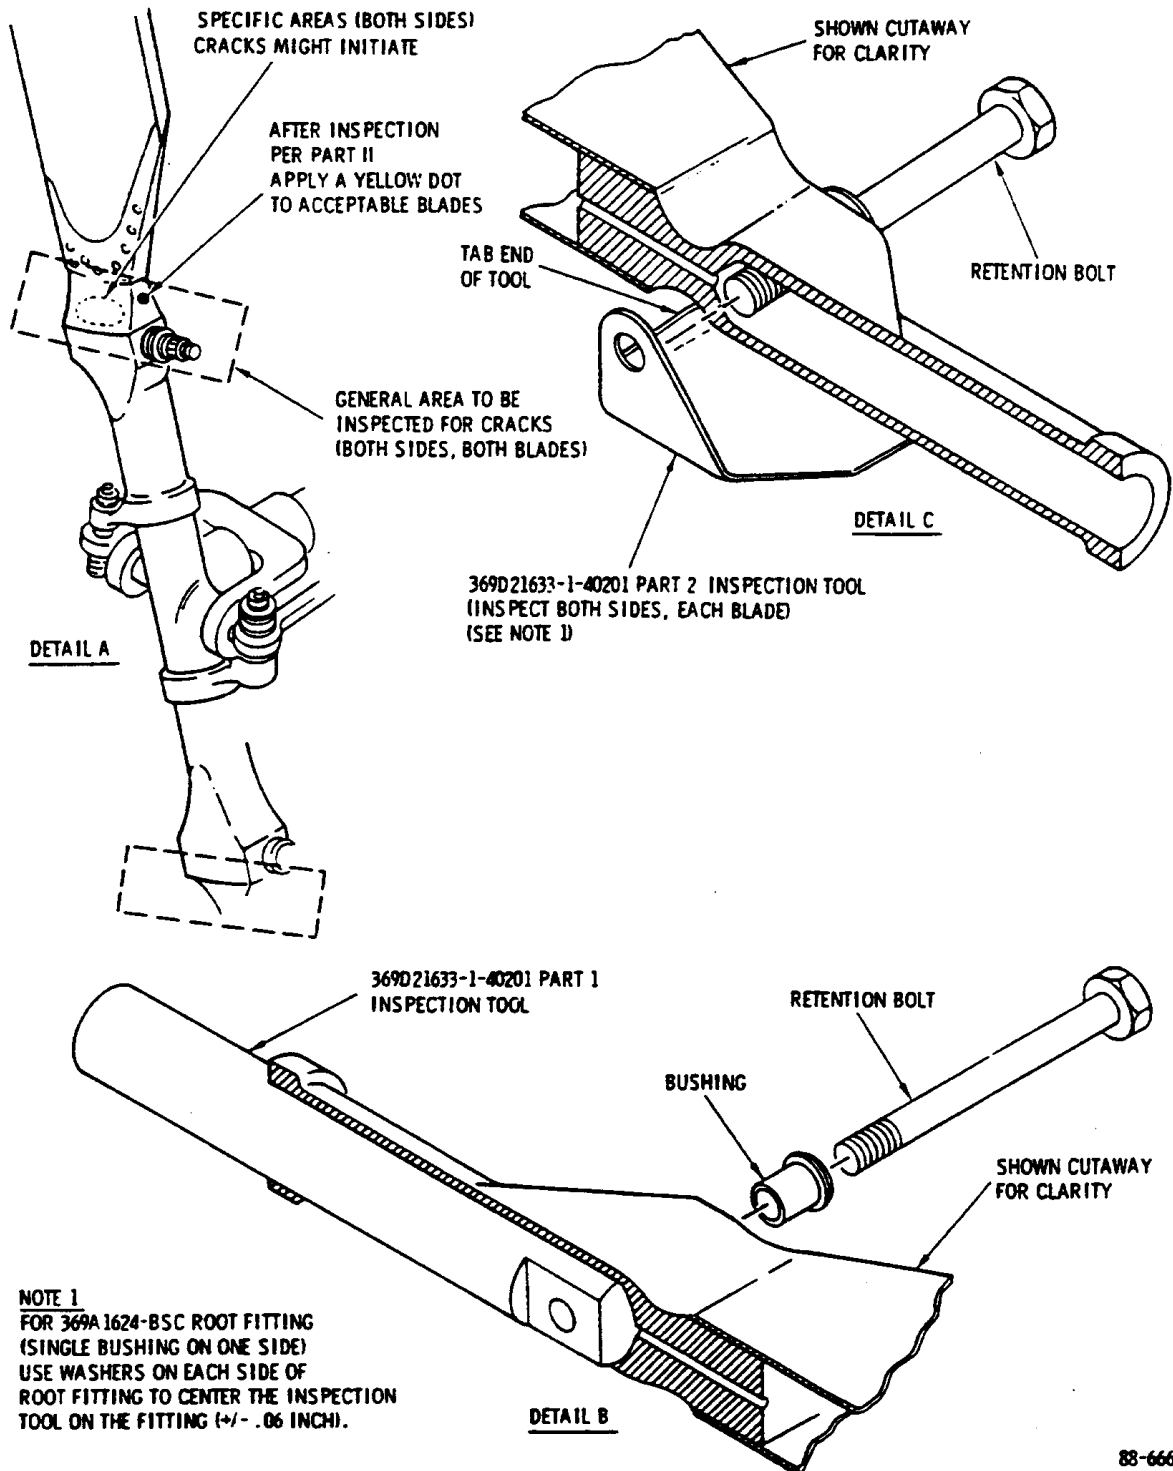
Figure 1. Inspection of Tail Rotor Blade Root Fitting.

SUMMARY: Due to a failure of a tail rotor blade root fitting, MD Helicopters, Inc. (MDHI) is requiring operators to perform an inspection of all aluminum tail rotor blades to ensure that no crack exists in the tail rotor blade root fitting **and** that the tail rotor blade root fitting has proper wall thickness. Thin wall thickness in the tail rotor blade root fitting can lead to tail rotor blade failure.

- Visually check both sides of each tail rotor blade in the area detailed in Figure 1, Detail A, for any indications of cracking.
- Tail rotor blades having indications of cracking shall be removed from service and returned to MDHI for further inspection and warranty consideration.
- As required, install acceptable tail rotor blades per the applicable maintenance manual.

Tail rotor blade is *acceptable* if tail rotor blade retention bolt *cannot* be inserted thru root fitting and inspection tool (Part 1) holes. Unacceptable tail rotor blades shall be removed from service and returned to MDHI Warranty and Repair Department for further inspection and warranty consideration.

Tail rotor blade is **acceptable** when the tail rotor blade attachment bolt **cannot** be inserted thru the root fitting holes and both sides of the inspection tool (Part 2). Unacceptable tail rotor blades shall be removed from service and returned to MDHI Warranty and Repair Department for further inspection and warranty consideration.

c. With HS610C6244R375X375 bushing (Qty. 1) (369A1624-BSC root fitting) or 369H5308 bushings (Qty. 2) and 369H5309 crush washers (369A1624-3 root fitting) installed, ensure, there are no foreign objects inside the bore of the tail rotor blade root fitting. With root fitting vertical, inboard end up, insert the 369D21633-1-40201 Part I inspection tool into the I.D. of the root fitting. Align root fitting strap retention holes with tool hole. (See Figure 1, Detail B.) Attempt to install the retention bolt through the root fitting and tool holes.

d. With HS610C6244R375X375 bushing (Qty. 1) (369A1624-BSC root fitting) or 369H5308 bushings (Qty.2) and 369H5309 crush washers (369A1624-3 root fitting) installed, position the 369D21633-1-40201 Part 2 inspection tool (tab end outboard) over one side of the root fitting. Align the holes in the inspection tool with the blade attach holes in the root fitting. For the 369A1624-BSC root fitting, use washers on each side of the root fitting (equal amounts) to center the inspection tool on the root fitting (See Figure 1, Detail C.). Attempt to install the retention bolt through the tool and the root fitting. (See the following CAUTION.)

f. Apply a yellow dot to acceptable tail rotor blades on the trailing edge of the root fitting approximately 1/2 inch outboard from the bushing. (See Figure 1, Detail A.)
