SERVICE BULLETIN

SUBJECT: REPLACEMENT OF 369A8442-BASIC LATCH ASSEMBLY ON THE PARTICLE SEPARATOR BYPASS DOOR.

MODELS AFFECTED: All McDonnell Douglas Helicopter Company (MDHC) 369 Series helicopters including the 369A (OH-6A) Series helicopter.

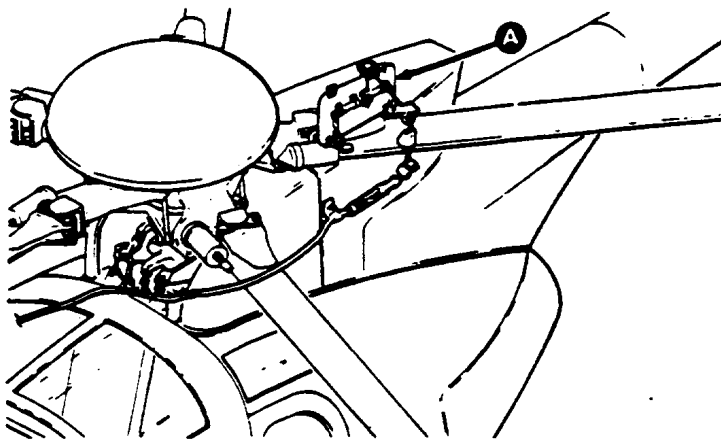
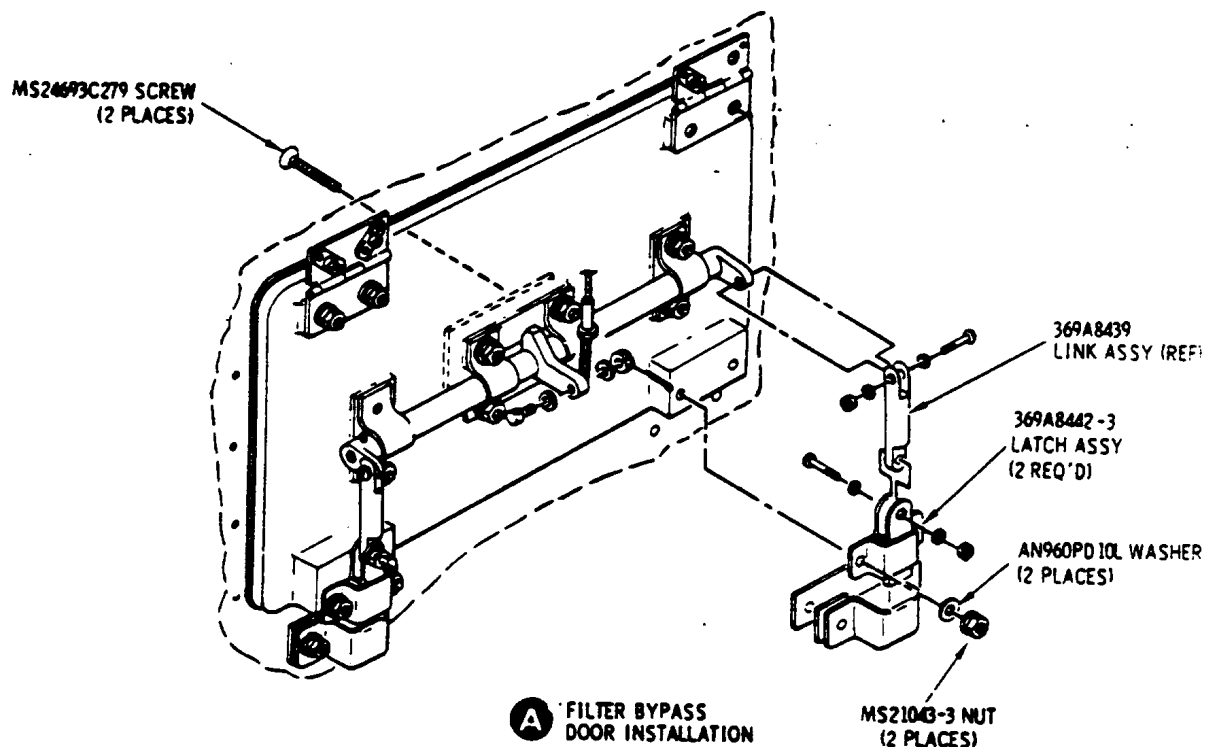
Figure 1. Installation of 369A8442-3 Latch Assemblies

PREFACE: MDHC has received reports of the latches on the engine inlets filter bypass door fracturing and allowing the latch portion of the assembly to fall into the plenum chamber which in turn could result in damage to the engine. A new and improved latch assembly has been introduced to prevent future occurrences of this problem. MDHC is requiring operators to replace the existing latch assembly with the improved design per the instructions given in this Notice.

- a. Disconnect 369A8439 link assemblies from 369A8442-BSC latch assemblies. (See Figure 1)
- b. Remove 369A8442-BSC latch assembly. (two places)
- c. Install 369A8442-3 latch assembly in two places on bypass door.
- d. Attach 369A8439 link assemblies to 369A8442-3 latch assemblies.
- e. Remove FOD cover installed over engine air inlet. Verify that area around base of mast, inlet plenum and entire plenum chamber is free of debris and other foreign objects.
- f. Record compliance to this Notice in the compliance record section of the helicopter log book.
