**McDonnell Douglas
Helicopter Company**
SERVICE INFORMATION LETTER

LETTER NO HL-30
DATE 12 JULY 1973
PAGE 1 OF 2

SUBJECT: REPLACEMENT OF BOOM FAIRING ASSEMBLY ON FIRST
PRODUCTION HELICOPTERS, SN 0001 THRU 0100

MODELS AFFECTED: 369H Helicopter Serial No. 0001 thru 0005
369HS Helicopters Serial No. 0001S thru 0100S
369HM Helicopter Serial No. 0001 thru 0004;
0005M thru 0100M

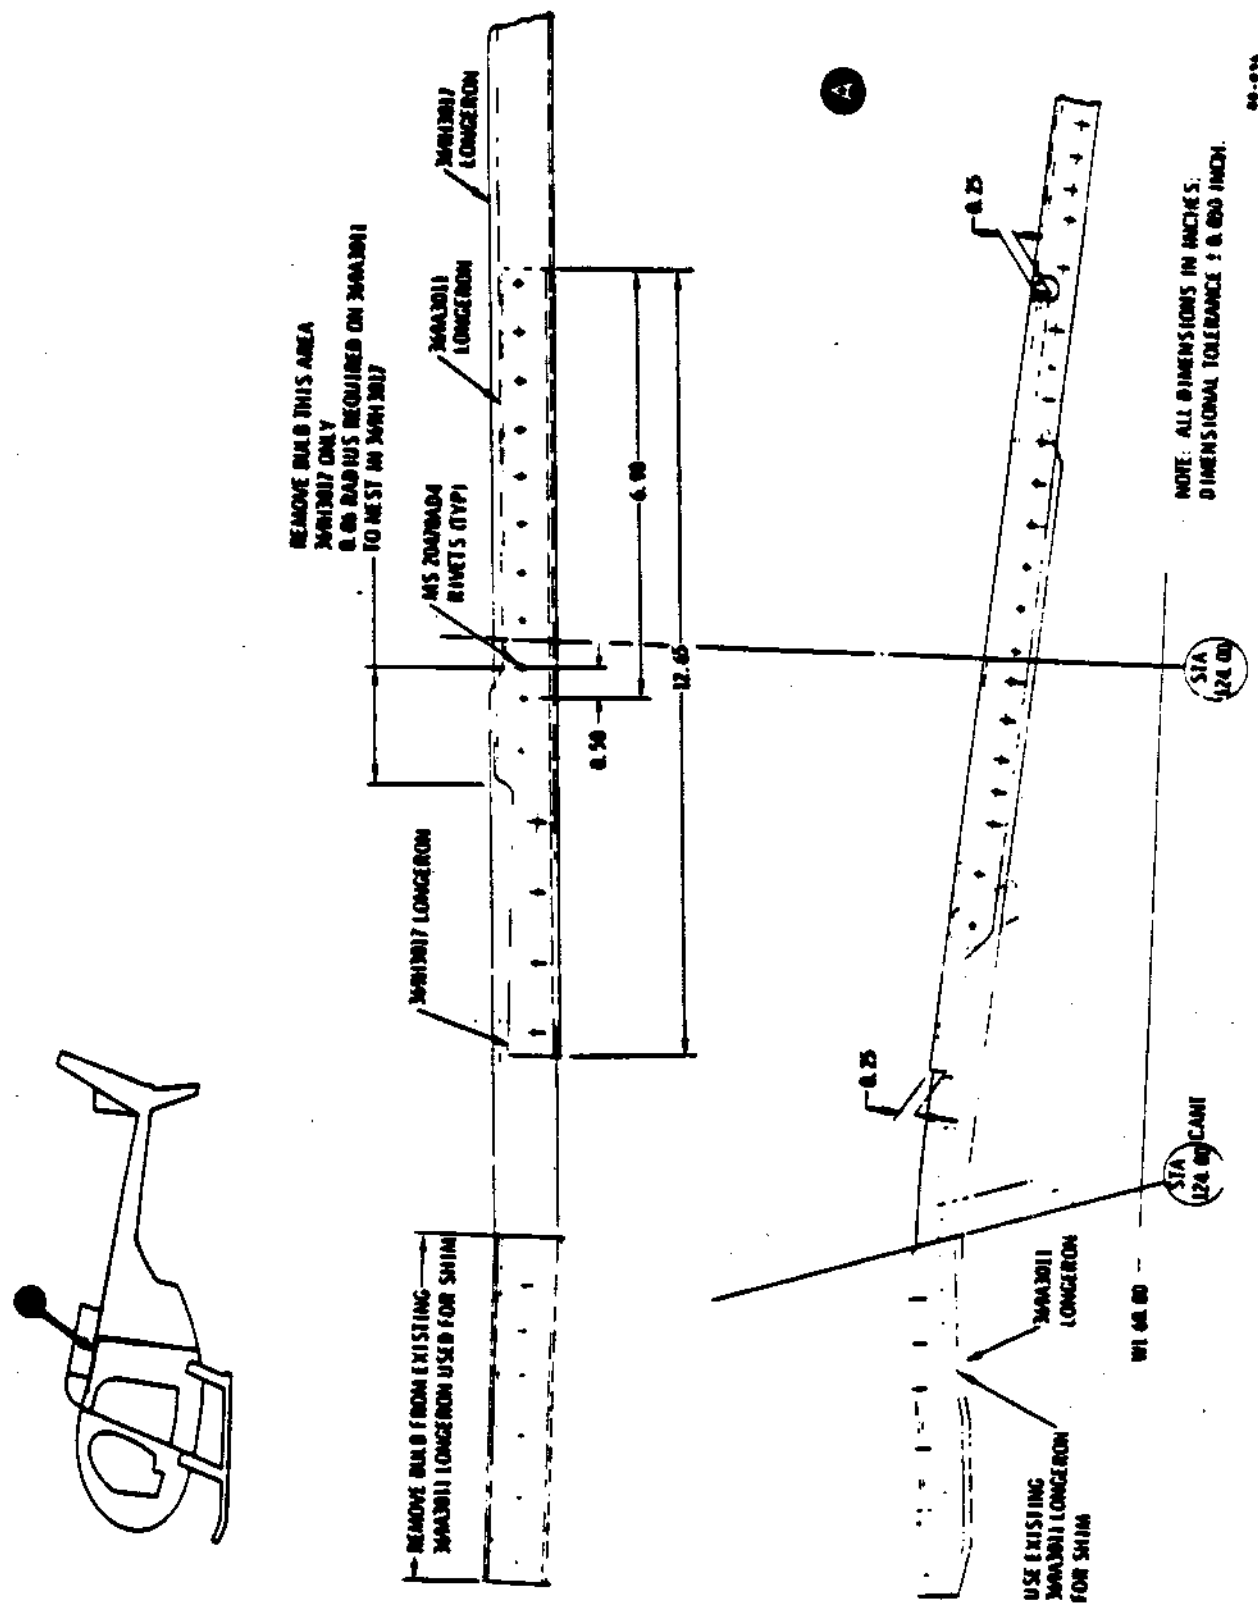
Figure 1. Modification and Replacement of Boom Fairing Assembly

Due to the difference in design of the mast support structure used on the above affected first production helicopters, it is necessary, when installing a replacement boom fairing assembly, to modify and lengthen the 369H3017 upper longerons to permit attachment at the mast support structure.

The method for extending the 369H3017 upper longerons with added sections of 369A3011 longerons is illustrated on page 2 of this letter. As shown, the bulb section of the 369H3017 longeron is removed, and a 0.060-inch radius applied to the added section of the 369A3011 longeron, so that the two pieces will nest together. Also, a section of existing 369A3011 longeron with the bulb section removed is used as a shim at the forward end of the extended 369A3011 longeron, to ensure a proper fit when riveted to the mast support structure. No additional rivets are added to the side of the longerons. The rivet spacing on the top of the longerons at the shim area is increased.
