TECHNICAL BULLETIN

DATE: 6 JUNE 1978
PAGE 1 OF 3

REPLACEMENT OF PLENUM WALL FITTINGS – TORQUE PRESSURE GAGE TUBING AND ENGINE OIL PRESSURE GAGE TUBING

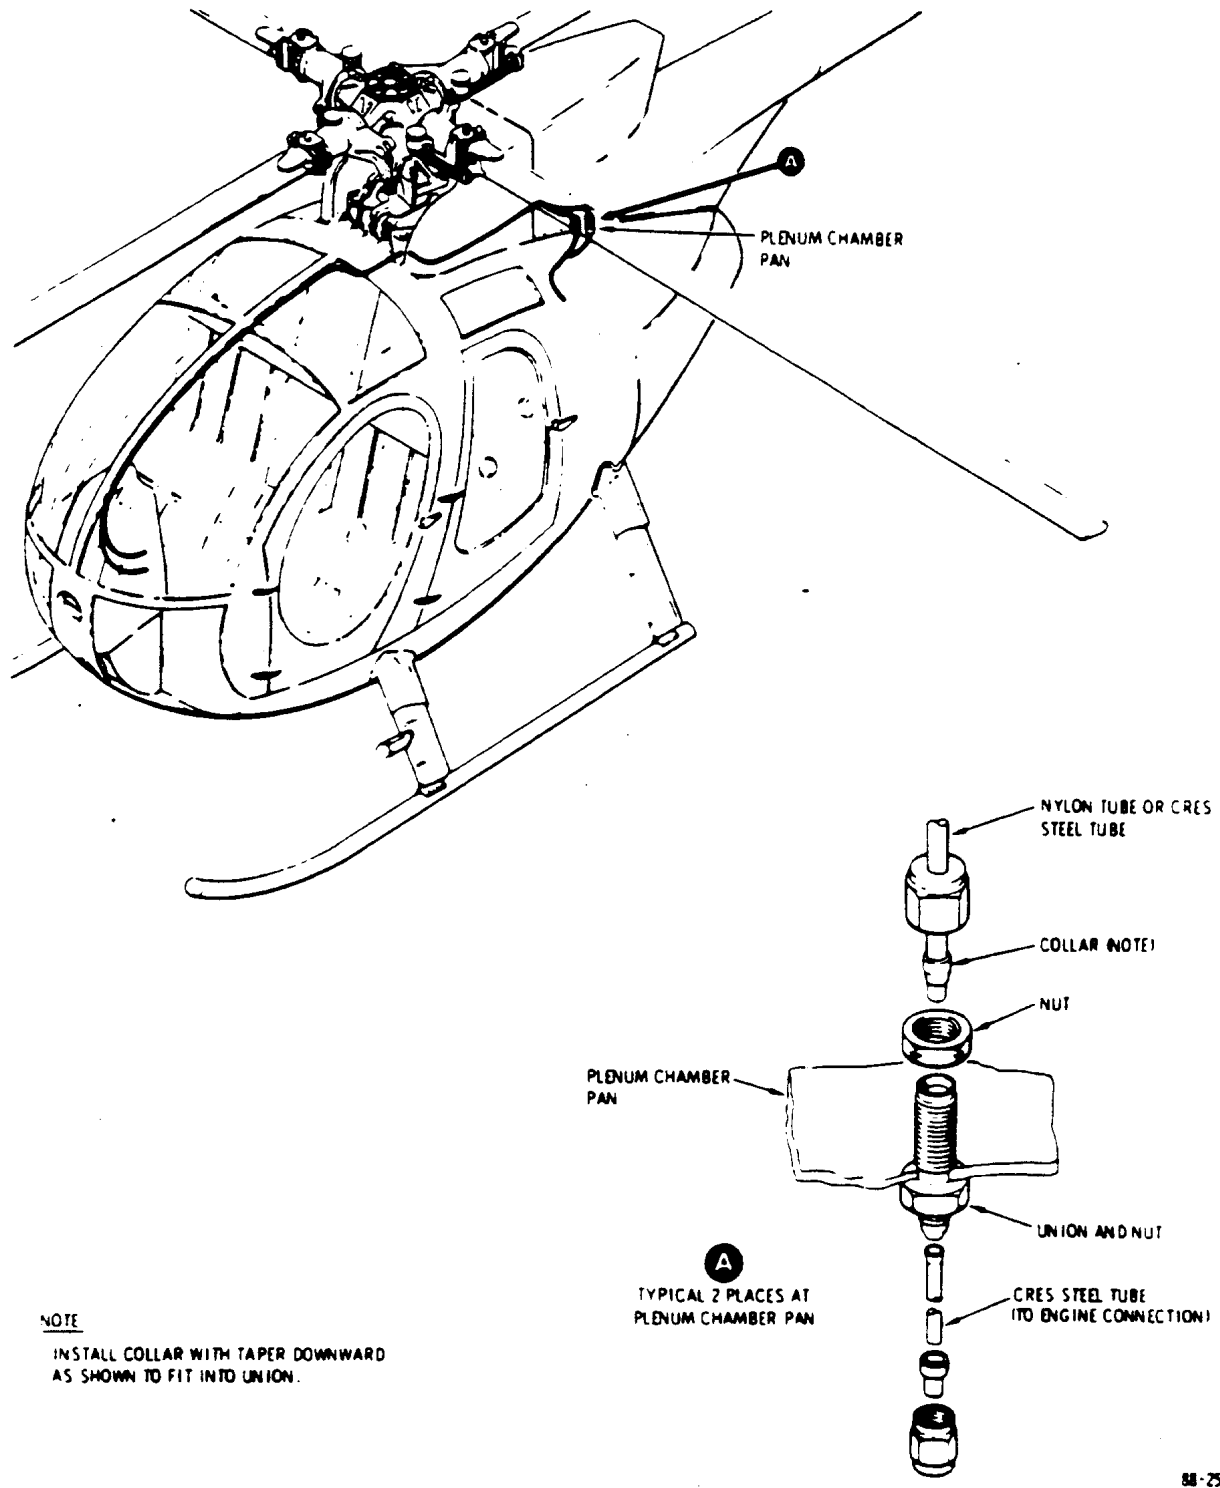
Figure 1. Replacement Of Plenum Wall Fittings - Oil/Pressure Gage Tubing Torque.

Field reports indicate that breakage and damage to the reducer installed on the plenum chamber pan fitting has occurred during normal service or removal and installation of the engine oil pressure line. Installation of new type fittings is recommended for both the torque pressure gage line and engine oil pressure gage line, to facilitate removal and installation of the tube assemblies and preclude possible breakage and failure of the fittings.

- (3). Open LH engine compartment access door.
- (4). Disconnect pressure line nuts at forward and aft sides of both plenum chamber pan fittings. Cap pressure lines. Refer to Basic HMI.
- (5). Remove existing fittings (reducers and unions) from plenum chamber pan.
- (6). Install new AS12-3XH2BZ-SS-T fittings at plenum chamber pan, as shown in Figure 1.
- (7). Uncap lines and connect forward and aft sections of engine oil pressure and torque pressure gage lines to new fittings.
- (8). Check installation of new fittings for discrepancies.
- (9). Perform pressure and leak test of both lines between engine and gages at 200psi.
- (10). Bleed and service oil pressure lines, per basic HMI.
- (11). Close engine compartment access door. Reinstall aft bulkhead access cover and engine air intake fairing.
