SERVICE LETTER

SL369H-134 SL369D-113 SL369E-065 SL369F-058 SL500N-010 SL600N-007

REQUIRED INSPECTIONS AND CRITICAL INSPECTION AREAS

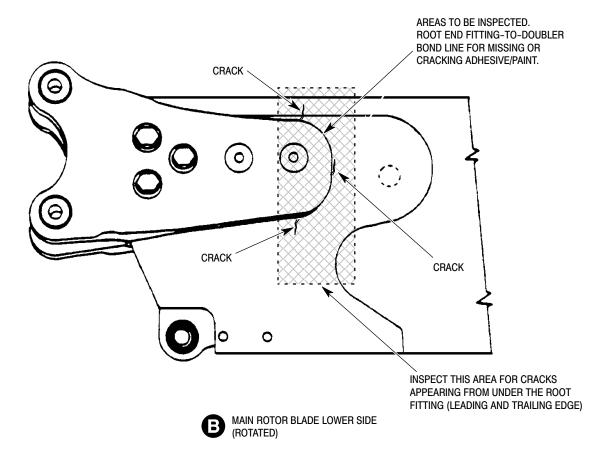
Figure 1. Main Rotor Blade and Lead-Lag Link Critical Areas

MD Helicopters Inc. (MDHI) wishes to emphasize the critical areas of the main rotor blade and lead-lag links for helicopters that average more than six Torque Events per hour (Refer to Figure 1). These areas are already included in the pilot preflight and maintenance inspections, but become more critical for helicopters which average more than six Torque Events per hour.

Owners/operators should review and perform all the required inspections and checks at the required intervals published in the Airworthiness Limitations Section, Continued Airworthiness Section, Service Information Notices/Service Bulletins, Airworthiness Directives and Rotorcraft Flight Manual. The inspections/checks and intervals are critical for safe flight and continued airworthiness.
