# **TECHNICAL BULLETIN**

## REWORK OF ONE-WAW LOCK ASSEMBLY, PN 369A7010 SERIES

All Model 369H Series Helicopters ALL PN 369A7010 Series One-Way Lock Assemblies in Spares Inventory at date of this Notice

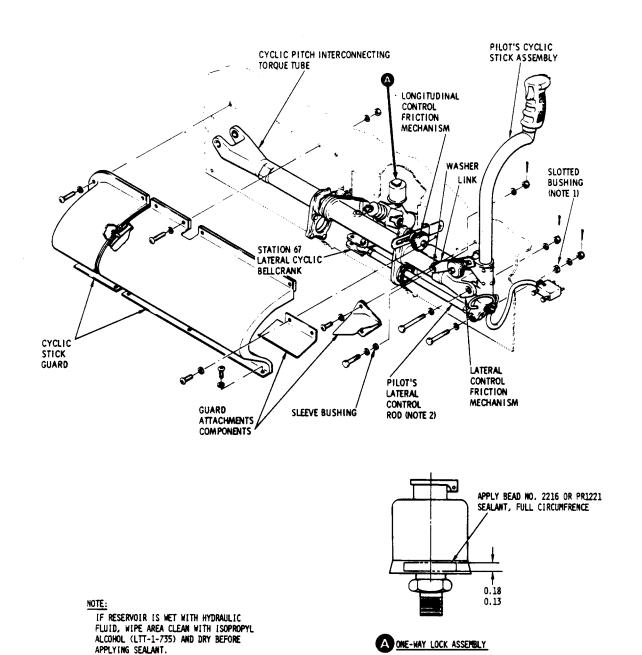
Figure 1. Rework of One-Way Lock Assembly

This Service Information Notice lists a procedure to seal the One-Way Lock Assembly to preclude leakage and-loss of fluid from around of base.

- a. Remove one-way lock from helicopter. (Refer to Section 7 of Basic HMI)
- b. Prepare No. 2216 of PR1221 class B per manufacturer's instructions.
- c. Using extrusion gun or spatula, apply 0.18/0.13-inch bead of sealant full circumference between base of reservoir and bowl flange and dry per manufacturer's instructions. (See Figure 1.)
