SERVICE BULLETIN

DATE: 12 SEP 1977

REWORK OF PN 369A7120 LONGITUDINAL FRICTION GUIDE LINK, CYCLIC PITCH CONTROL INSTALLATION

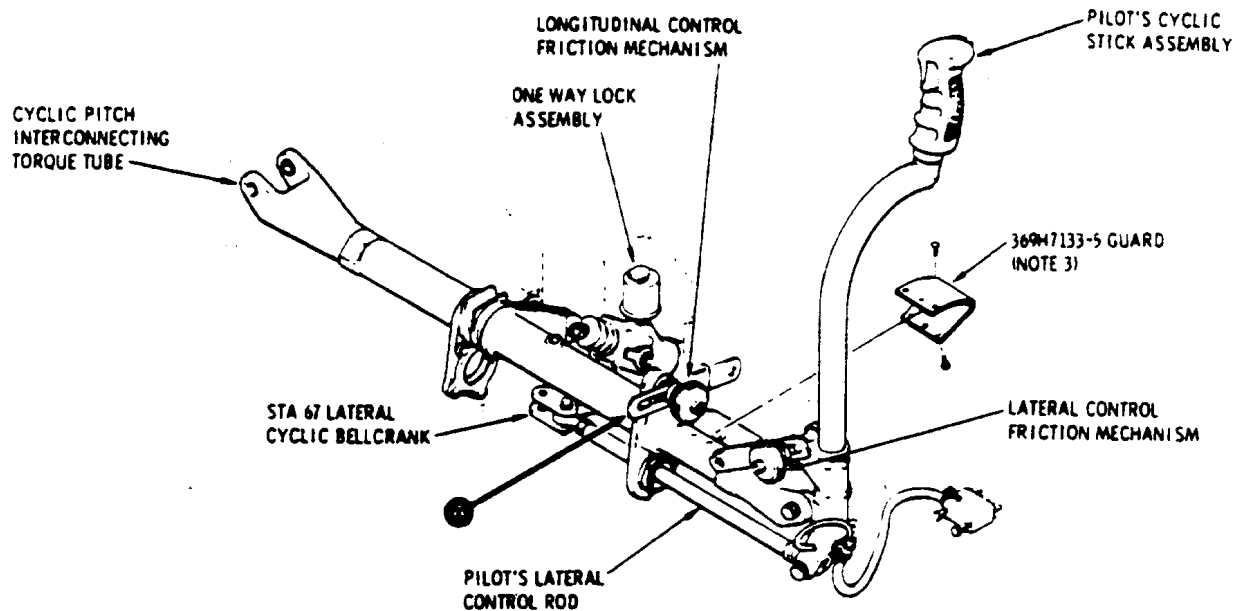
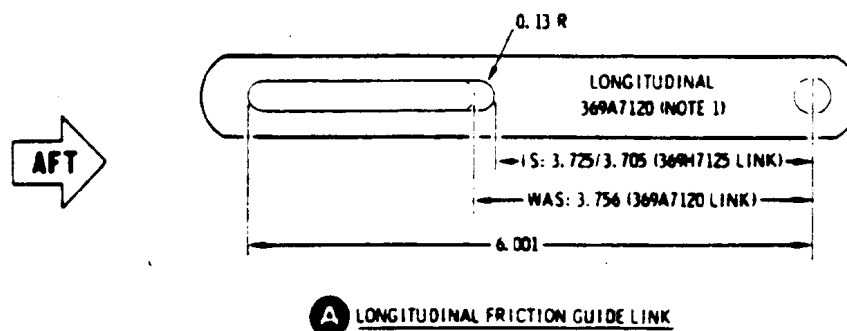
Figure 1. Rework of 369A7120 longitudinal friction guide link to 369H7125 config.

The information given in this Service Information Notice lists a procedure for field modification of the subject longitudinal friction guide link in order to increase the full aft travel when rigging cyclic controls. Rework of the guide link is designed to facilitate rigging and obtain proper blade angle travel with cyclic pitch control at full aft position.

- (2). Using hand file or portable grinder, elongate aft end of slot in link, per dimensions shown in Figure 1.
- (3). Reidentify reworked link with new part number, 369H7125; use electric etching pen or impression stamp.
- (4). Reinstall link and cyclic friction mechanism.
- (5). Check cyclic stick operation through full travel of friction guide link slot.

NOTE: Early model helicopters may be equipped with 369H7133-5 guard riveted (6 places) to the interconnecting torque tube below the friction control mechanism (see figure 1). If guard is installed and interference between guard and seat structure is noted after rework of guide link, remove guard from torque tube.

1. AFTER REWORK, REIDENTIFY LINK PN 369H7125.
2. ALL DIMENSIONS IN INCHES.
3. REMOVE GUARD IF INTERFERENCE IS NOTED.
