TECHNICAL BULLETIN

REWORK OF STATIC PRESSURE TUBE INSTALLATION TO MINIMIZE ALTIMETER NEEDLE OSCILLATION

All 500 Models 369H Series Helicopters

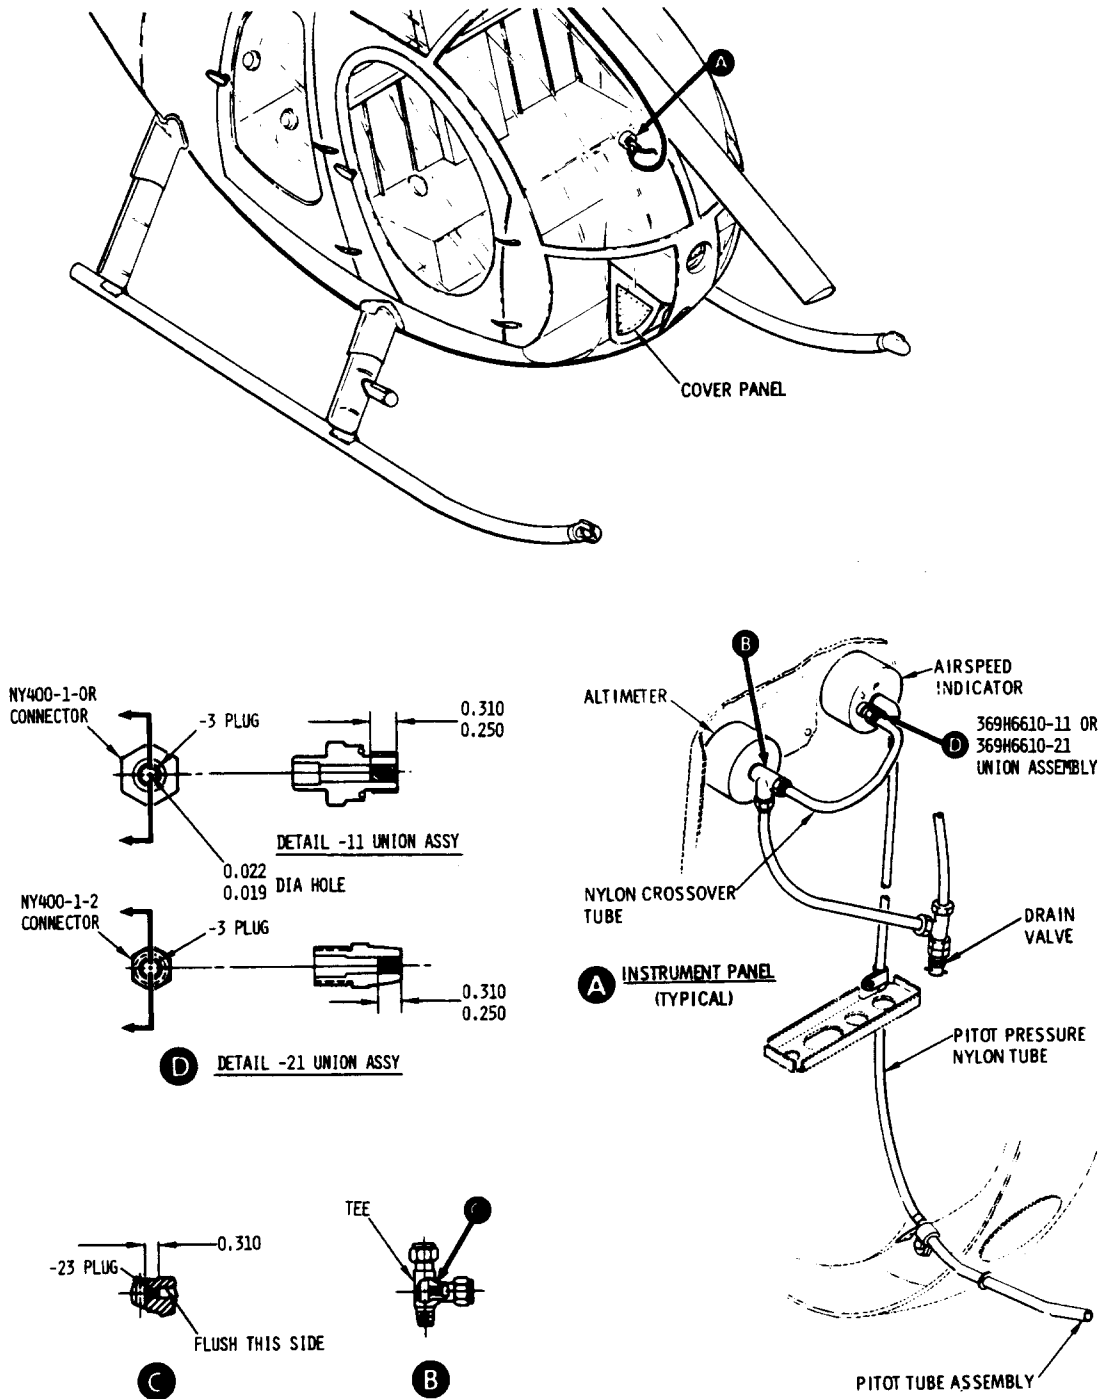
Figure 1. Rework of Static Pressure Tube Installation

The information given in this Service Information Notice lists a procedure for rework of the hardware connecting the crossover tube between the altimeter and airspeed indicators on the instrument panel to reduce needle bounce. The rework consists primarily of removing the existing 369H6610-3 plug from the connector at the airspeed indicator and installing a new 369H6610-23 plug in the existing tee at the altimeter indicator.

- a. Check that all electrical power is OFF.
- b. Remove instrument panel fairing and hood, per Basic HMI.
- c. Disconnect drain tube from 369H6628 tee at altimeter indicator. (See Figure 1.)
- d. Press fit new 369H6610-23 plug into tee as shown, reconnect drain tube to tee. (See View B.)
- e. Disconnect crossover tube from connector at airspeed indicator.
- f. Remove existing -3 plug from 369R6610-11 or -21 union assembly.
- g. Reconnect crossover tube to connector at airspeed indicator.
- h. Reinstall instrument panel fairing and hood.
- i. Perform flight test to check instrument operation.
