SERVICE BULLETIN

DATE: 21 NOVEMBER 2011
PAGE 1 OF 6

TAIL ROTOR BLADE ASSEMBLY INSPECTION

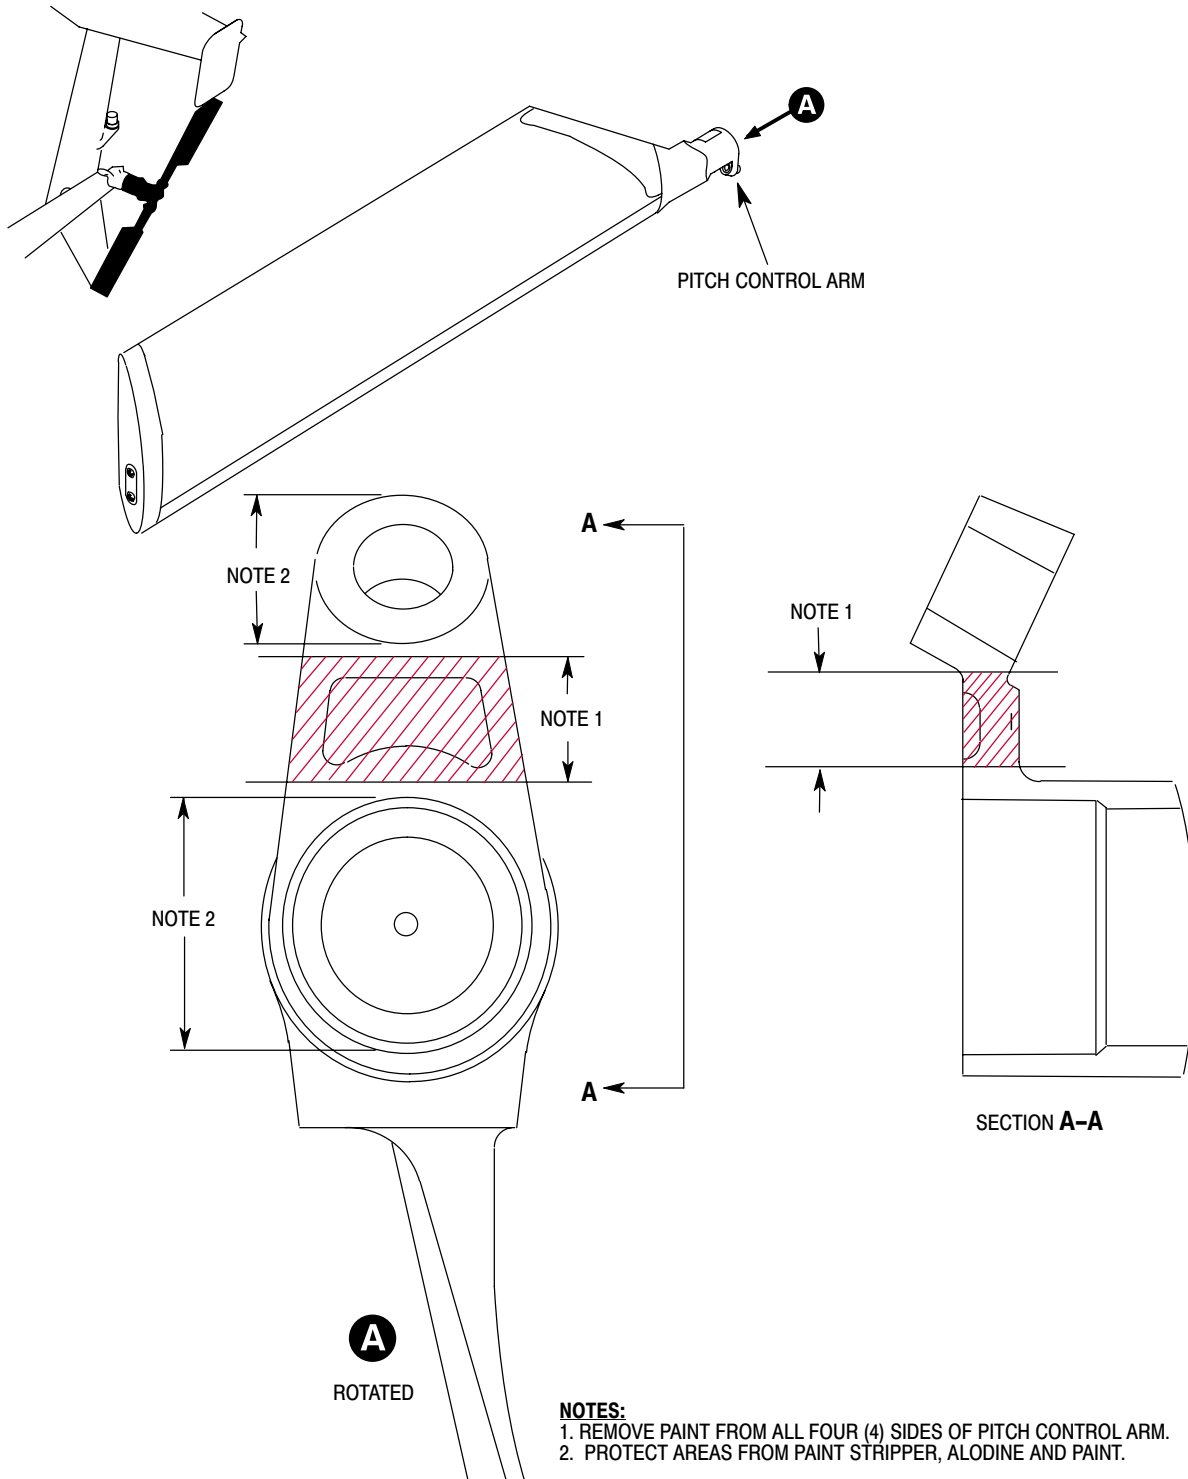
Figure 1. Tail Rotor Pitch Control Arm

Failure to comply with this bulletin can result in the pitch control arm separating from the tail rotor blade. This will lead to an unbalanced condition, vibration, partial loss of tail rotor pitch control and possible loss of directional control of the helicopter.

Perform this Bulletin within five (5) flight hours of receiving this Bulletin. Remove Tail Rotor Blade Assembly, strip paint and inspect each pitch control arm (all four sides and the pocket) for corrosion, corrosion pitting or cracks in the hatched areas shown in Figure 1 of this Bulletin.

- (4). (Ref. Figure 1 hatched area). Use a bright light and 10X magnifying glass to inspect the tail rotor blade pitch control arm (all four sides and the pocket) for corrosion, corrosion pitting or cracks. No corrosion, corrosion pitting or cracks are allowed. If corrosion, corrosion pitting or cracks are present, replace blade assembly before next flight. (Ref. CSP-HMI-2, Section 64-10-00 or CSP-H-2, Section 8). Mark the defective tail rotor blade assembly as scrap and destroy.

- (5). Make sure the inspection area has a “dimpled” shot peen surface texture. If the inspection area surface is not shot peened or there is evidence of blending or material removal that affected the shot peened surface, replace blade assembly before next flight. (Ref. CSP-HMI-2, Section 64-10-00 or CSP-H-2, Section 8). In addition, check rotorcraft maintenance records to make sure no rework was done in this area. Mark the defective tail rotor blade assembly as scrap and destroy.

- (6). If no corrosion, corrosion pitting or cracks exist and the inspection area has an acceptable shot peen surface texture, refinish stripped pitch control arm as follows:

- (a). Apply alodine per instructions contained in the CSP-HMI-2, Section 20-40-00 or CSP-H-2, Section 2).
 - (b). Apply primer and paint to match original as required (Ref. CSP-HMI-2, Section 20-30-00 or CSP-H-2, Section 2).
